west virginia department of environmental protection

**ORDER
ISSUED UNDER THE
WATER POLLUTION CONTROL ACT
WEST VIRGINIA CODE, CHAPTER 22, ARTICLE 11**

ORDER NO.: 8749

1. Rover Pipeline LLC is conducting land disturbance activity in Doddridge and Tyler Counties, West Virginia. Rover Pipeline LLC was issued Water Pollution Control Permit No. WV0116815, Registration No. WVR310726 on December 15, 2016.

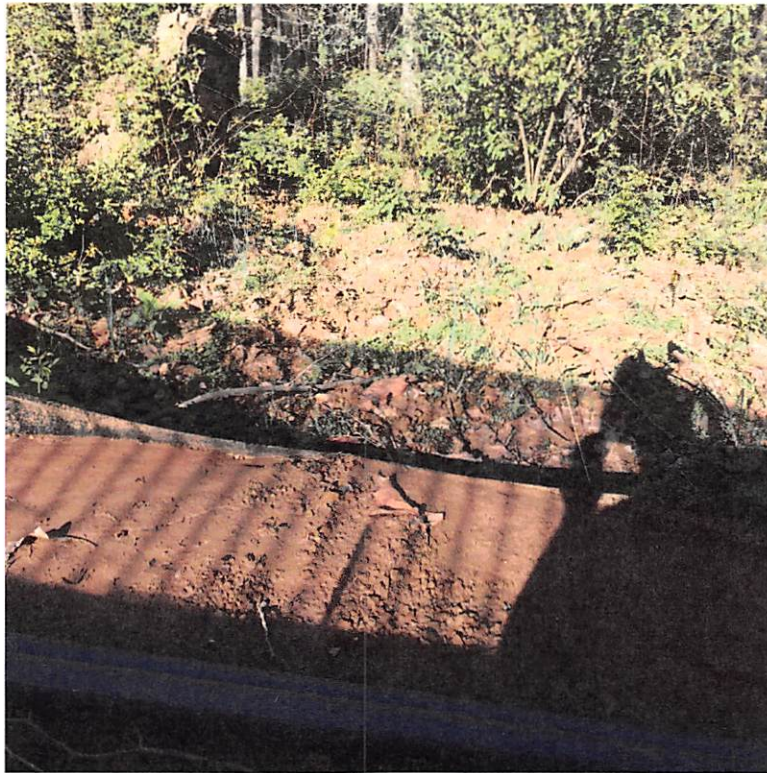
Improperly maintained silt fence at Sherwood Compressor.

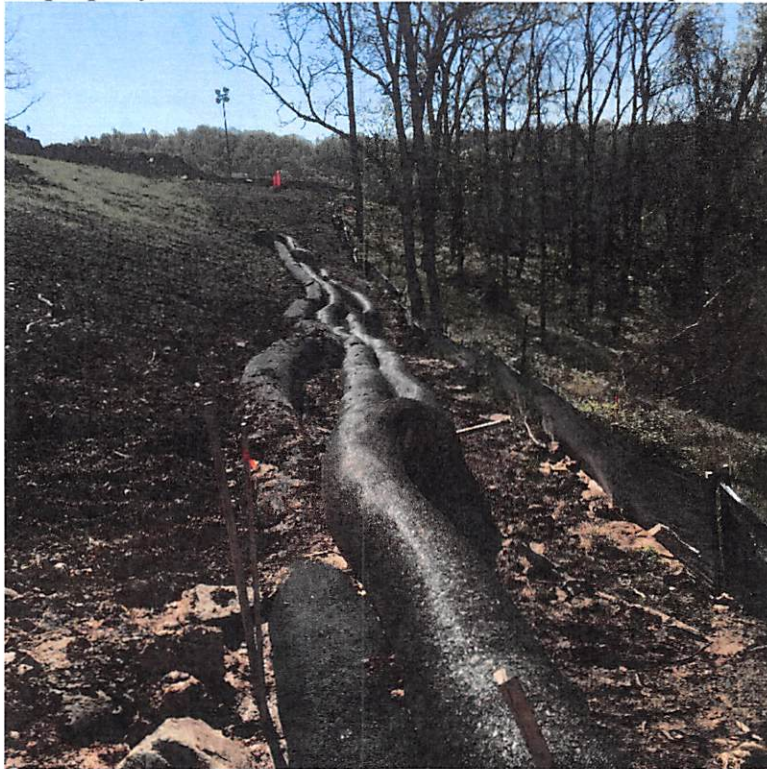
Maintenance issues and improperly installed controls (spacing and method of staking of filter sock) at Sherwood Compressor.

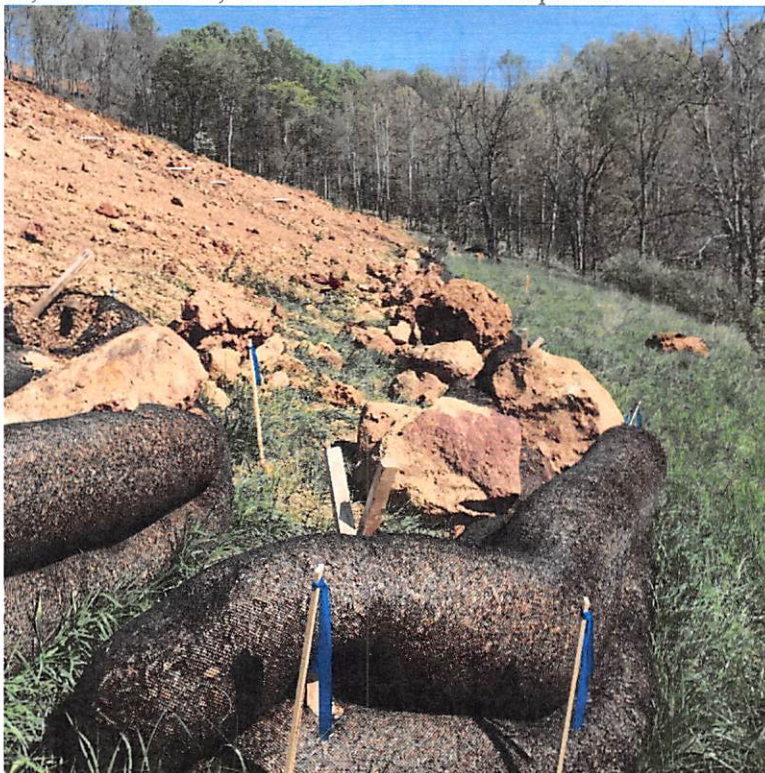
Maintenance issues at Sherwood Compressor.

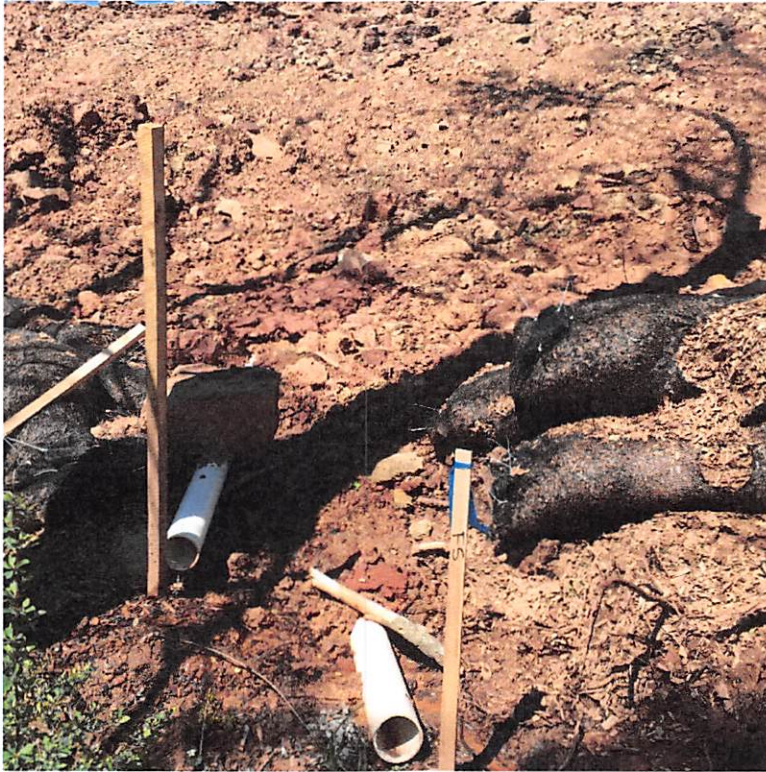
Improperly installed controls (removal of section of filter sock) at Sherwood Compressor.

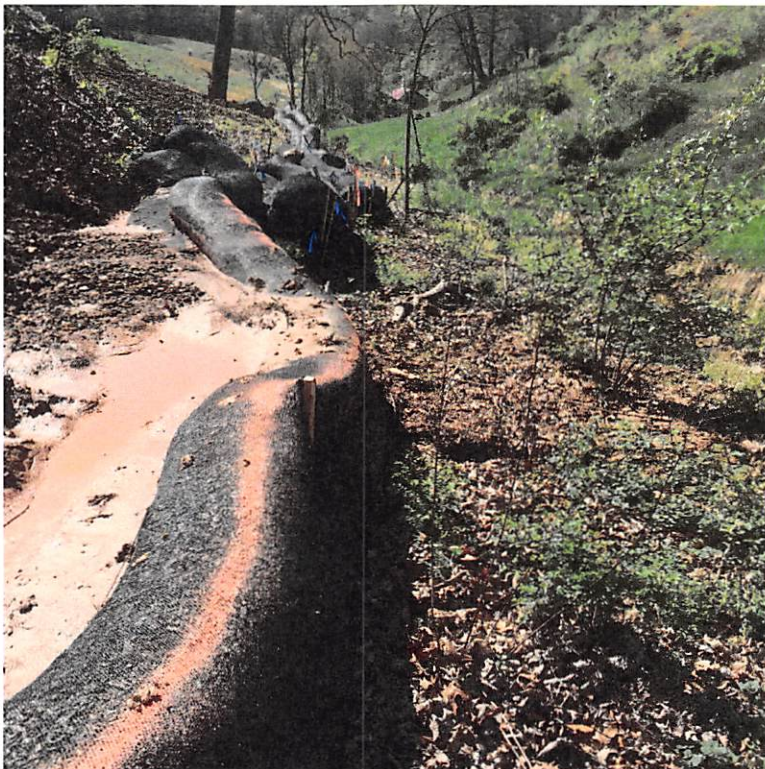
Maintenance issues at Sherwood Compressor.

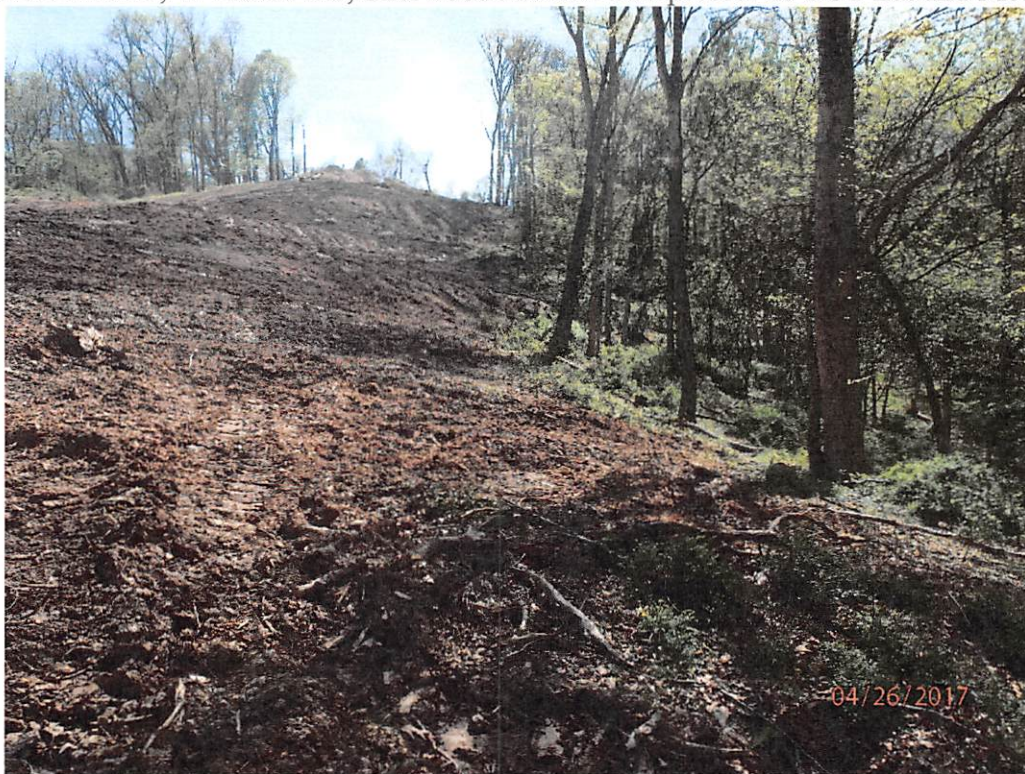
Areas of disturbed soil lacking E&S controls on Sherwood Lateral pipeline ROW.

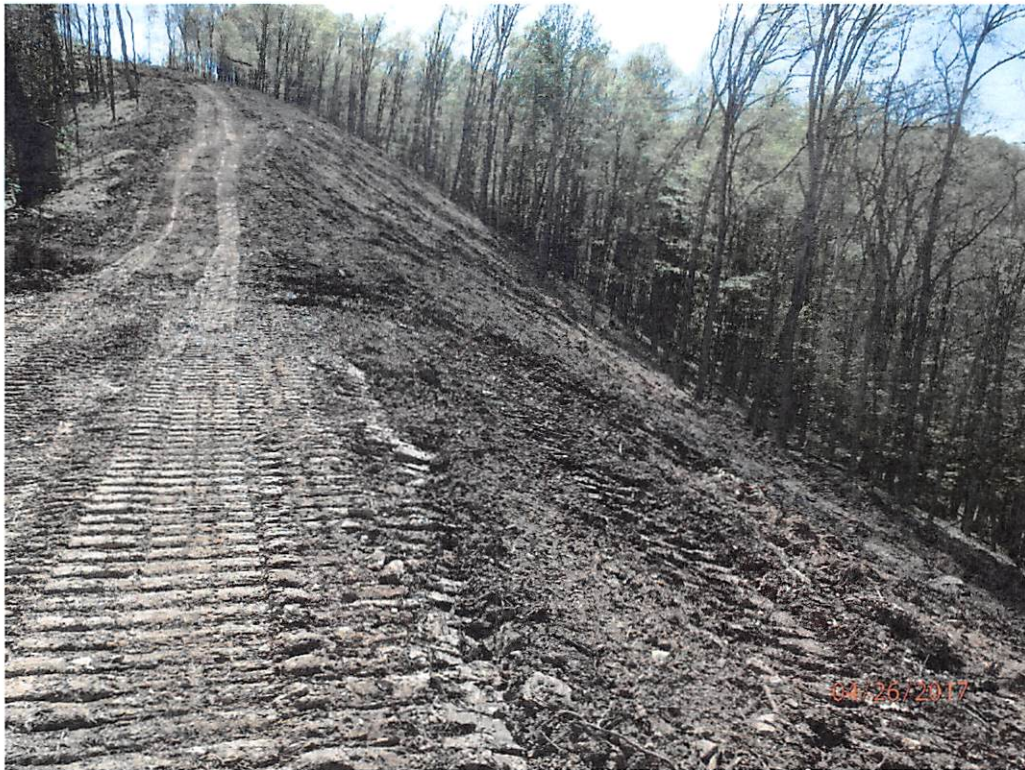
Areas of disturbed soil lacking E&S controls on Sherwood Lateral pipeline ROW.

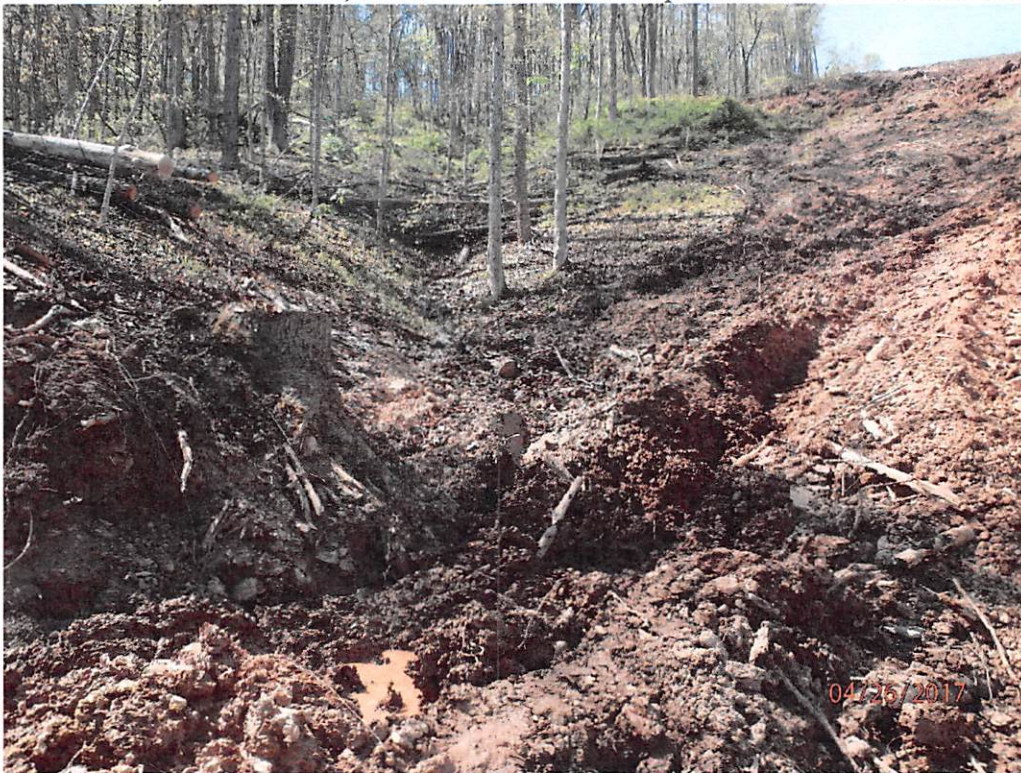
Ephemeral stream that has had equipment in channel. Soil has been disturbed with no E&S controls in place.

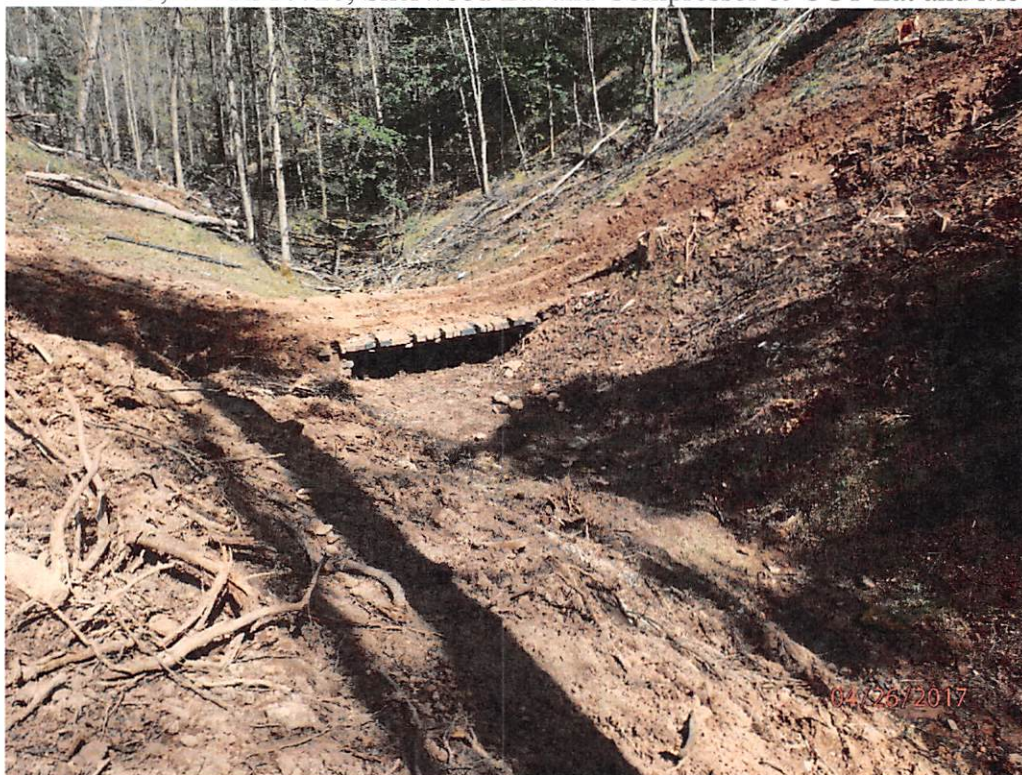
UNT of Buckeye Creek (Sherwood Lateral Pipeline ROW). Disturbed soil with no controls in place and sediment deposits in stream.

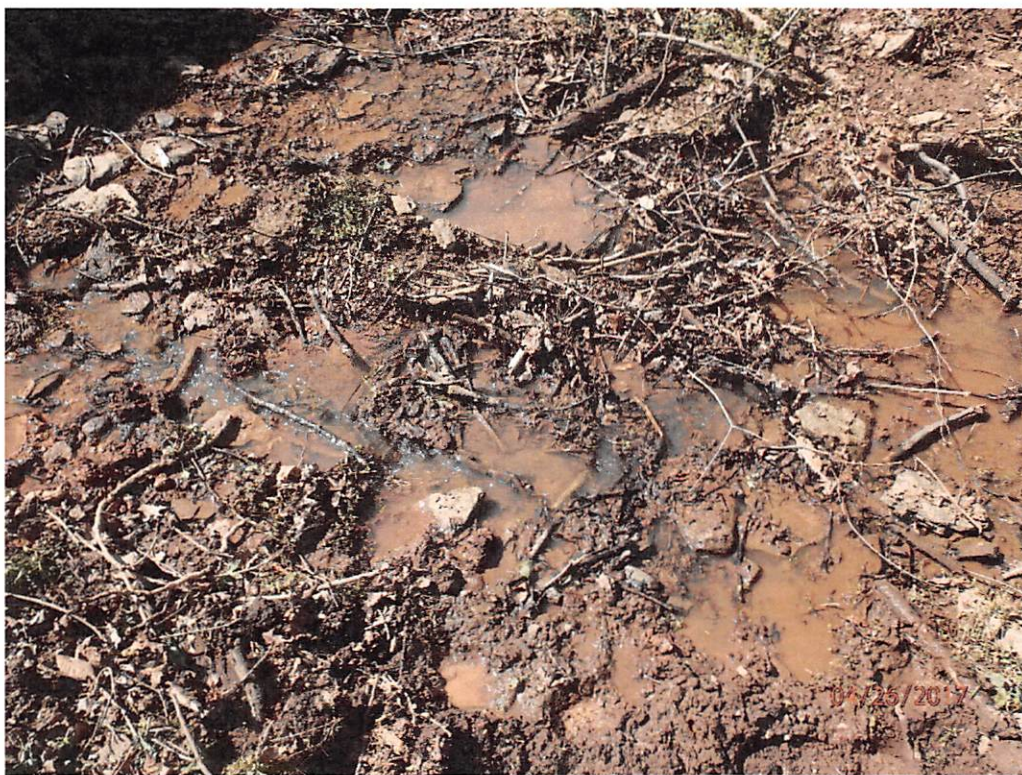
UNT of Buckeye Creek (Sherwood Lateral Pipeline ROW). Disturbed soil with no controls in place and sediment deposits in stream.

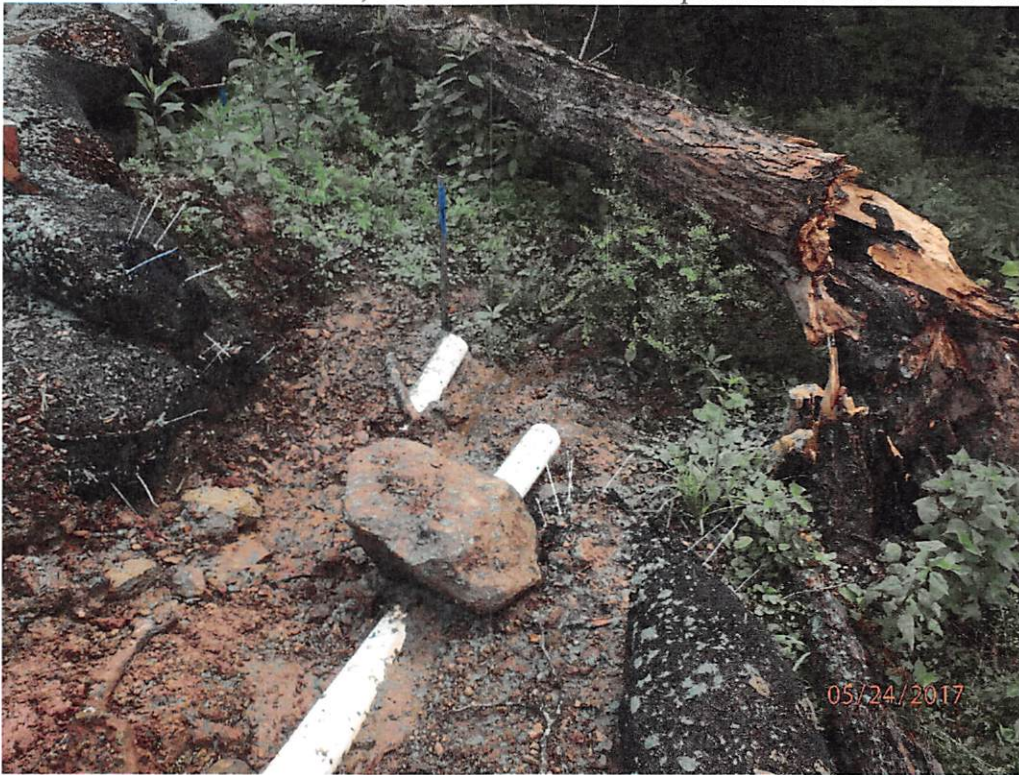
Portion of filter sock downslope of compressor site near Eibscamp Run that is improperly installed.

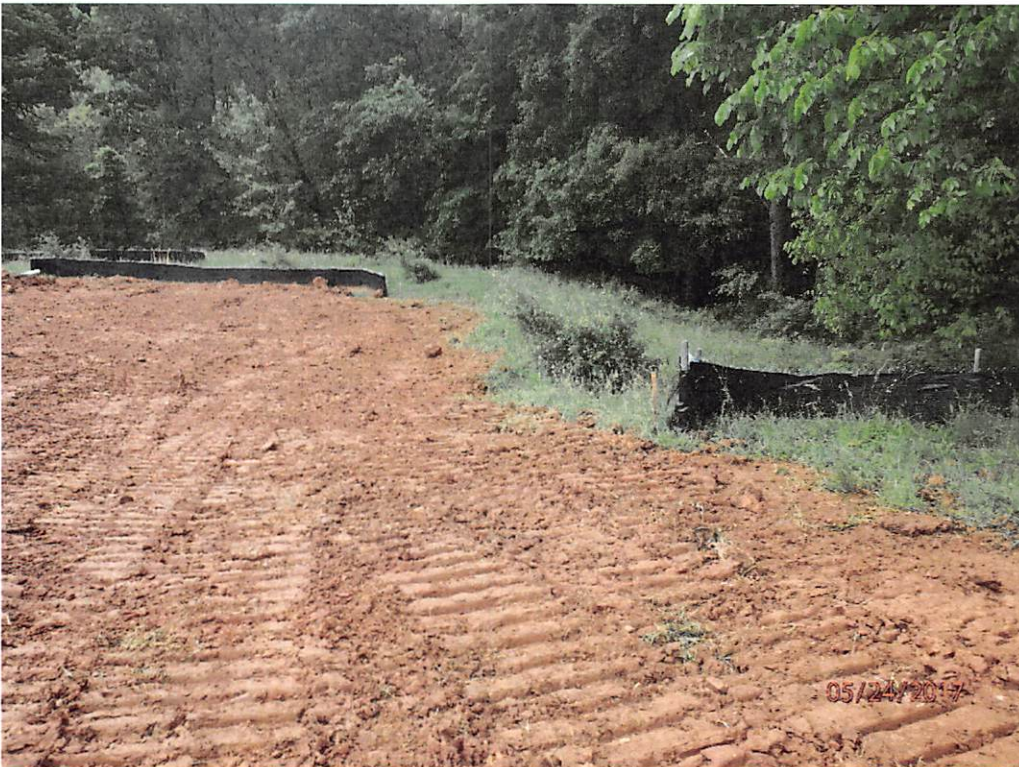
Silt fence on the western perimeter of the compressor site that needs to be extended.

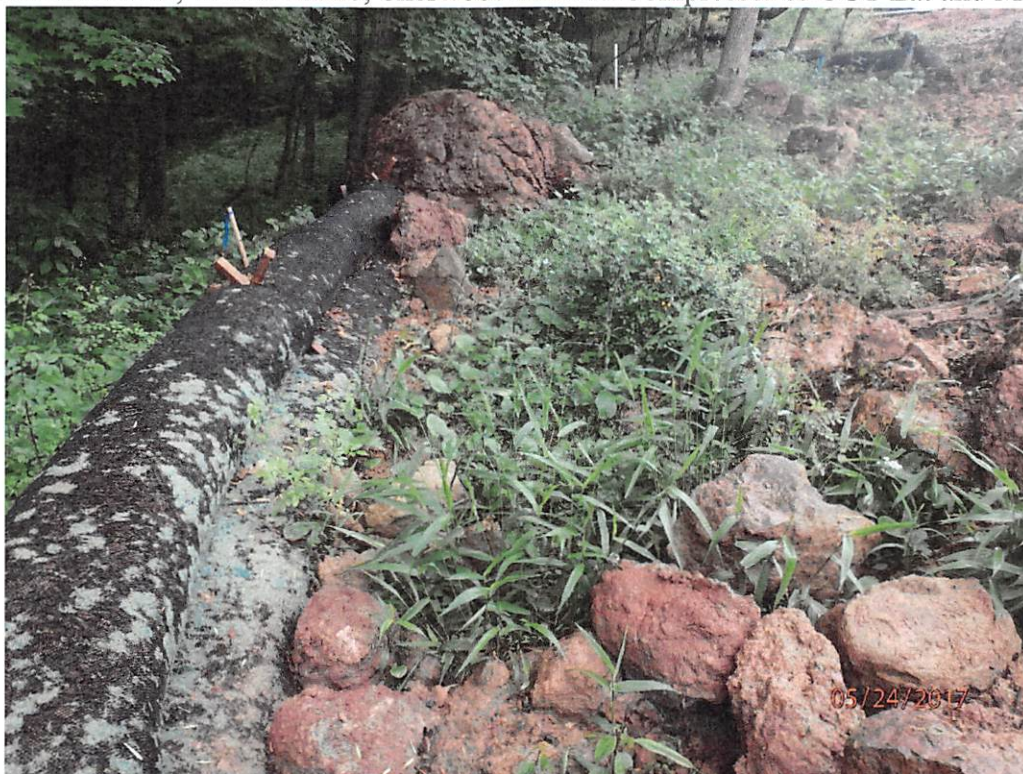
Perimeter controls below access road on compressor site.

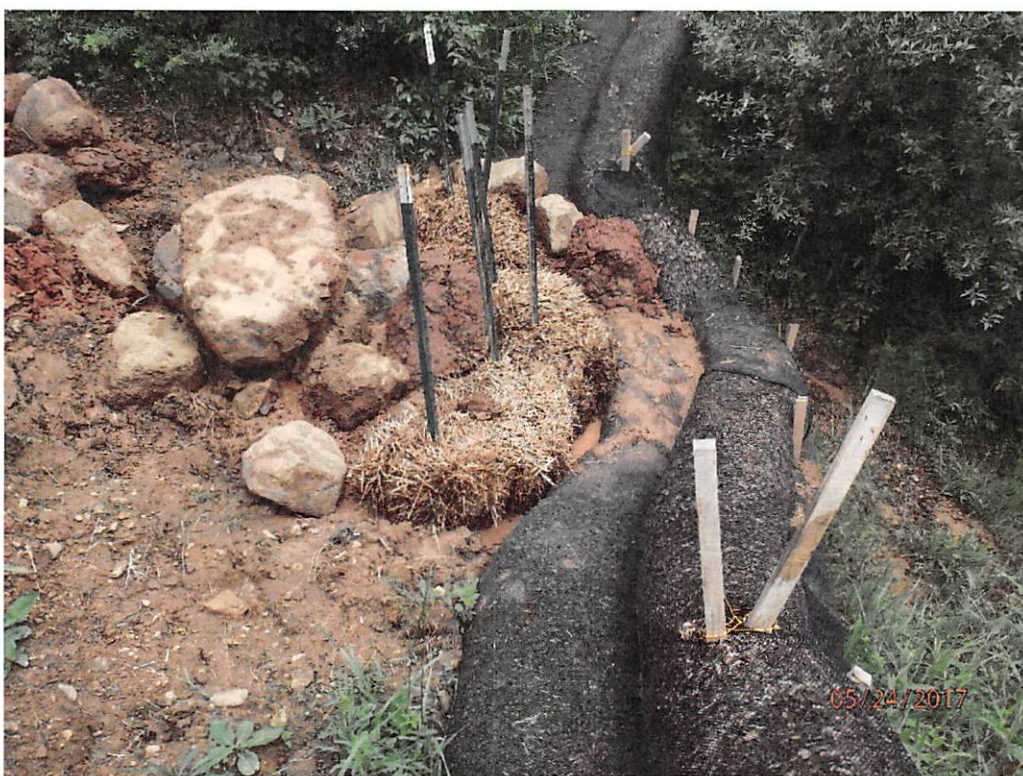
Perimeter controls below compressor site near Eibscamp Run.

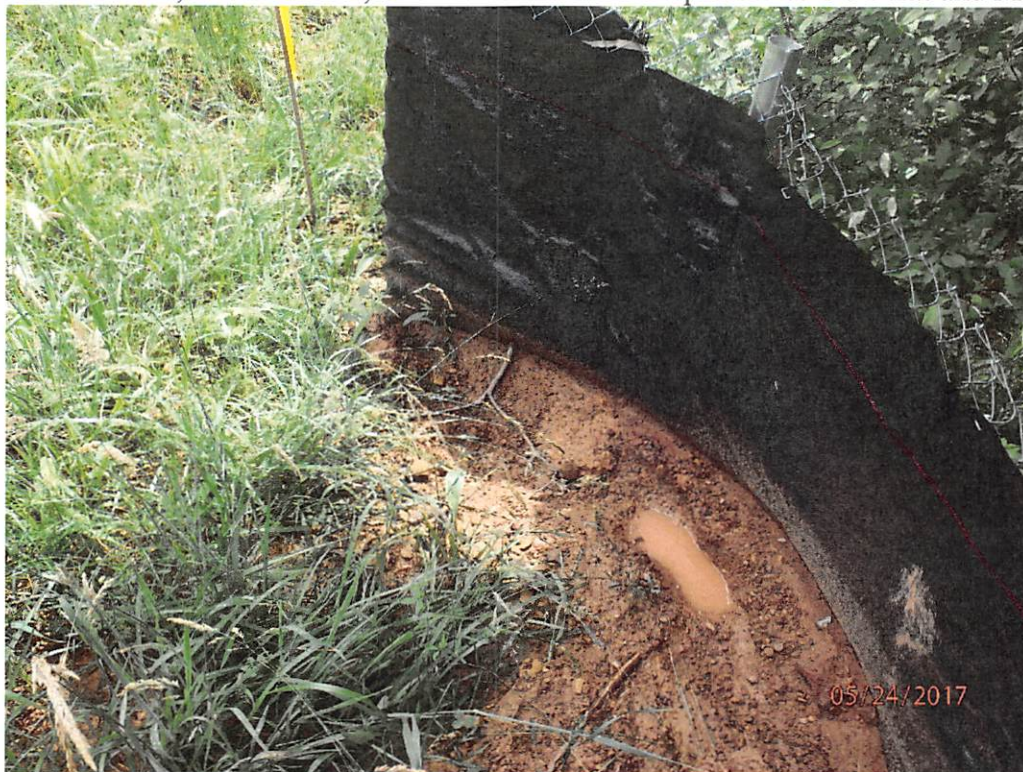
Perimeter controls west of compressor station in need of maintenance.

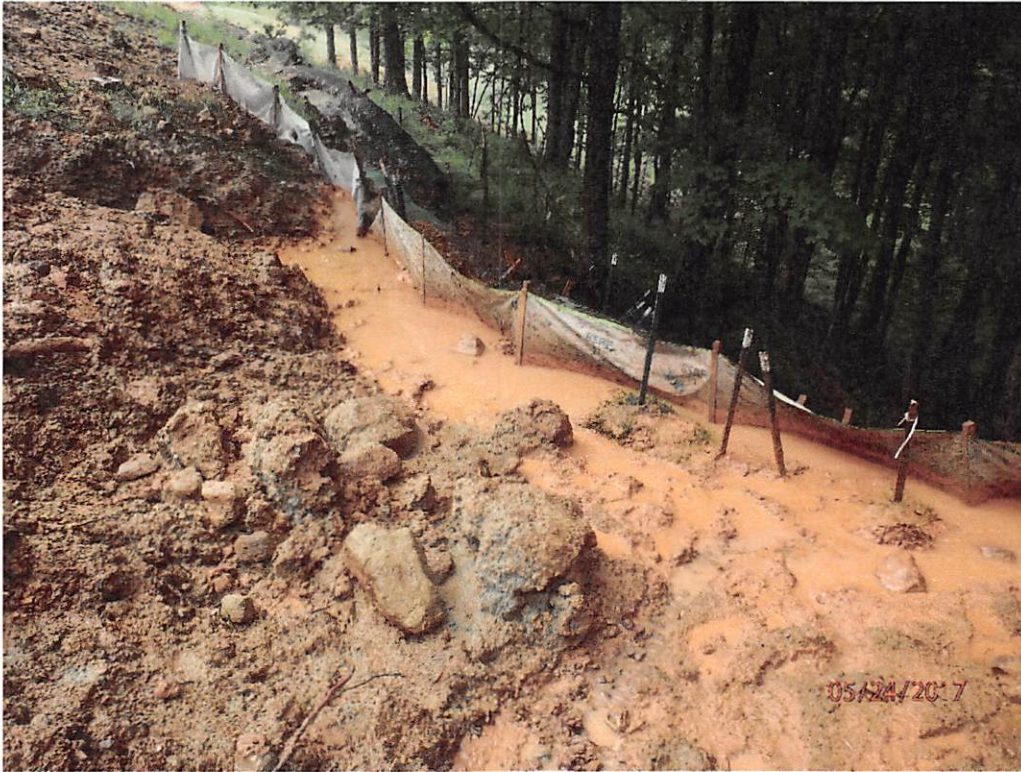
Area below compressor access road where concentrated flow is being treated with sheet flow controls. This area is consistently being overwhelmed which is causing sediment laden water to leave the site.

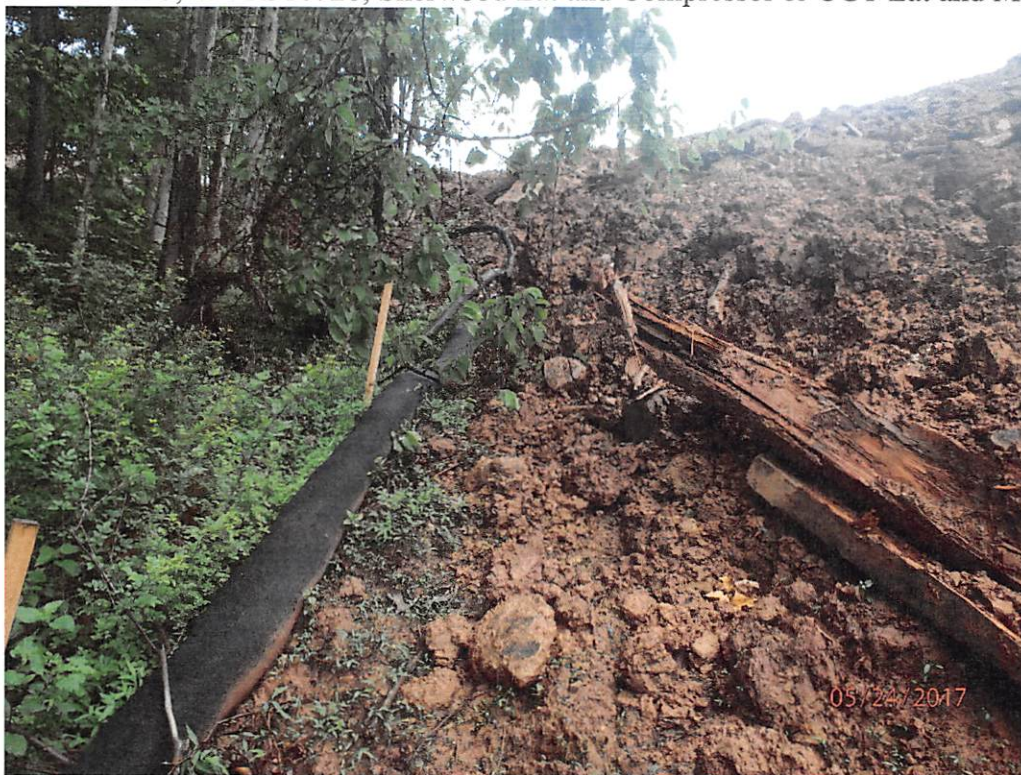
Area below access road near compressor site where construction activity has gone past LOD and compromised controls.

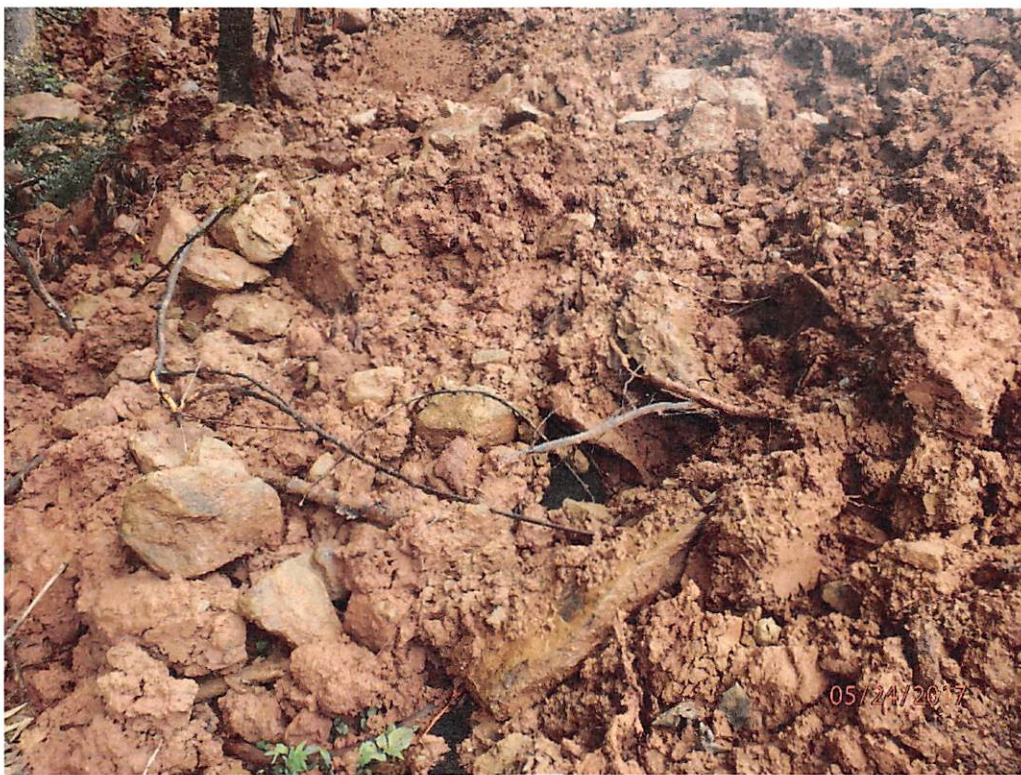
Area below access road near compressor site where construction activity has gone past LOD and compromised controls.

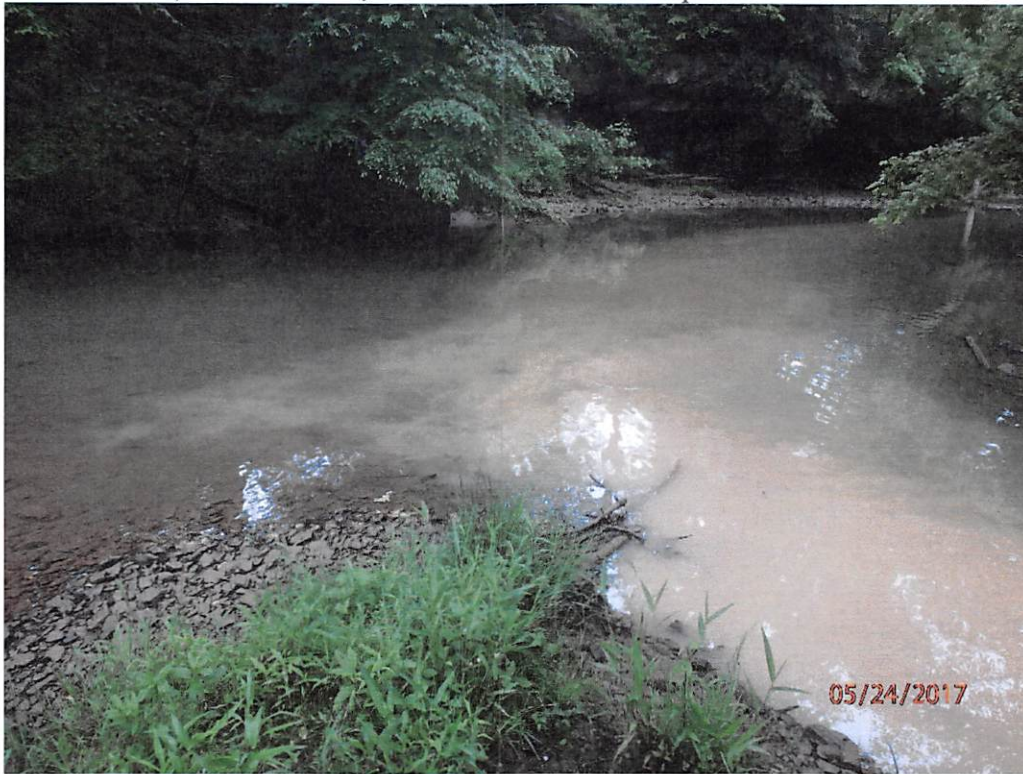
Confluence of Eibscamp Run and Meathouse Fork showing sediment plume from compressor site as well as Eibscamp Road Improvement project.

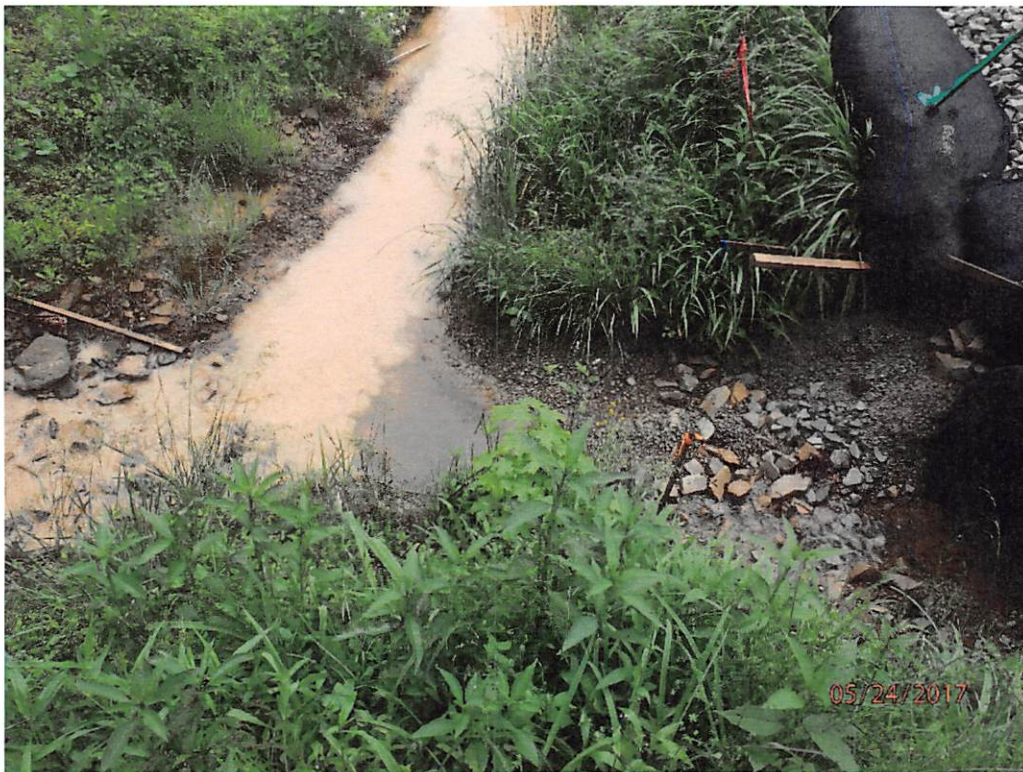
Confluence of UNT of Eibscamp Run & Eibscamp Run showing clean water from UNT coming into muddy water in Eibscamp Run.

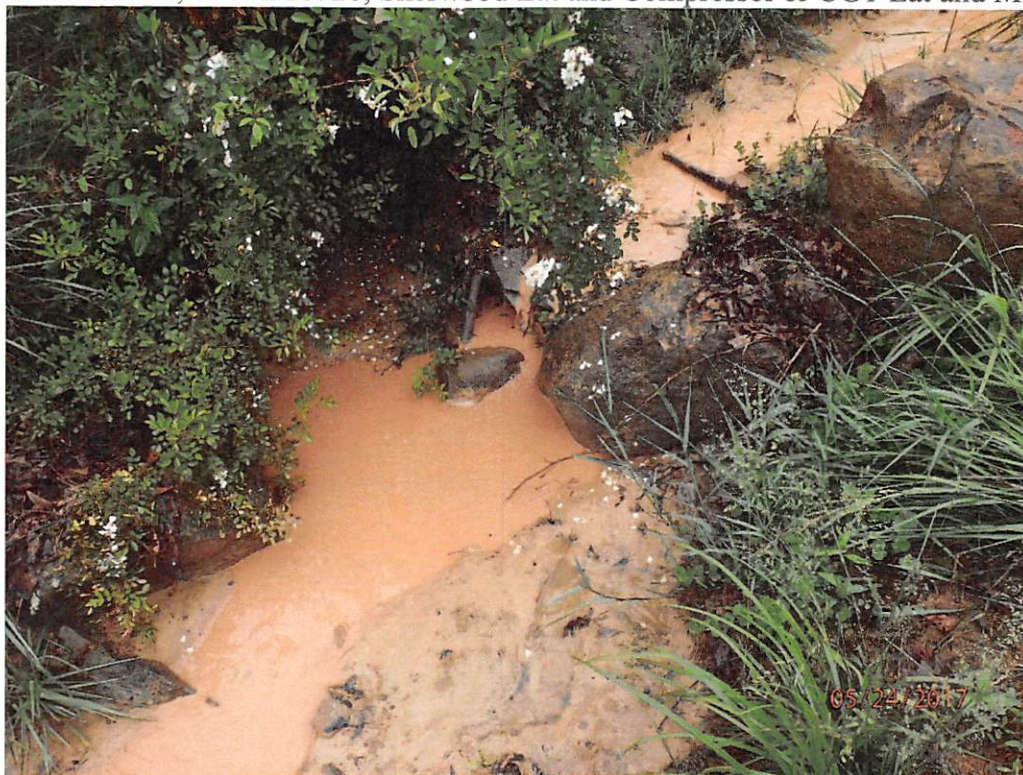
Sediment deposits / muddy water in Eibscamp Run just below compressor site.

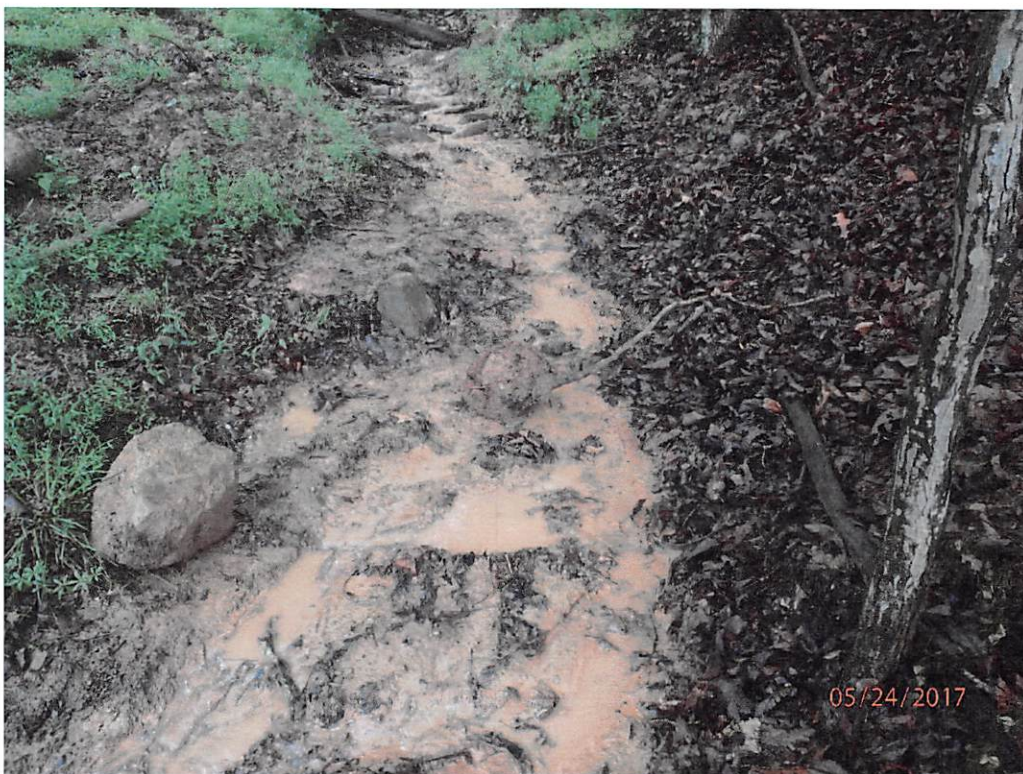
Head of Eibscamp Run near compressor site showing muddy water / sediment deposits.

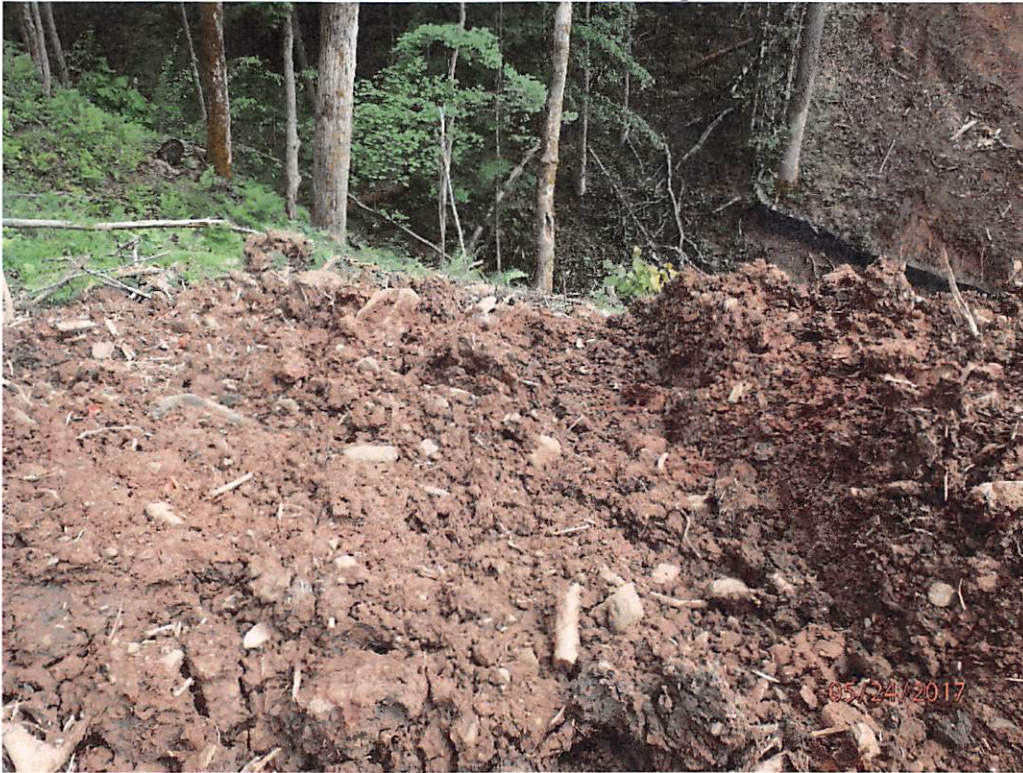
Water bar outlets that have no treatment, which is causing sediment laden water to leave site.

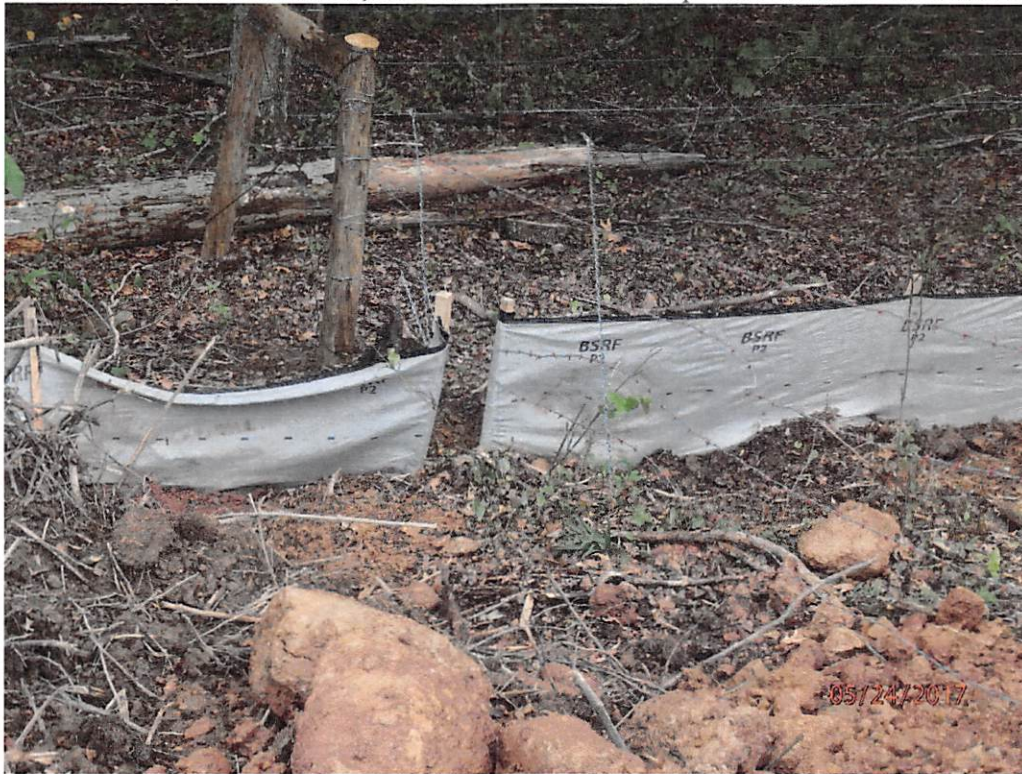
Improperly installed controls on Sherwood Lateral pipeline.

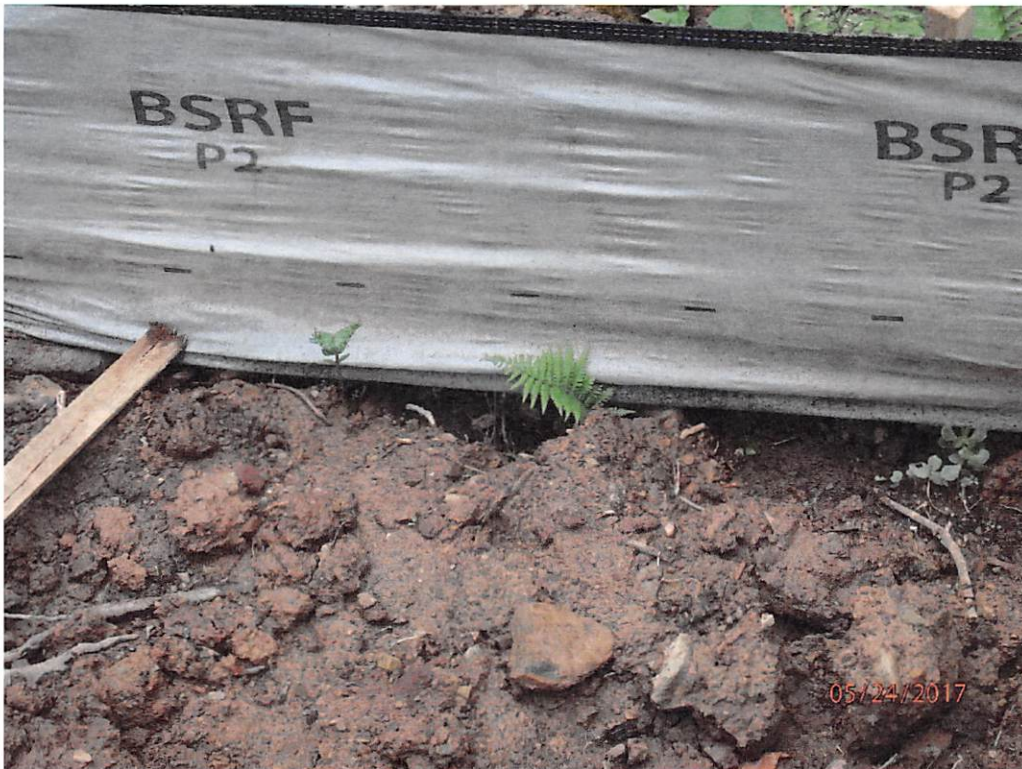
Improperly installed controls on Sherwood Lateral pipeline. Bottom picture is at stream crossing of UNT of Buckeye Creek.

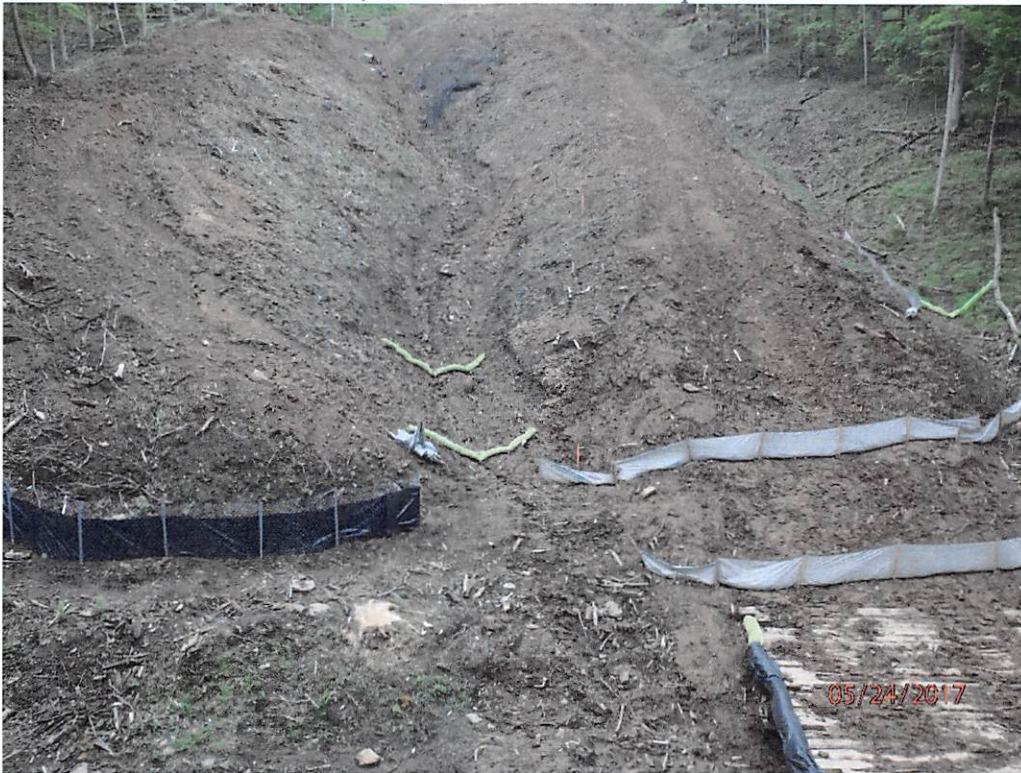
Overview of pipeline stream crossing of UNT of Buckeye Creek. Sheet flow controls being used in concentrated flow of ephemeral stream causing sediment deposits in stream. Silt fence being utilized in place of super silt fence.

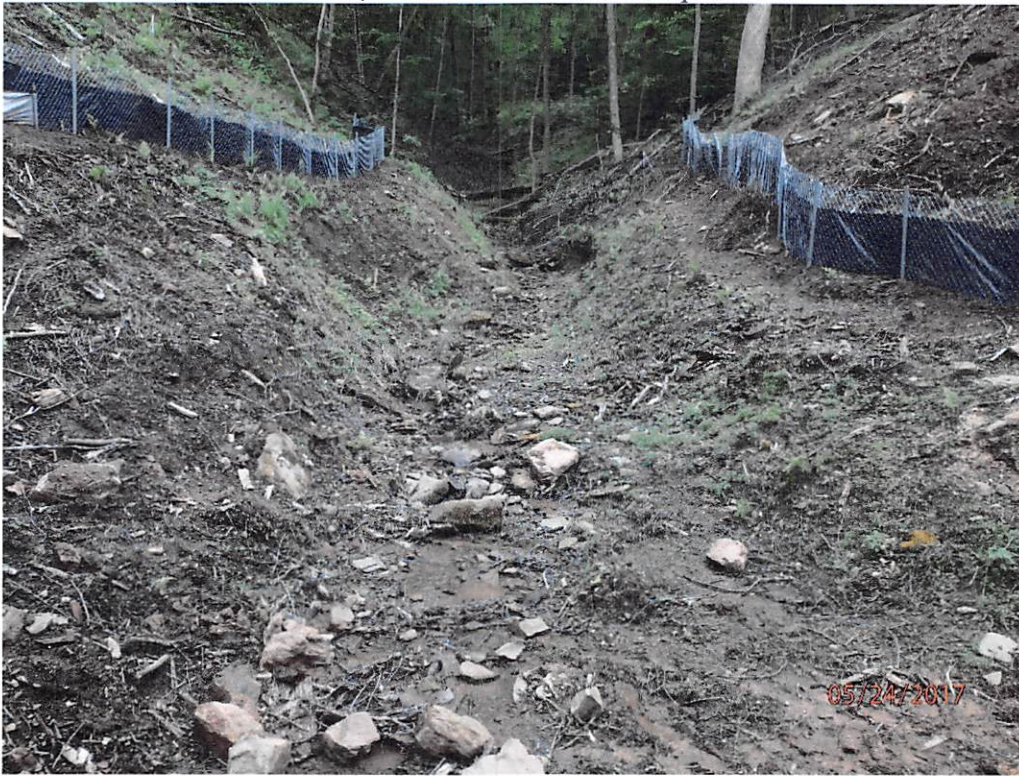
Stream channel upstream of pipeline crossing of UNT of Buckeye Creek.

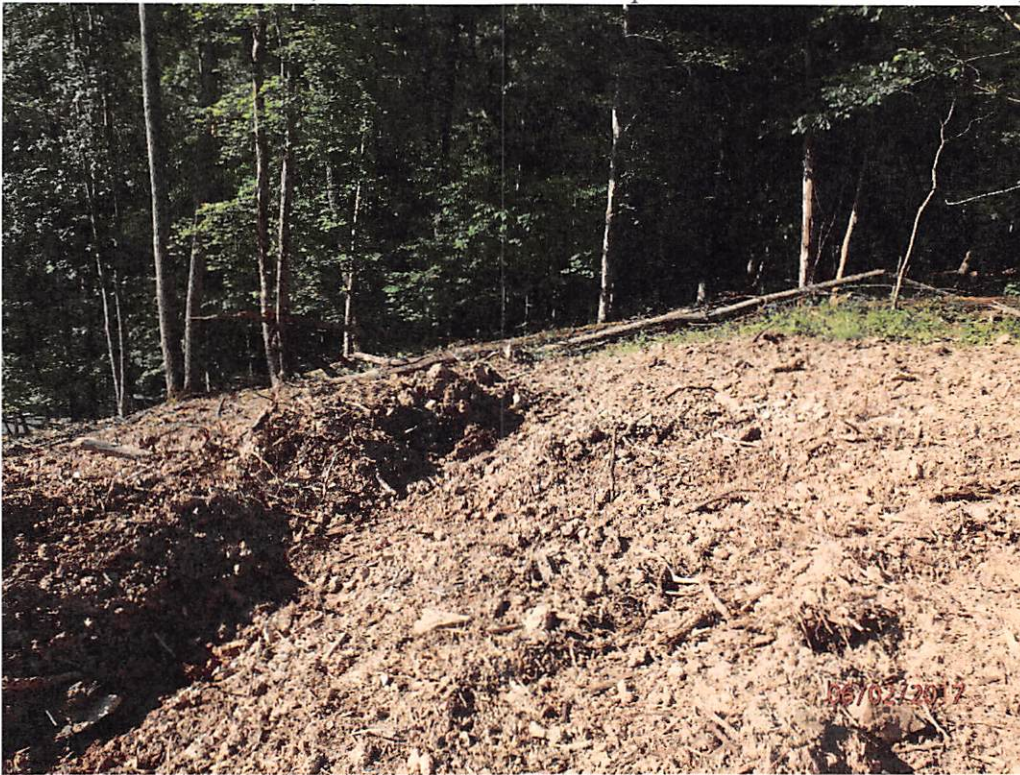
Water bars with no treatment at outlets.

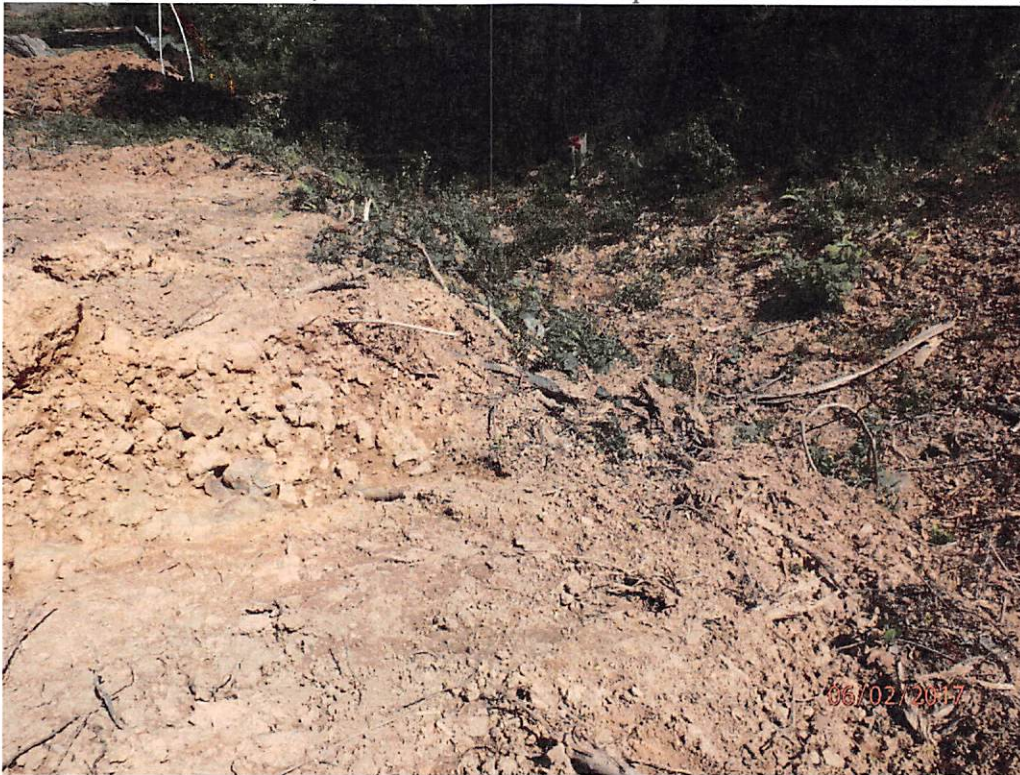
Water bar outlet that goes into ephemeral stream that leads off site with no controls in place.
