west virginia department of environmental protection

**ORDER
ISSUED UNDER THE
WATER POLLUTION CONTROL ACT
WEST VIRGINIA CODE, CHAPTER 22, ARTICLE 11**

ORDER NO.: 8749

1. Rover Pipeline LLC is conducting land disturbance activity in Doddridge and Tyler Counties, West Virginia. Rover Pipeline LLC was issued Water Pollution Control Permit No. WV0116815, Registration No. WVR310726 on December 15, 2016.

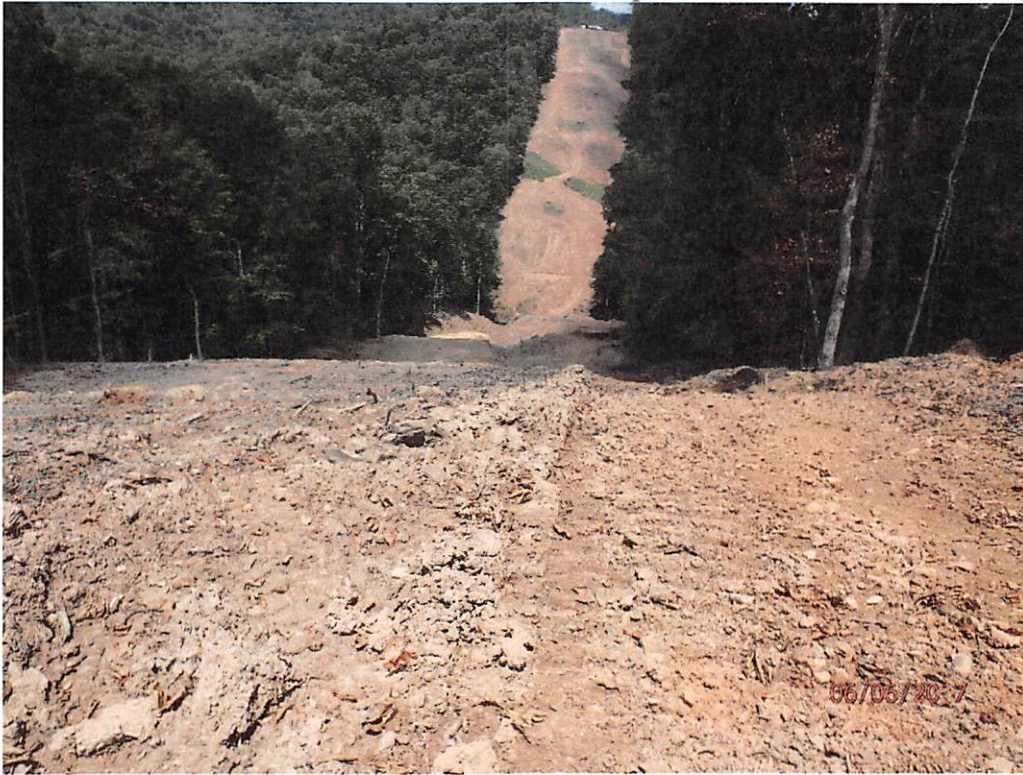
Water bars that have been damaged and were not maintained. Several areas on the project showed similar damage with no repairs even though it was evident that the damage had taken place several days prior to this inspection.

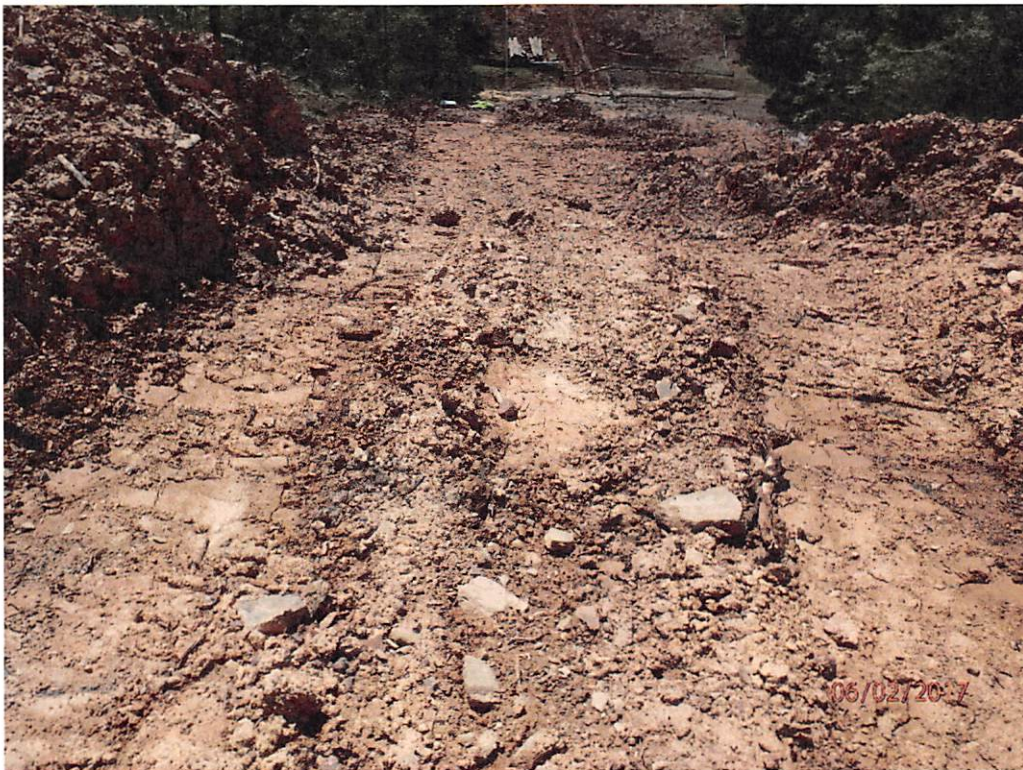
Water bars that have been damaged and were not maintained. Several areas on the project showed similar damage with no repairs even though it was evident that the damage had taken place several days prior to this inspection.

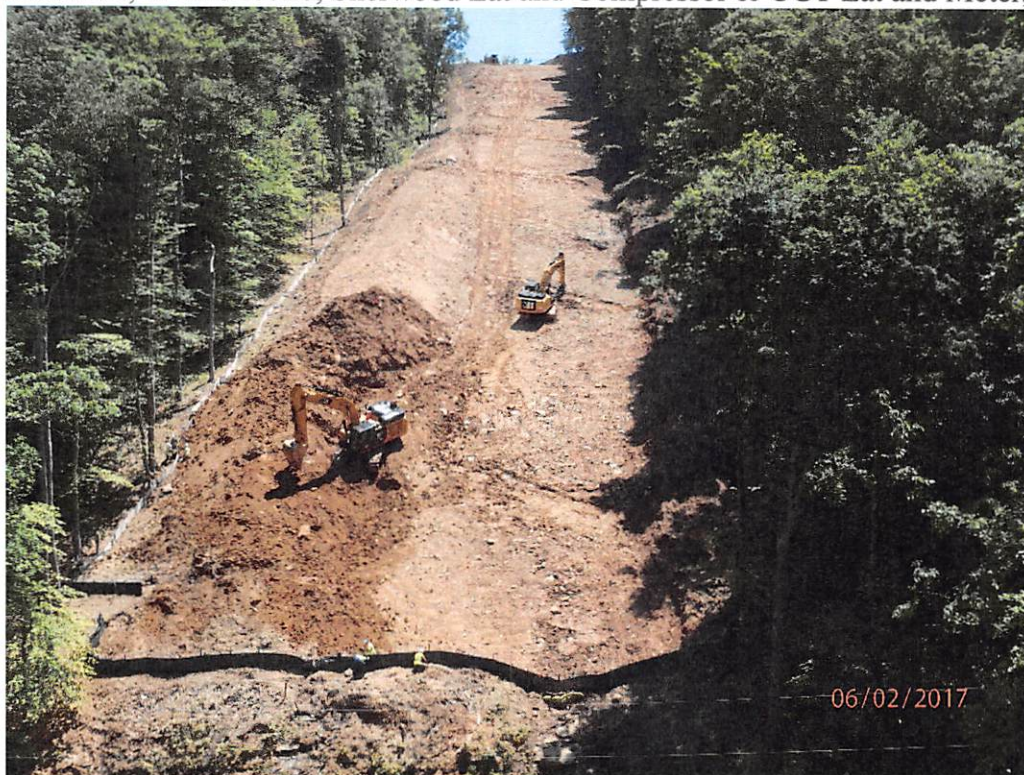
Pipeline section to the east of Englands Run where water bars were installed improperly which caused concentrated flow to be treated by sheet flow BMP's at the bottom of the hill near the receiving stream. An offsite ephemeral stream flows onto ROW which is also treated at pictured controls.

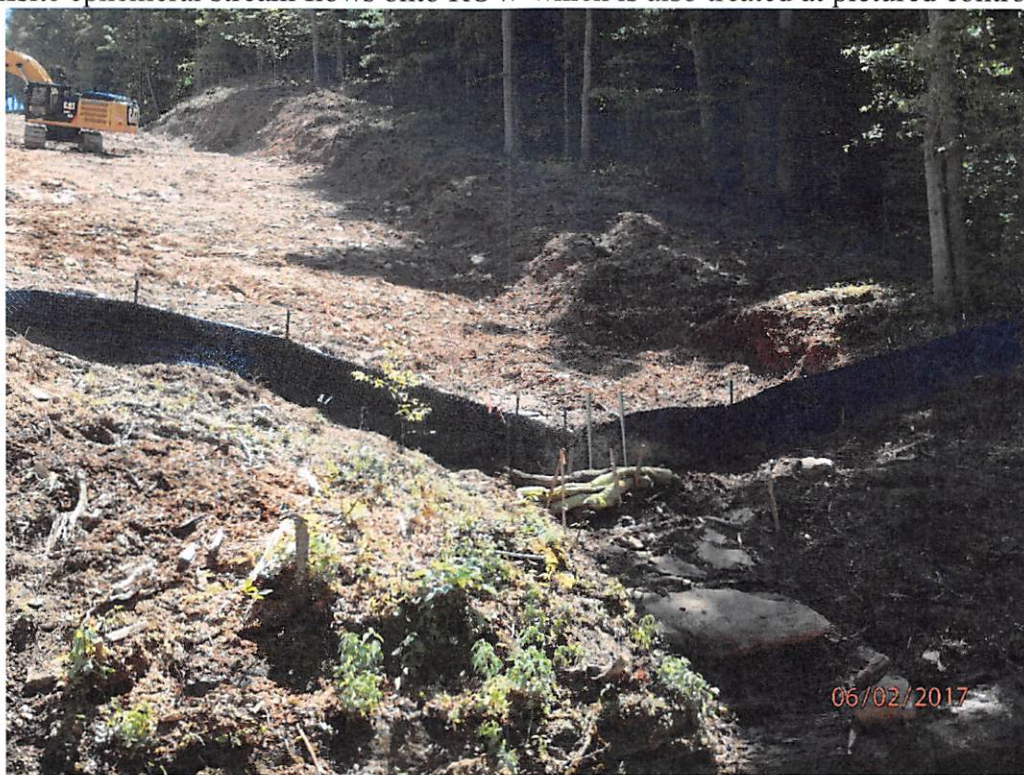
Pipeline section to the east of Englands Run where water bars were installed improperly which caused concentrated flow to be treated by sheet flow BMP's at the bottom of the hill near the receiving stream. An offsite ephemeral stream flows onto ROW which is also treated at pictured controls.

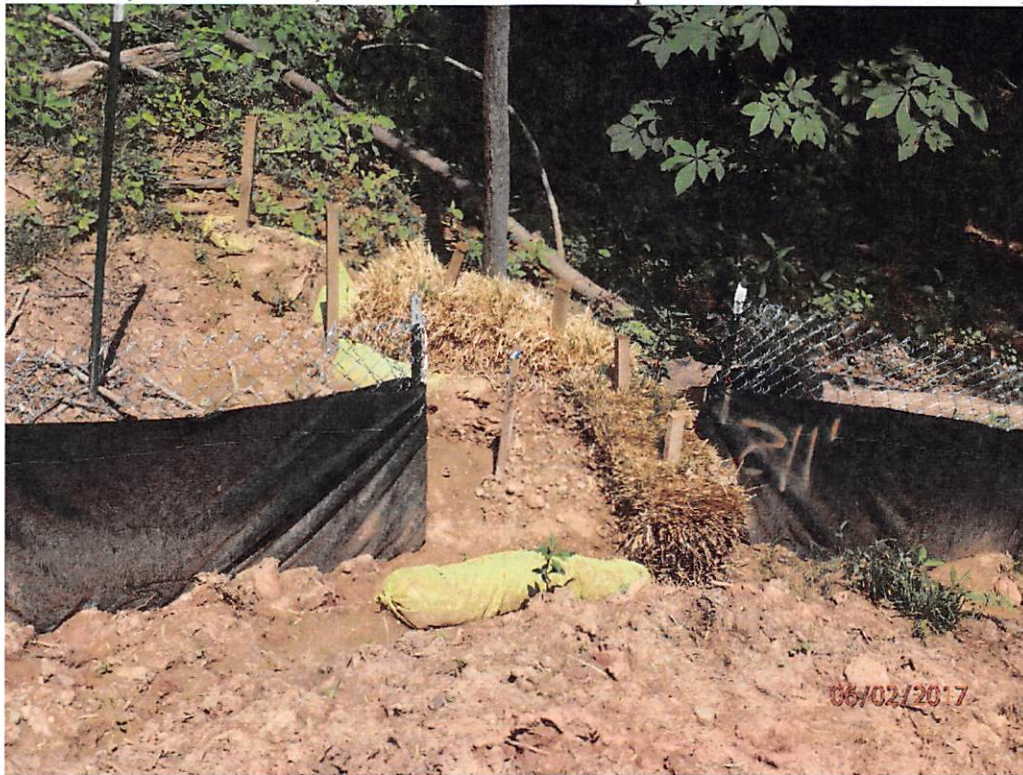
Offsite sediment deposits at 100+00 as a result of poor maintenance on controls.

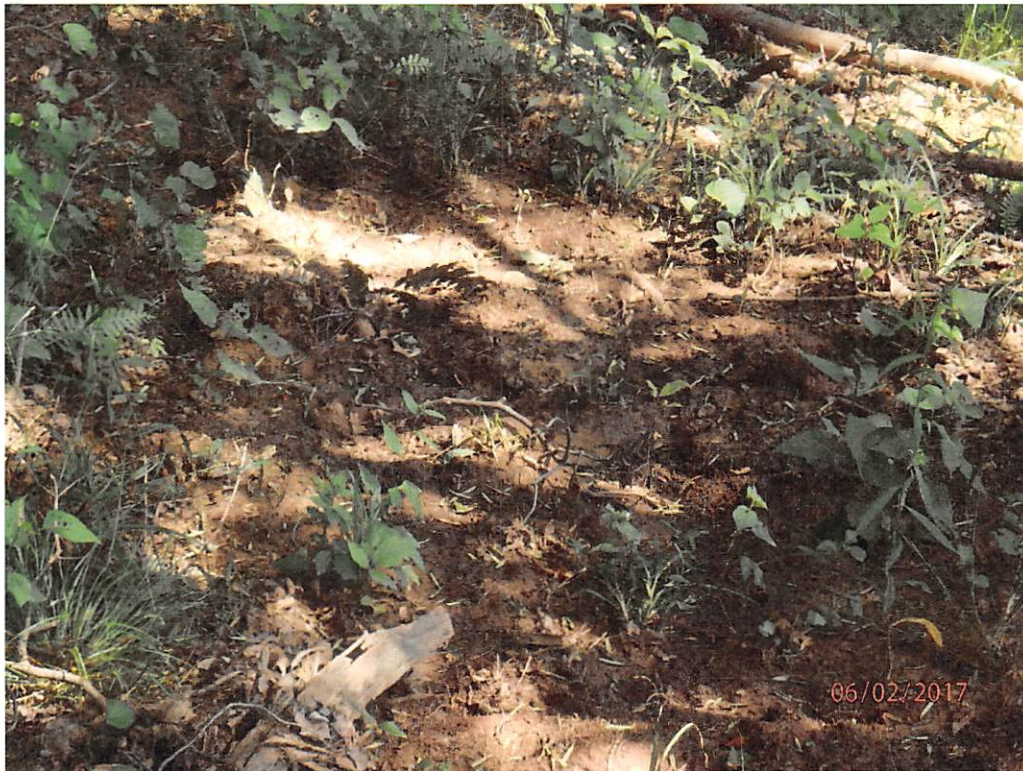
Offsite sediment deposits at 100+00 as a result of poor maintenance on controls.

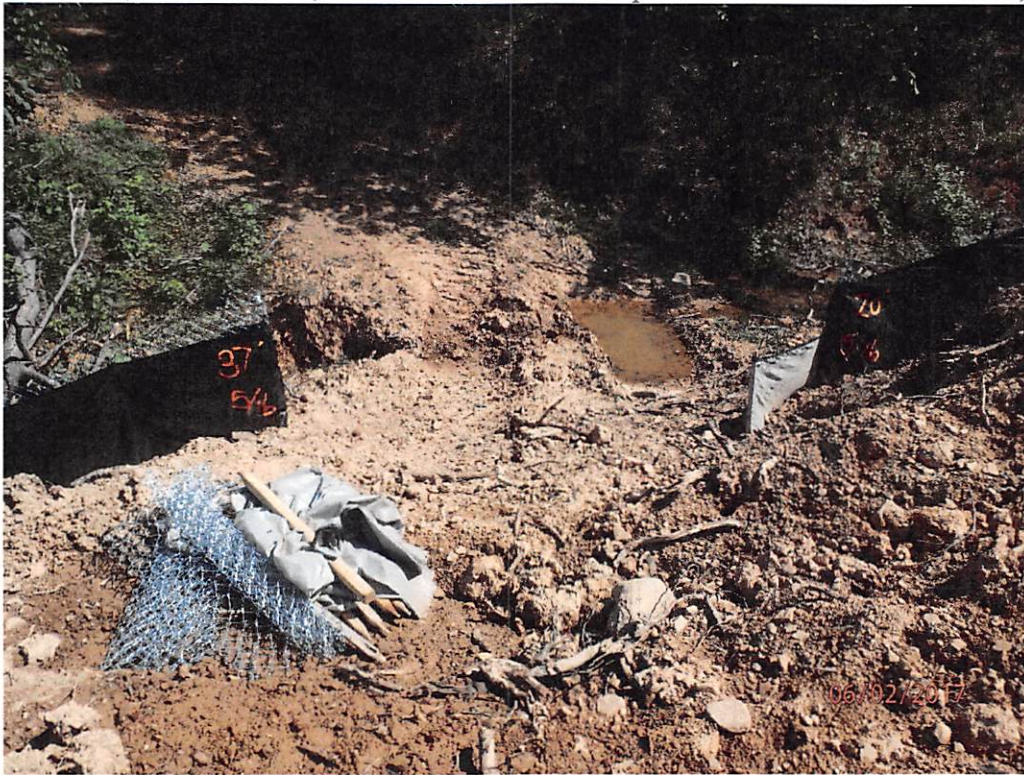
Sediment deposits in ephemeral UNT of Jockeycamp Run near 200+00.

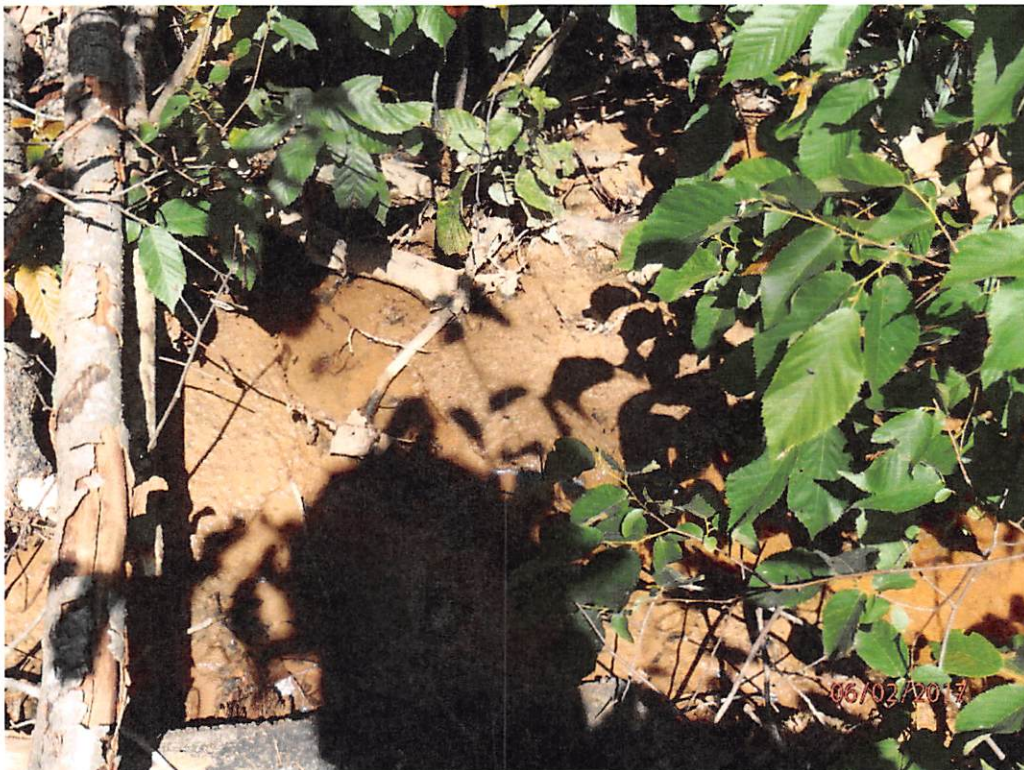
Sediment deposits in ephemeral UNT of Jockeycamp Run near 200+00.

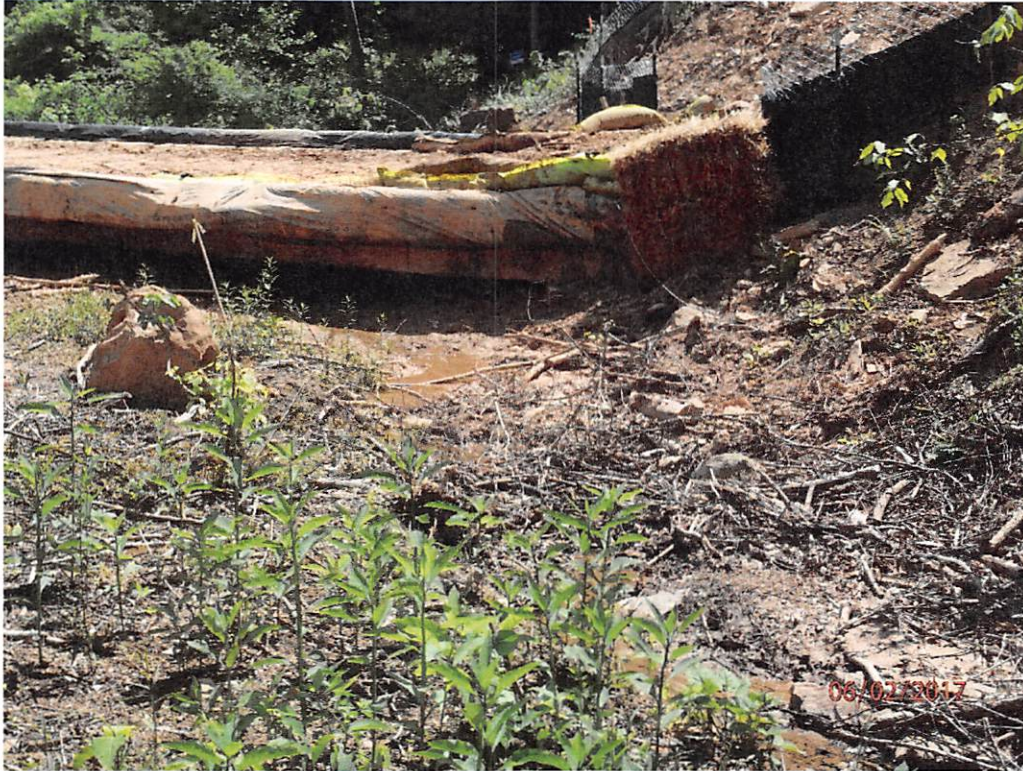
Sediment deposits in UNT of Morgans Run as a result of improper bridge installation and controls being overwhelmed due to improper water bar installation.

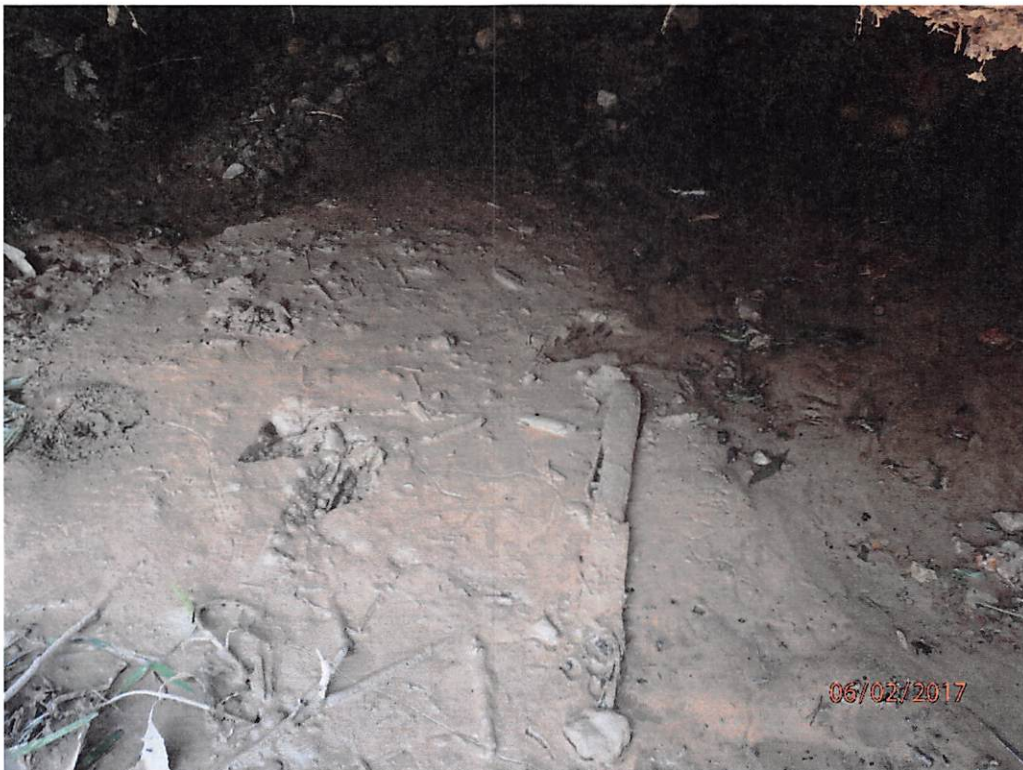
Sediment deposits in UNT of Morgans Run as a result of improper bridge installation and controls being overwhelmed due to improper water bar installation.

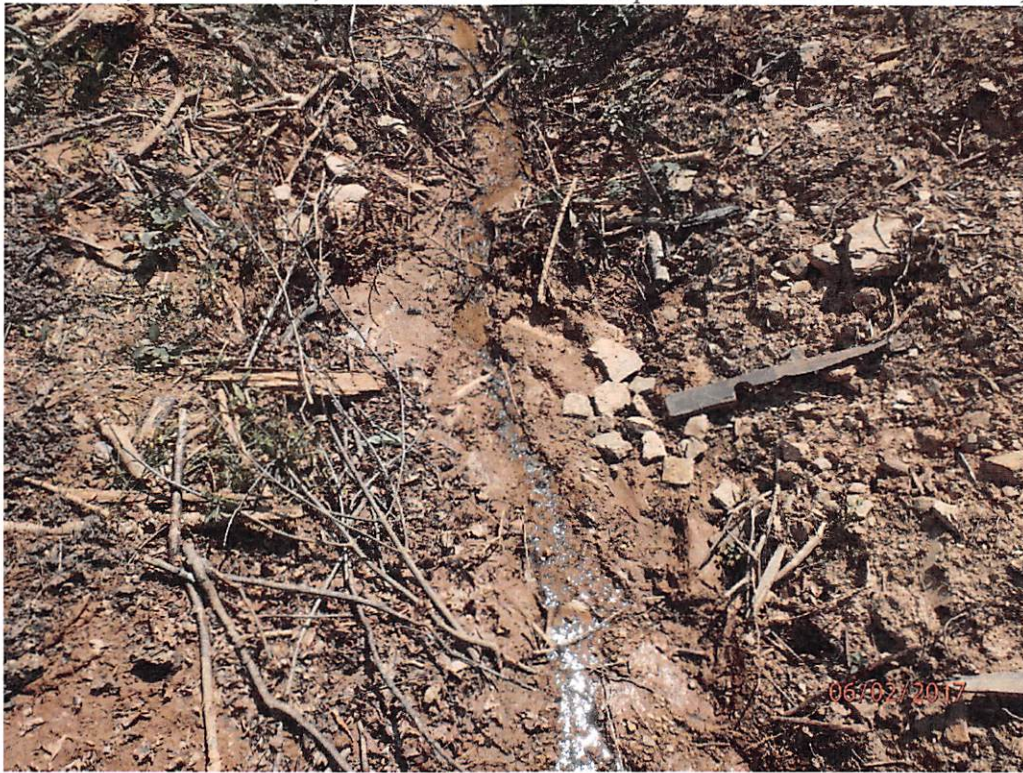
Sediment deposits in UNT of Morgans Run downstream of previously pictured bridge.

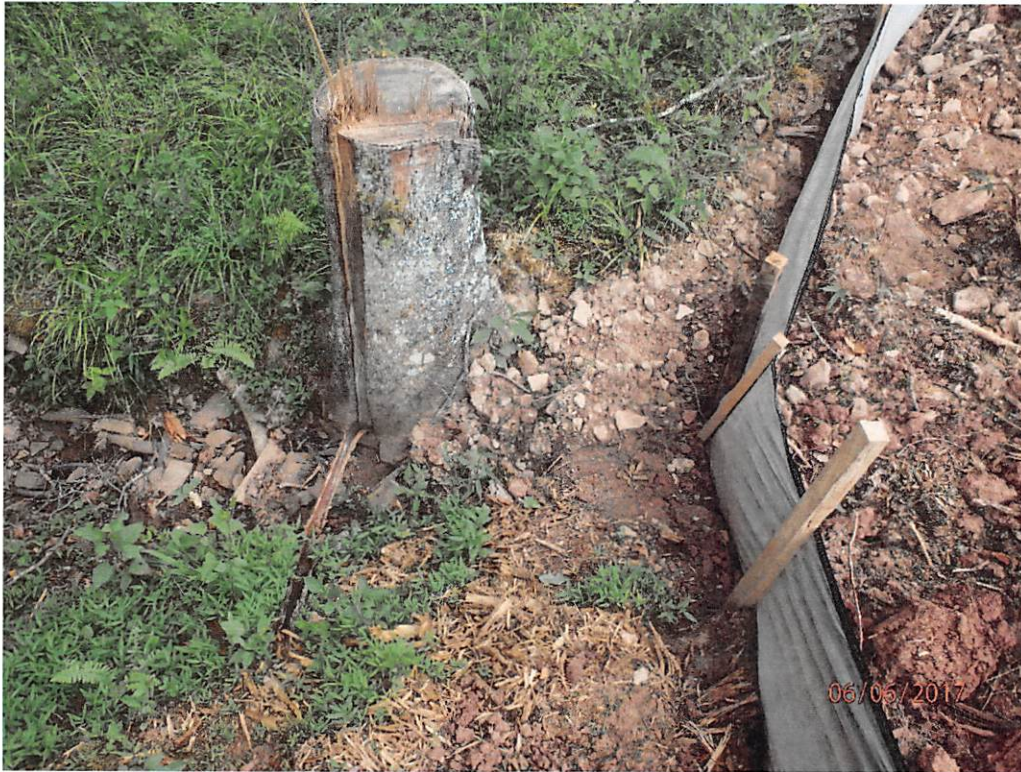
Ephemeral UNT of Nutter Fork with sediment deposits. Sheet flow BMP being used in concentrated flow.

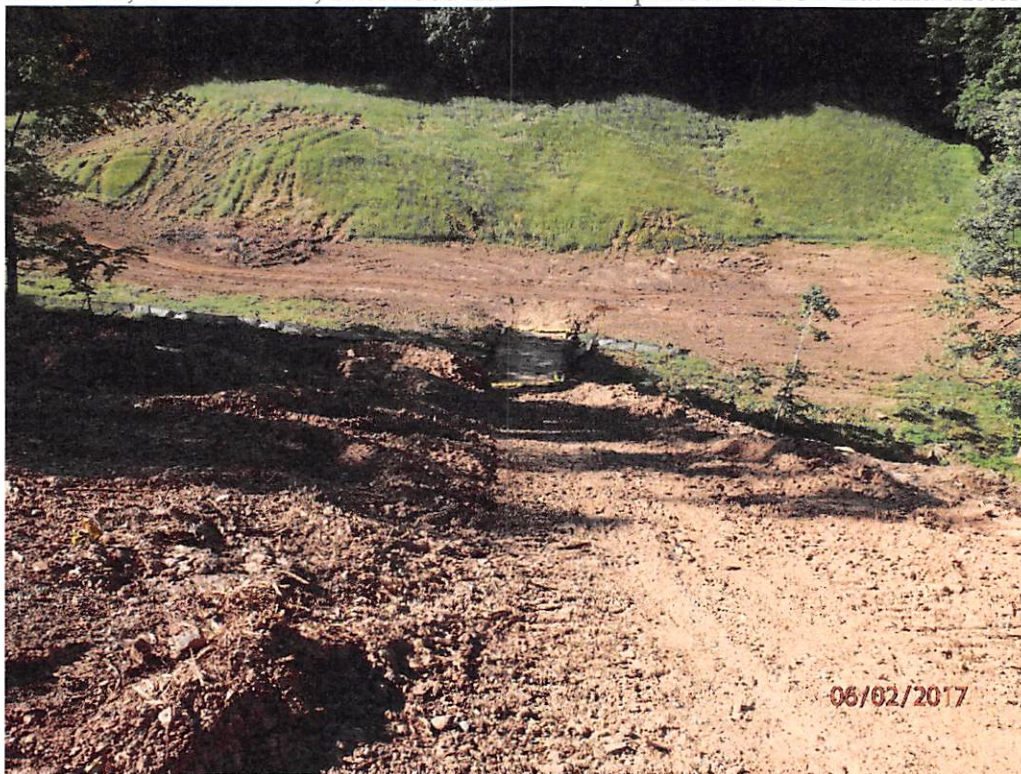
Improperly installed bridge on Rock Run, which is allowing sediment to get past control.

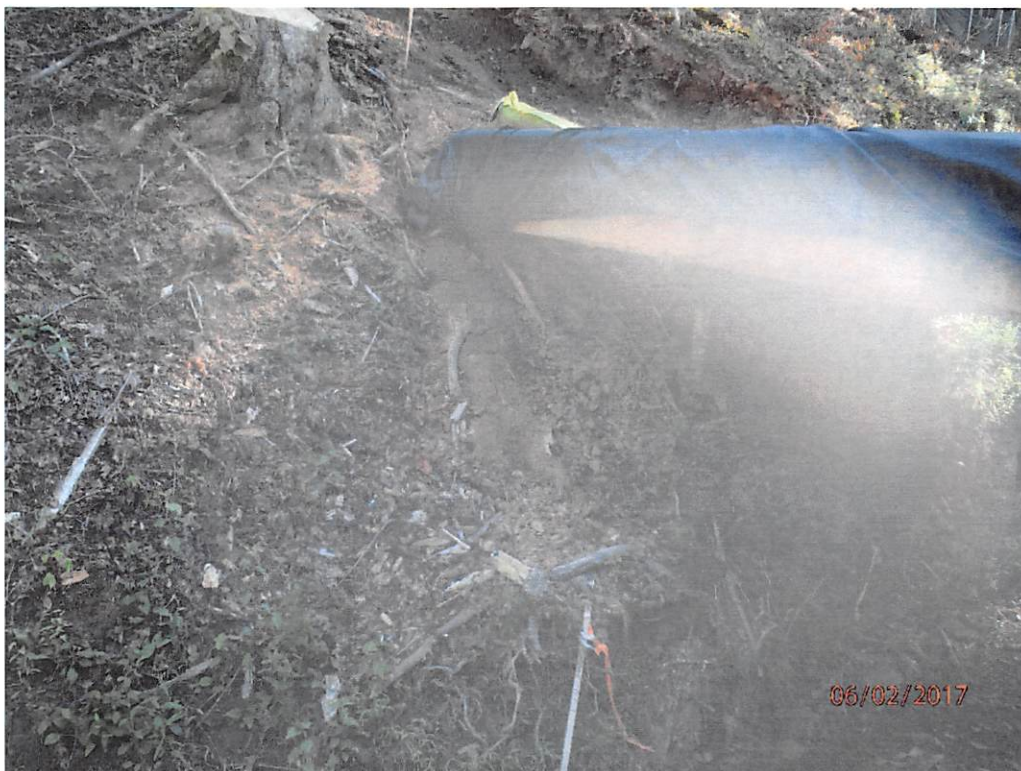
Improperly installed bridge on Rock Run, which is allowing sediment to get past control.

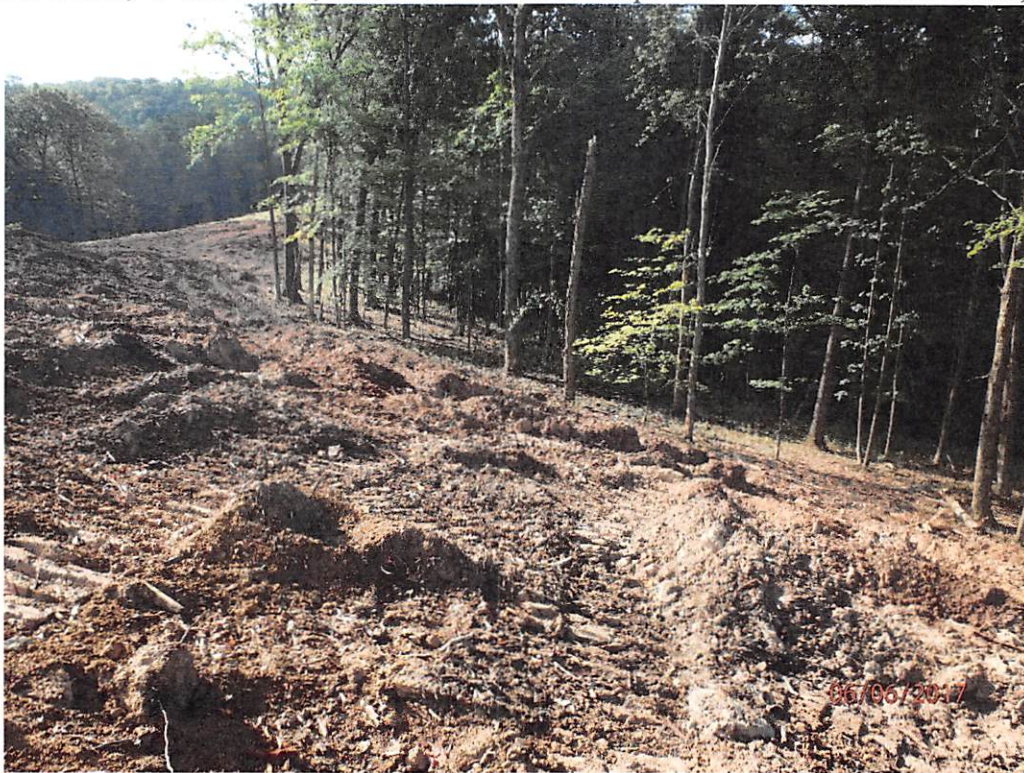
Areas of pipeline with no controls in place.

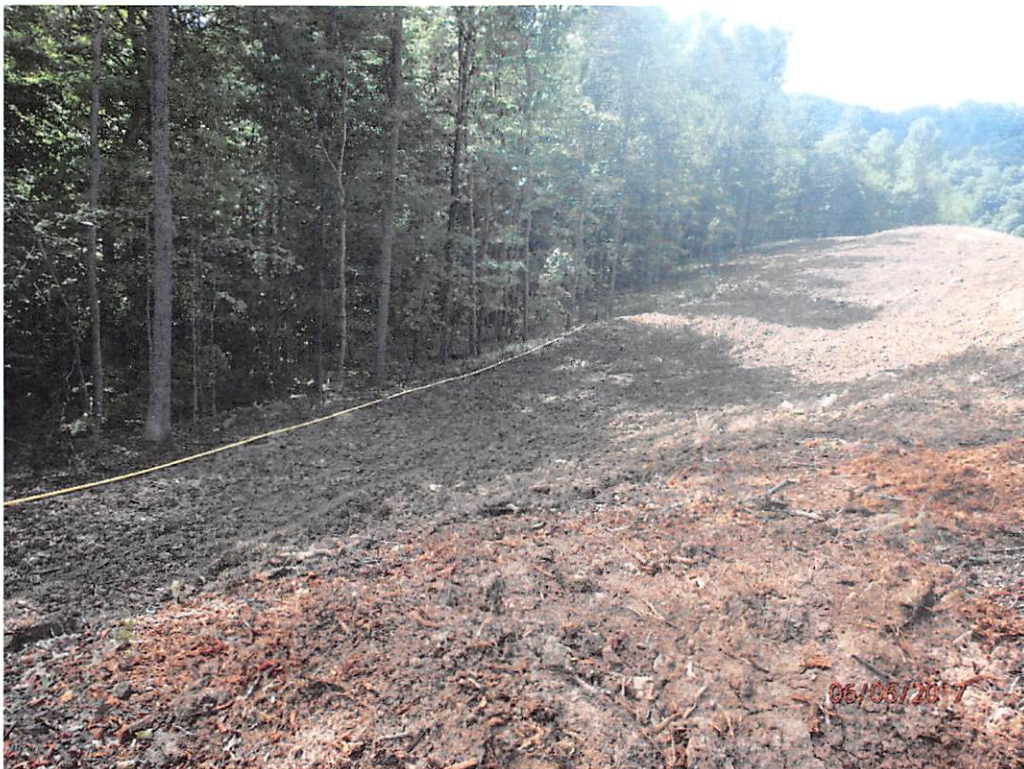
Areas of pipeline with no controls in place.

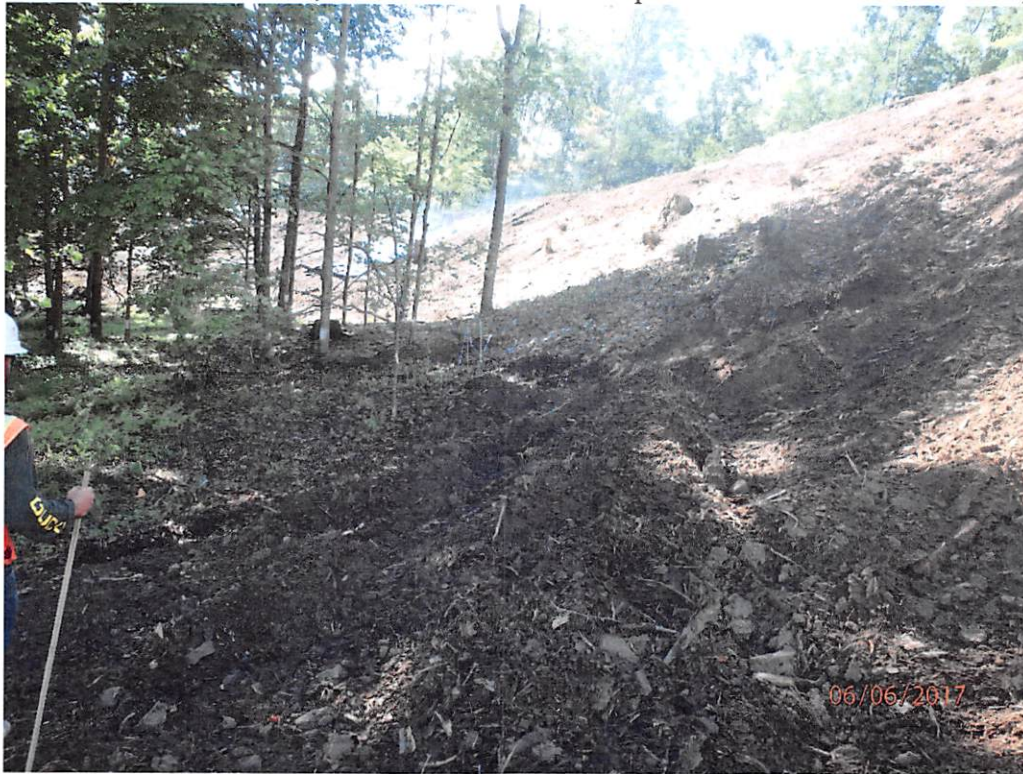
Areas of pipeline with no controls in place.

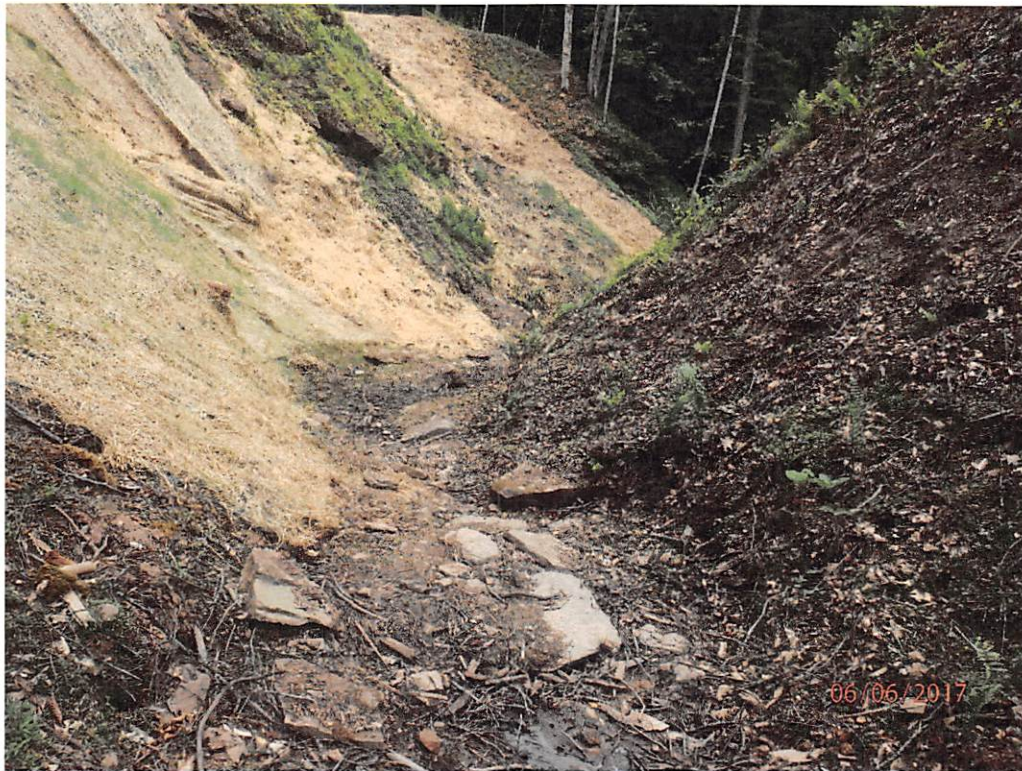
Areas of pipeline with no controls in place.

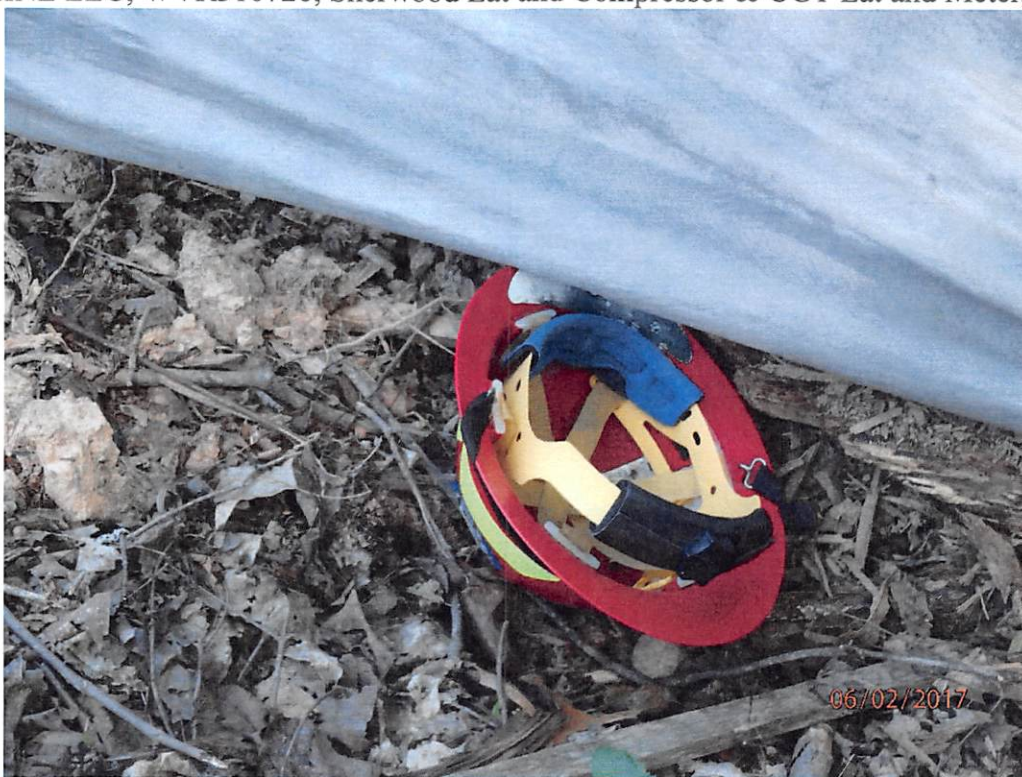
Improperly installed controls.

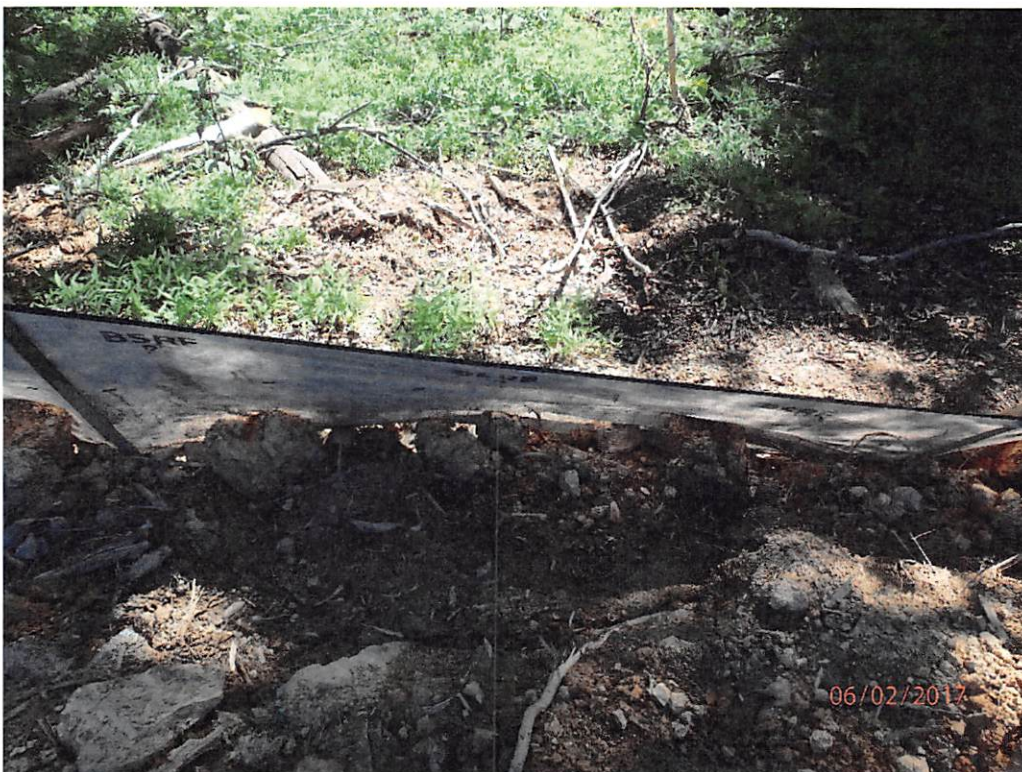
Improperly installed controls.

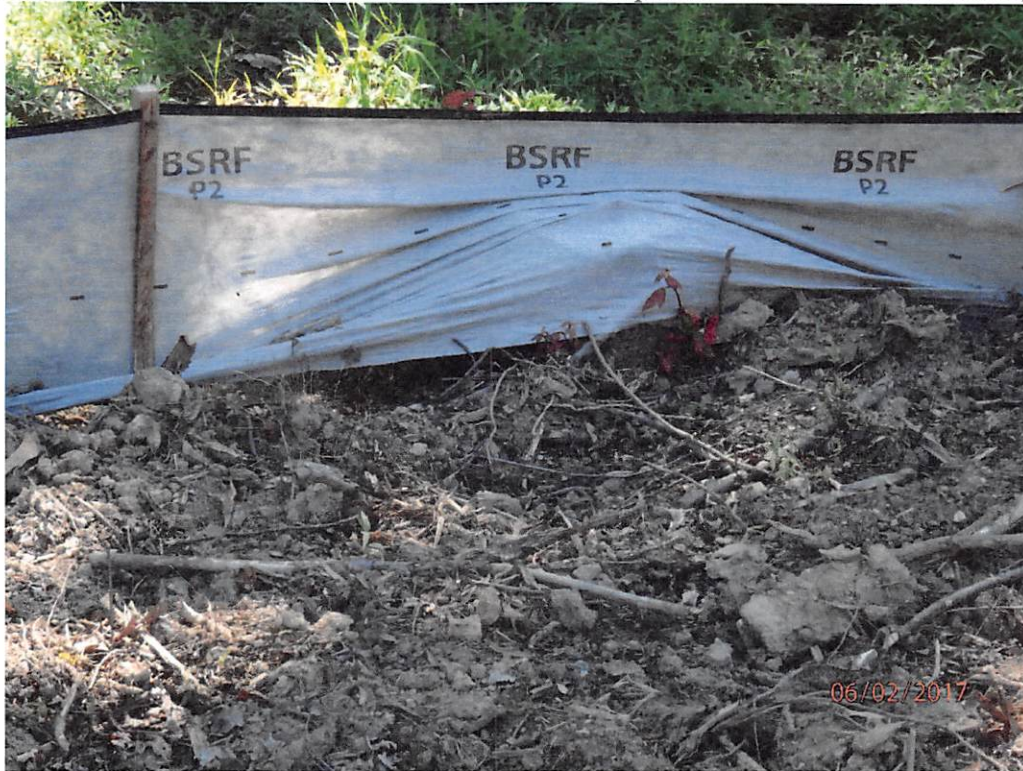
Improperly installed controls.

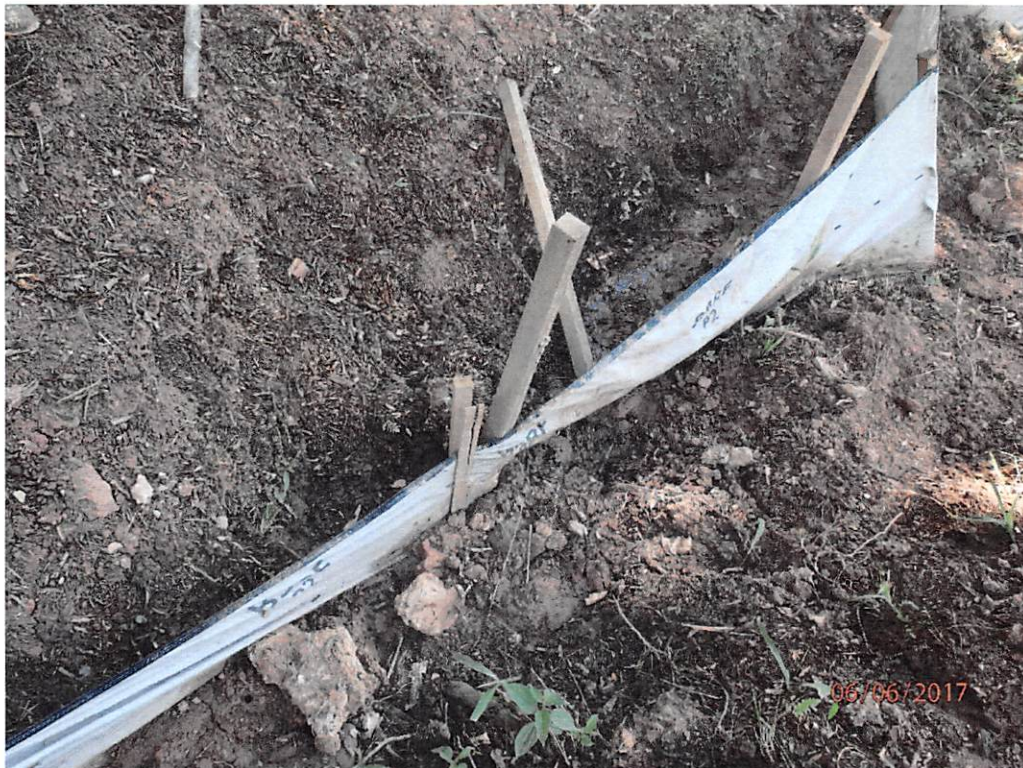
Improperly installed controls.

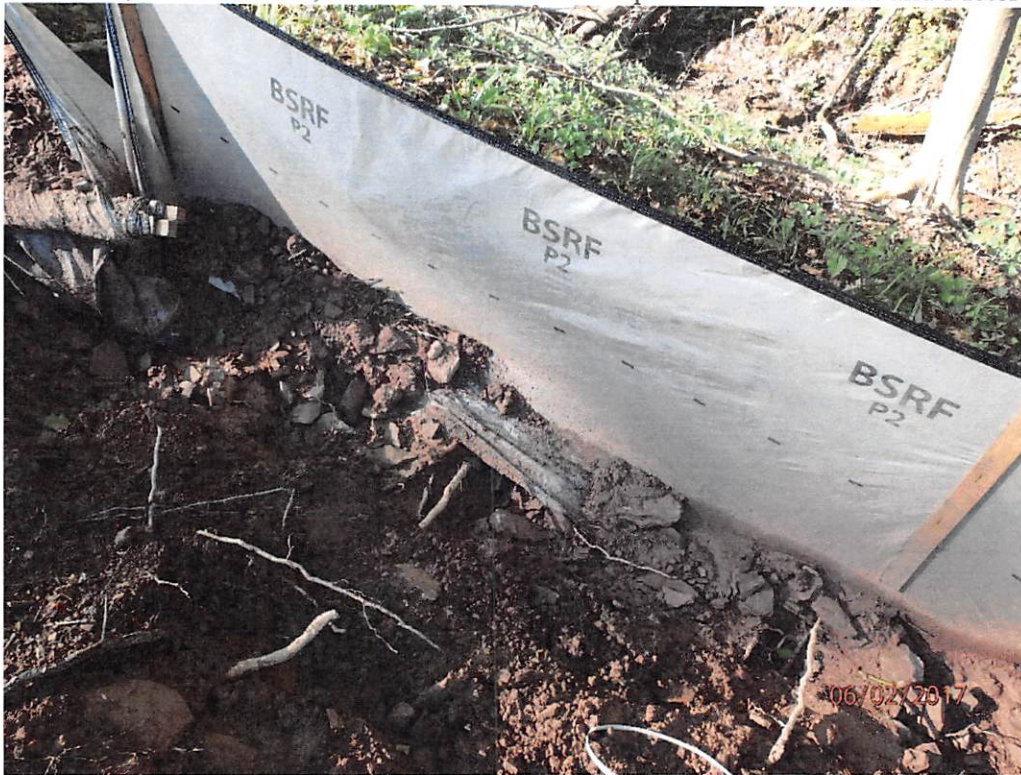
Concentrated flow from water bar that is following silt fence trench to the bottom of the hill near Rock Run.

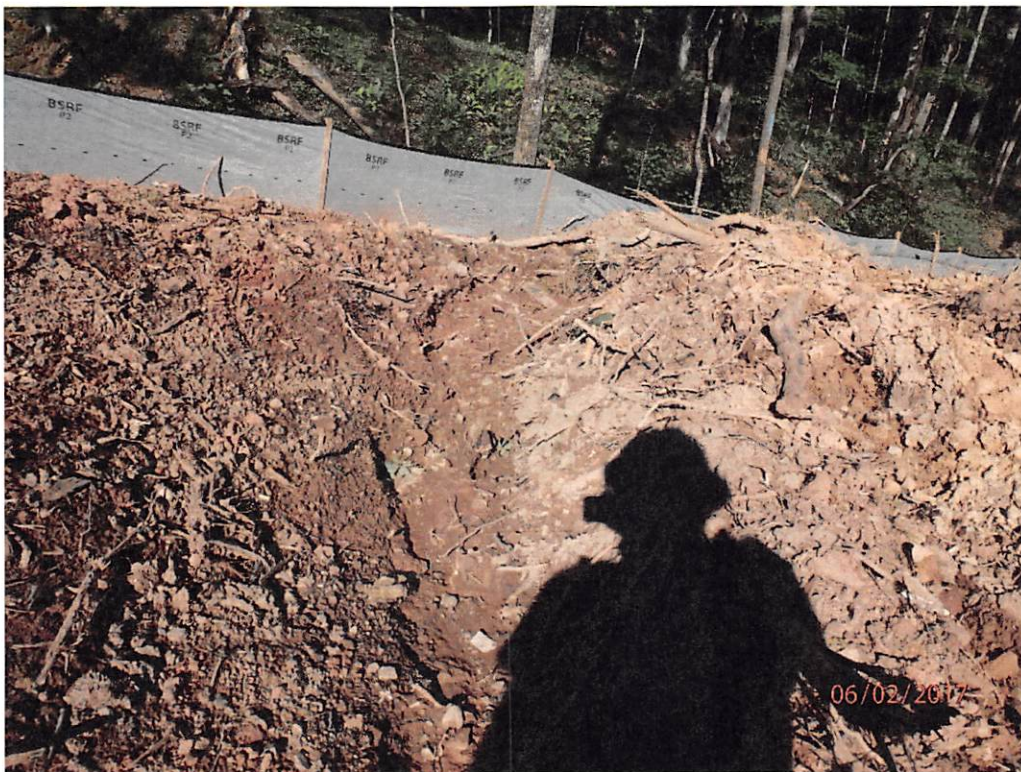
Concentrated flow from water bar that is following silt fence trench to the bottom of the hill near Rock Run.

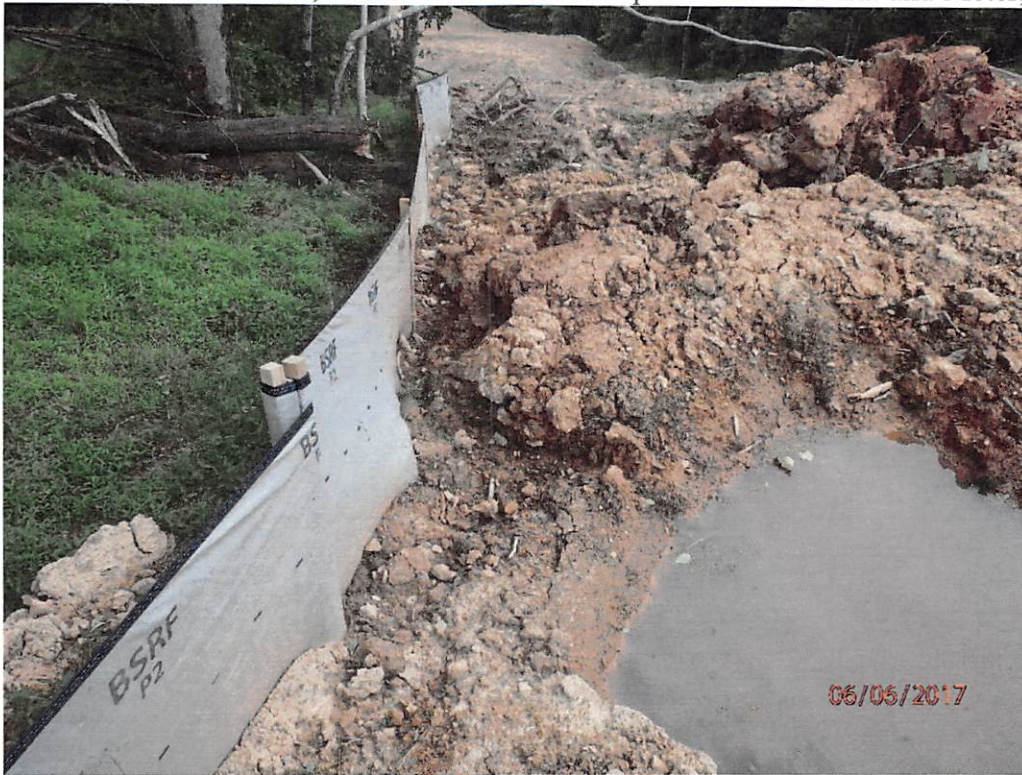
Concentrated flow from water bar that is following silt fence trench to the bottom of the hill near UNT Nutter Fork.

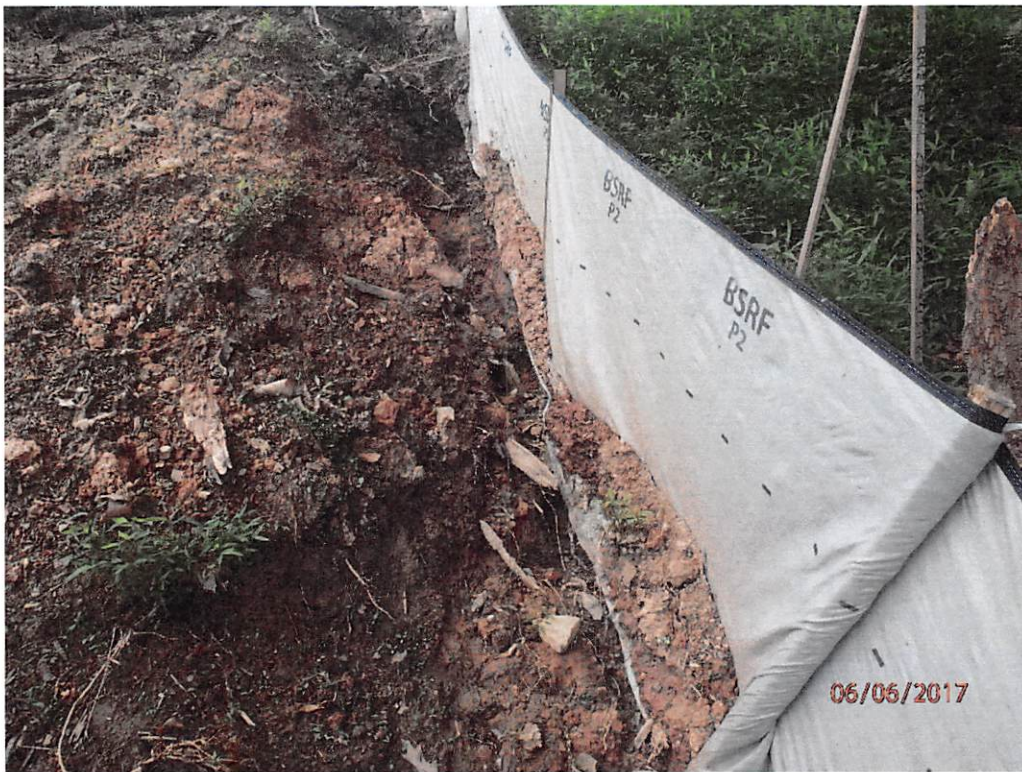
Concentrated flow from water bar that is following silt fence trench to the bottom of the hill near UNT Nutter Fork.

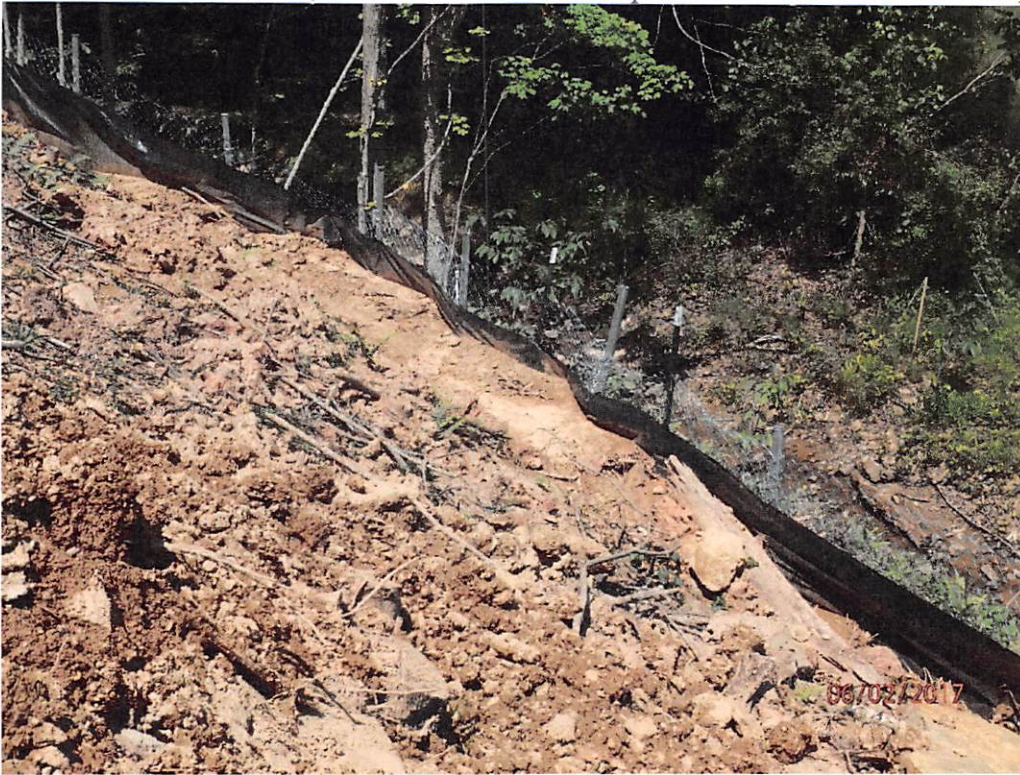
Silt fence in need of maintenance near UNT of Morgans Run.

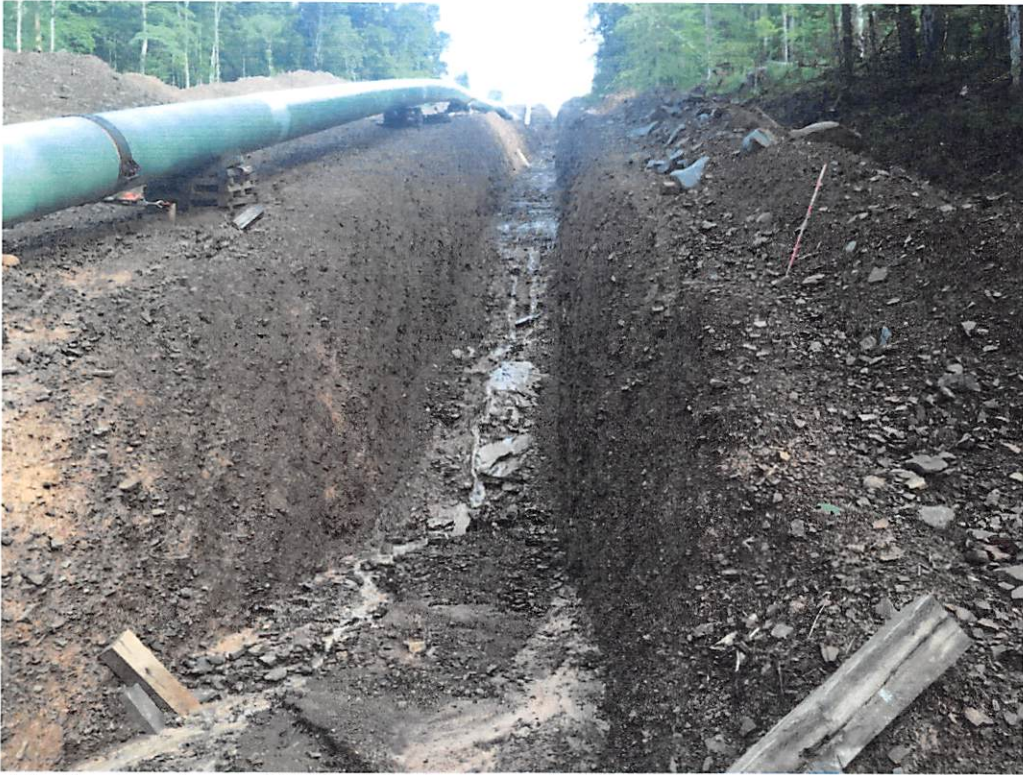
ROW with pipe trench near UNT of Buckeye creek. Water bars not in place and functioning as indicated in SWPPP.
