west virginia department of environmental protection

**ORDER
ISSUED UNDER THE
WATER POLLUTION CONTROL ACT
WEST VIRGINIA CODE, CHAPTER 22, ARTICLE 11**

ORDER NO.: 8749

1. Rover Pipeline LLC is conducting land disturbance activity in Doddridge and Tyler Counties, West Virginia. Rover Pipeline LLC was issued Water Pollution Control Permit No. WV0116815, Registration No. WVR310726 on December 15, 2016.

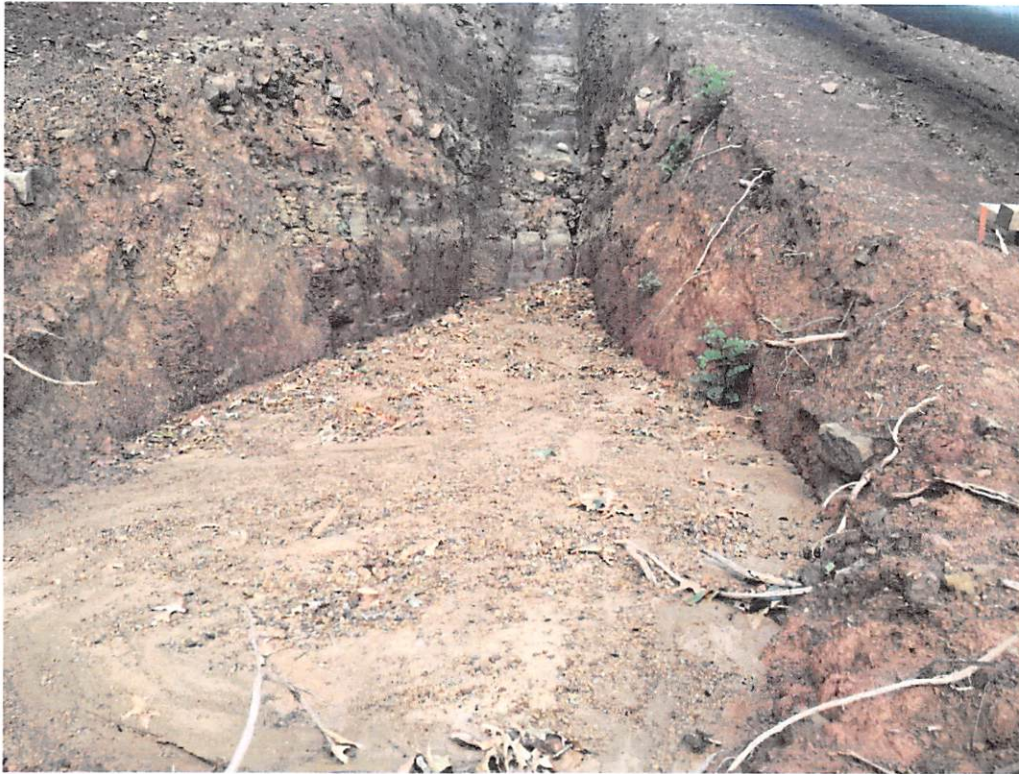
Sediment build-up at base of pipe trench.

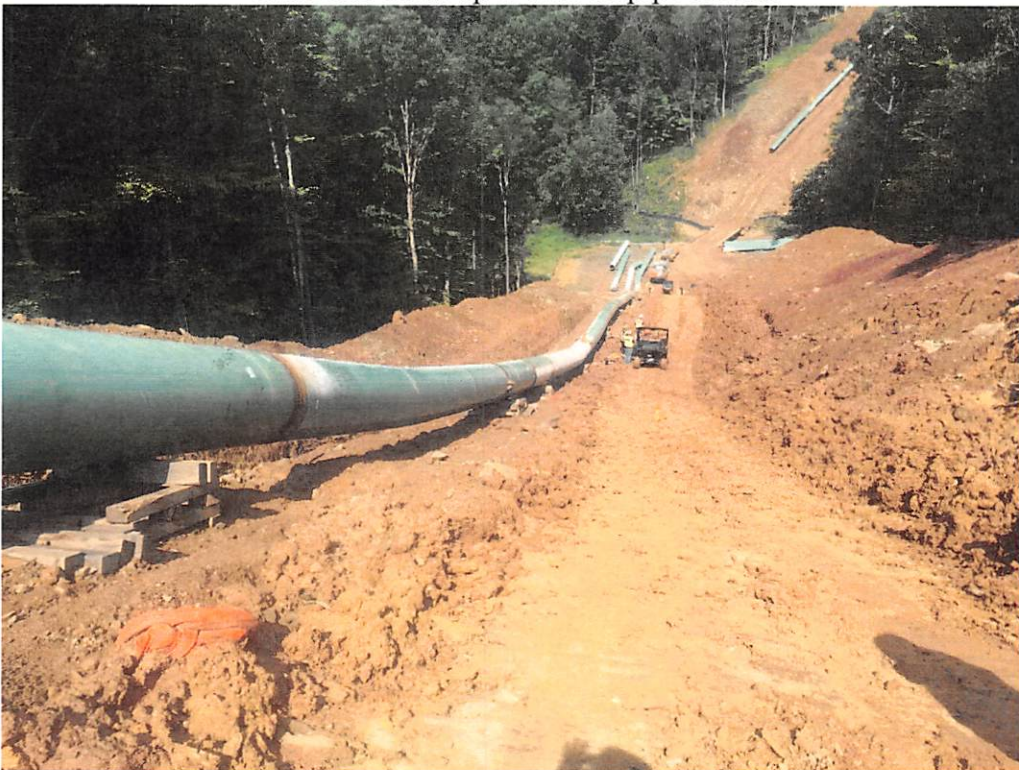
ROW near Morgan's Run showing lack of effective water bars, which caused storm water to follow pipe trench / ROW to the base of the hill.

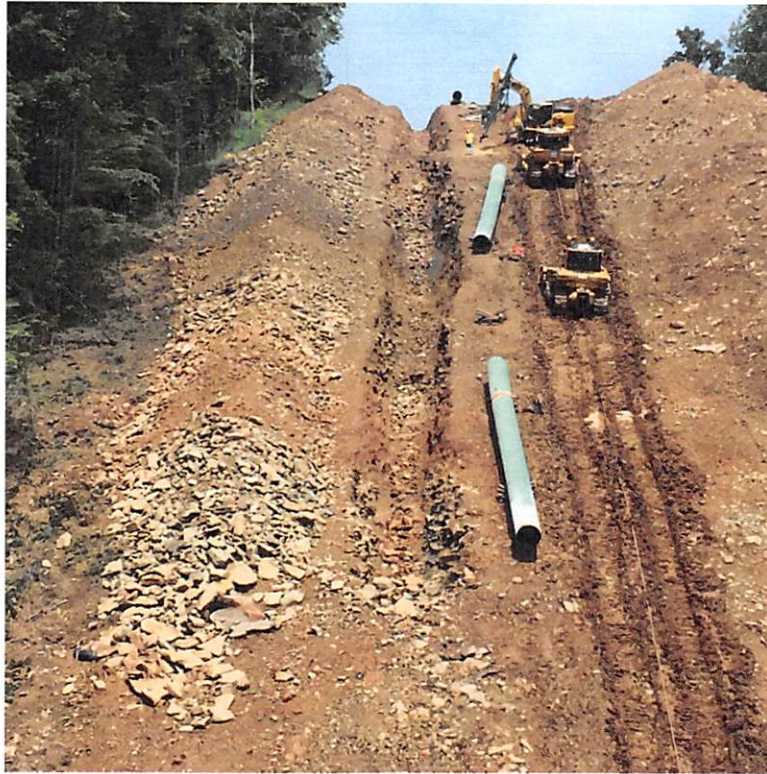
Area near England's Run where water is not being diverted off of ROW with effective water bars.

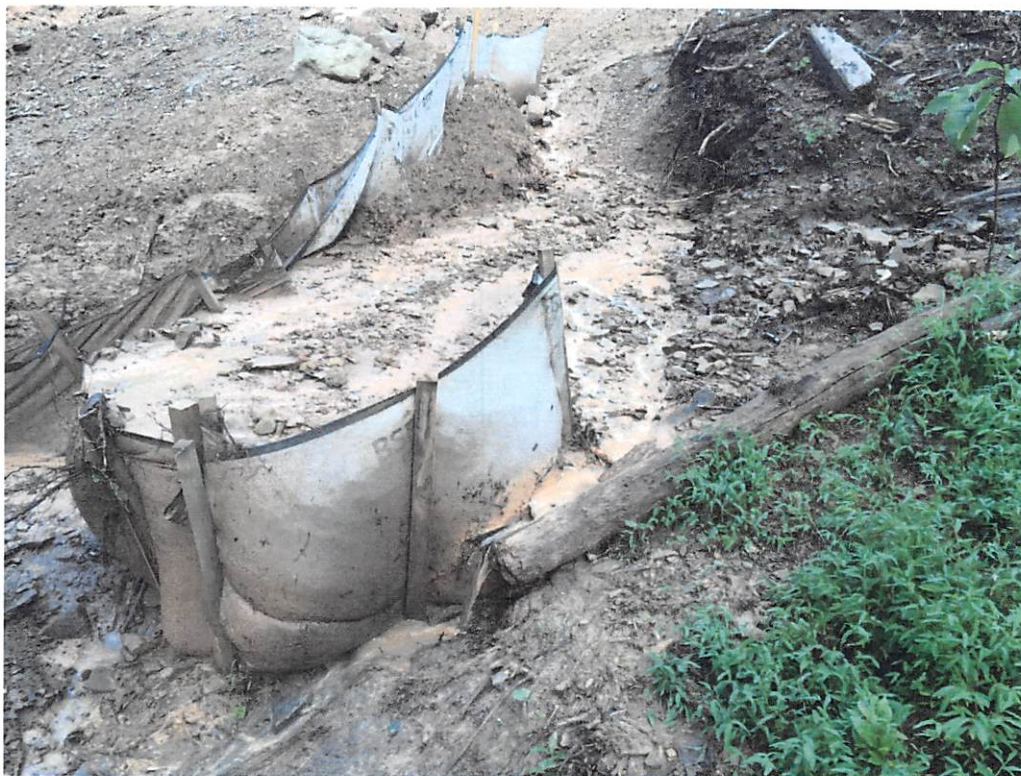
Sheet flow BMPs in need of maintenance and being used in concentrated flow areas near UNT of Buckeye Creek

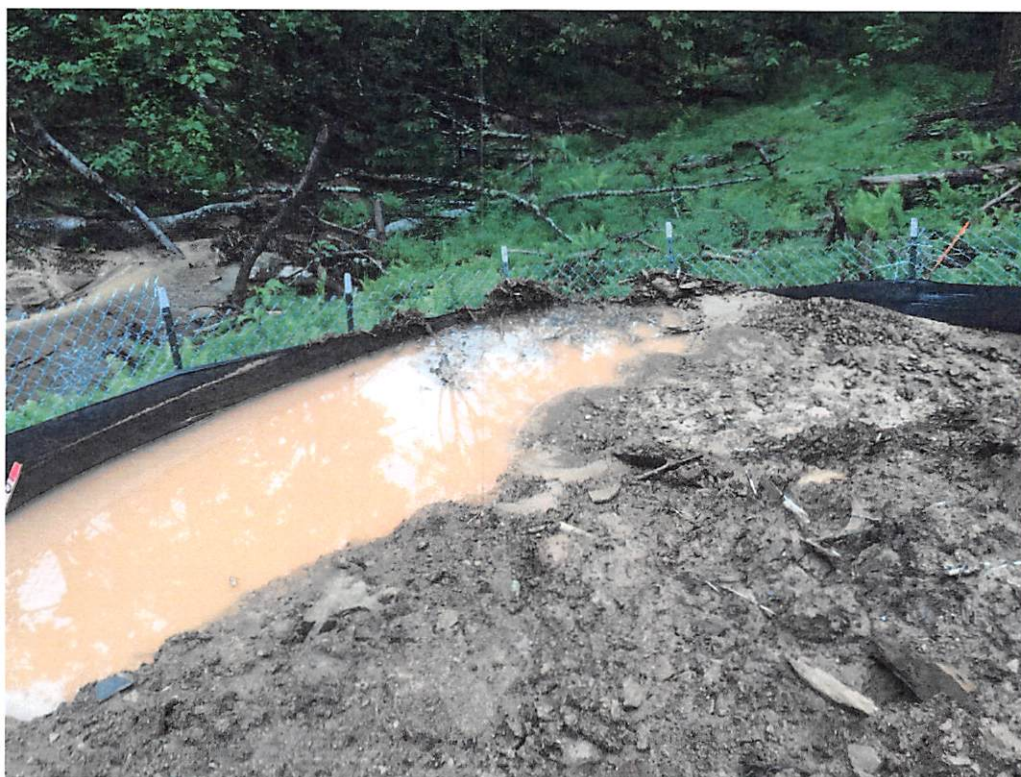
Sheet flow BMPs in need of maintenance and being used in concentrated flow areas near UNT of Buckeye Creek.

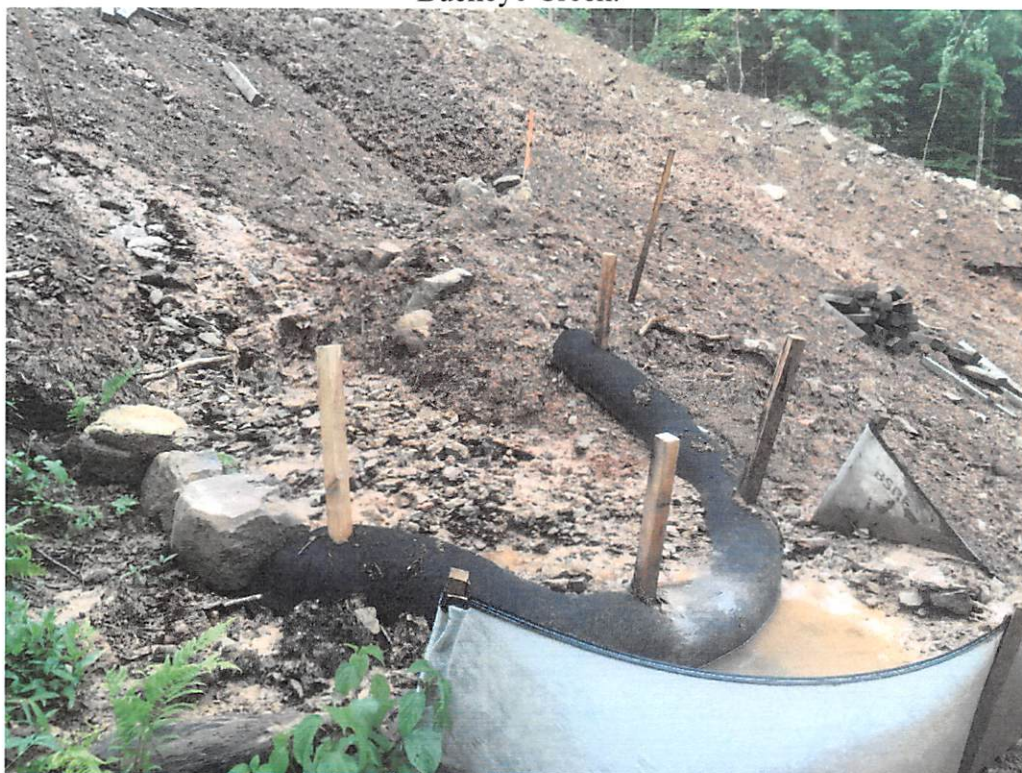
BMPs in need of maintenance near UNT of Buckeye Creek.

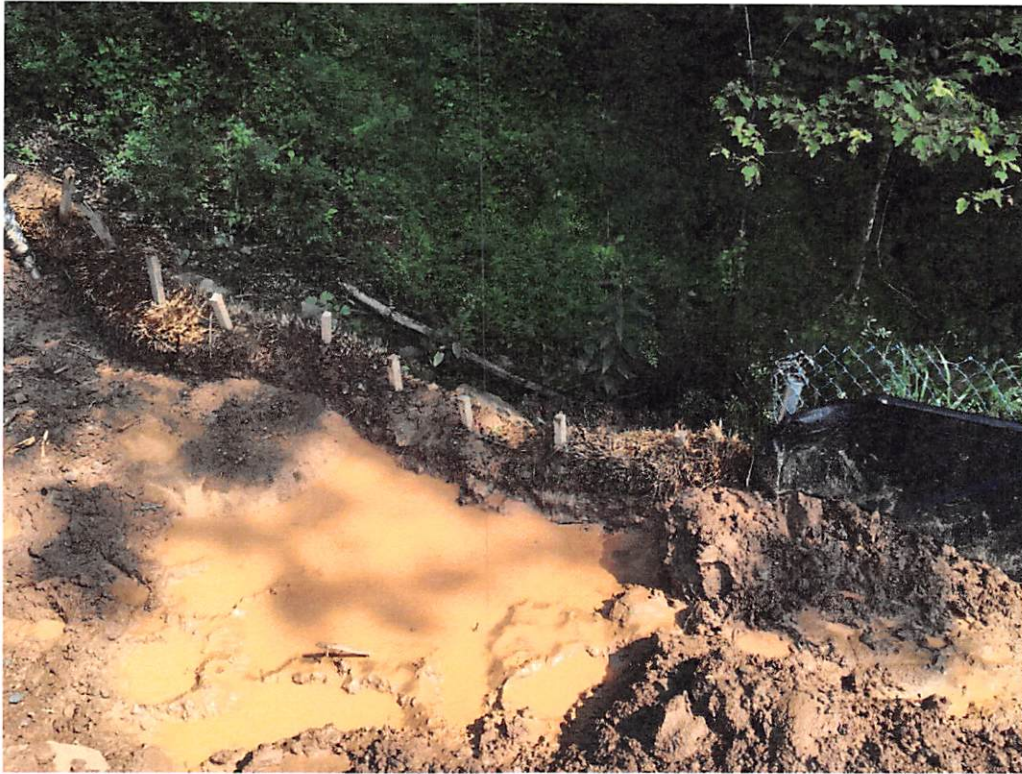
Insufficient BMPs causing conditions not allowable in UNT of Morgan's Run

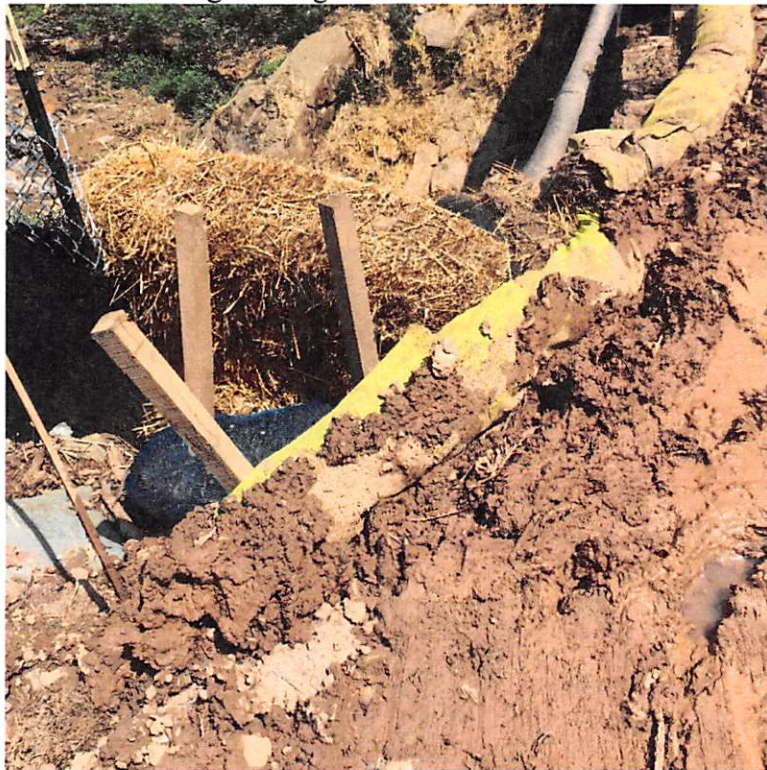
Damaged bridge at UNT of Nutter Fork.

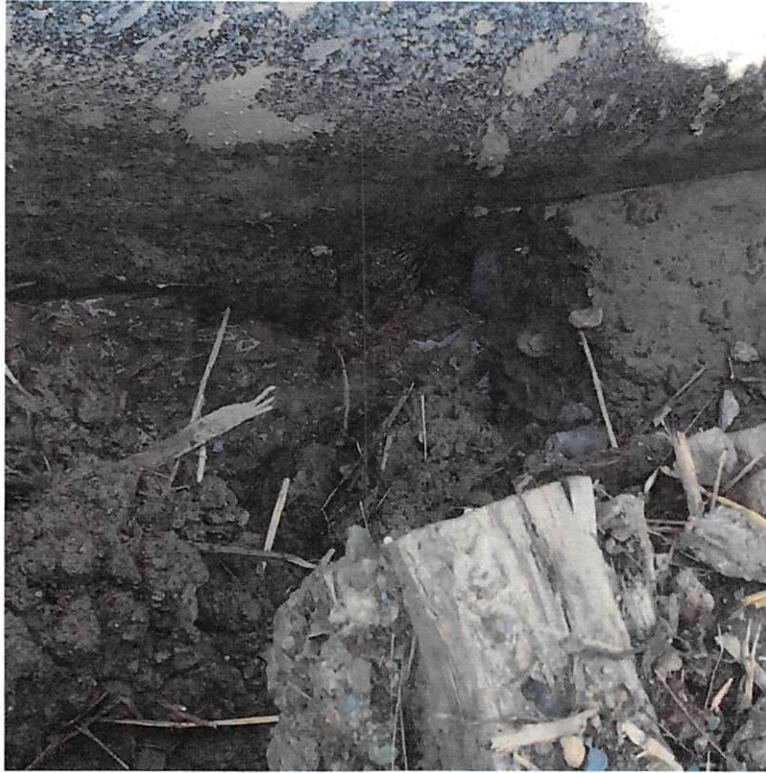
Hole in filter fabric at UNT of Nutter Fork causing sediment laden water to leave site.

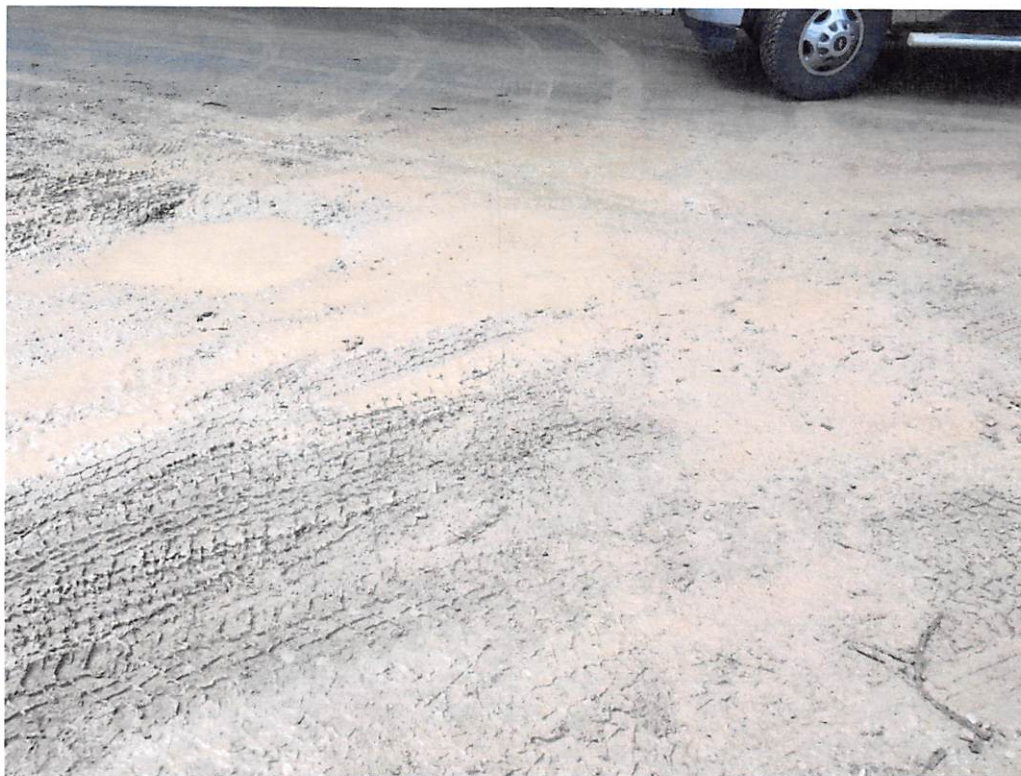
Unstable construction entrance causing mud to be tracked out onto Morgan's Run Road
