# Mountain Valley Pipeline Stream and Wetland Crossings

## Review of Inspection Reports

2024

WEST VIRGINIA  
**RIVERS**

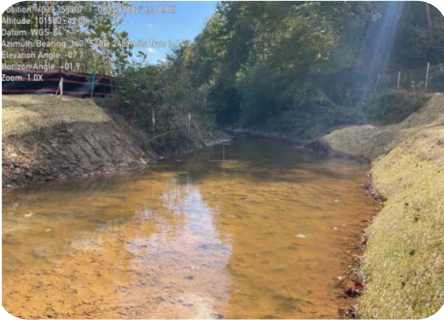
Downstream view of permitted impact area during post-construction assessment.

Two crossings of Rockcamp Run near MVP milepost 18.92 were inspected. Both crossings utilized the dam and pump method. Prior to construction of the crossing, both locations were rated “optimal” for biological conditions for each factor reviewed. Following construction, biological conditions were degraded and the lowest score (5) was assigned for all biological conditions assessed at each of the crossings.

The assessment indicates that this crossing received poor ratings due to a lack of vegetation and temporary presence of a high level of soil particles in the disturbed permitted impact area following the completion of the crossing and restoration efforts.

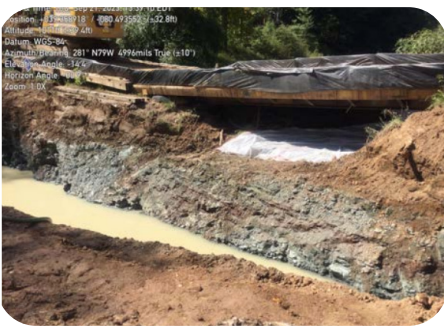
The excavation continued until pipe could be placed into crossing.

However, no indications that any problems occurred during construction were documented. The only exception noted was that a bank on the south side of the crossing area was restored to a shallower angle than the original bank.

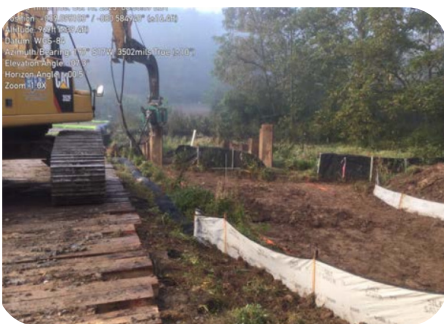
The sheet piling at W-K33.

Emergent wetlands W-K33 PEM and W-VV3 PEM, located near MVP Mileposts 45 and 65, respectively provide examples of wetlands impacted during crossing construction. Each wetland was classified as having negligible disturbance and heavy vegetative cover prior to construction and as highly disturbed with poor vegetative cover following construction.

Timber mats were used during construction, and inspections indicated that BMPs were implemented to avoid impacts. The complete lack of vegetation within the disturbed area was the primary reason for the low biological factor ratings.

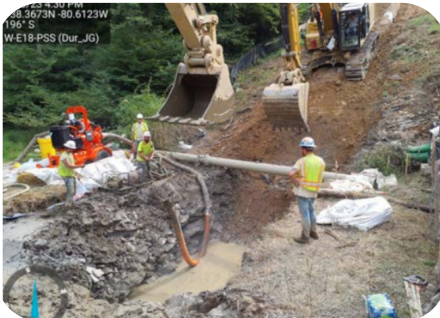
Contractor dewatering ditch line and ditching.

The dam and pump with flume crossing method was utilized to cross stream S-E50 near MVP Milepost 109.63. A wetland (W-E21) was also crossed at this location. Prior to construction of the crossing, the stream provided ideal habitat for aquatic life. Following construction, biological conditions were no longer suitable for habitat. Each of the biological conditions assessed changed from the best score to the worst score during installation of the stream crossing.

The inspection report indicates that BMPs were implemented; however, the crossing was impacted significantly. Blasting of stream bedrock was required to create the pipeline trench, and a heavy rain event halted crossing construction for a day.

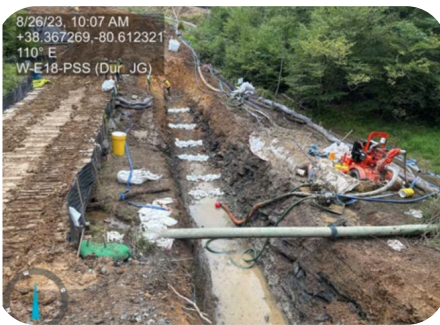
Excavated ditch dewatering and bottom pad installation.

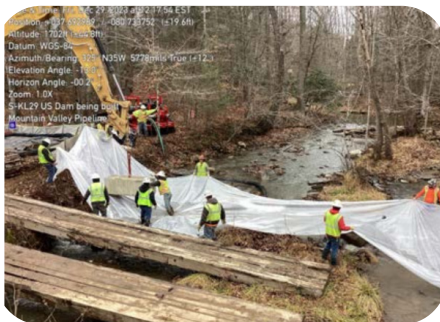
Constructing upstream dam.

MVP crosses Hungards Creek and Right Fork Hungards Creek near Milepost 170. These crossings provide examples of locations where unauthorized discharges to streams occurred during crossing construction. Heavy rains on January 28, 2024 (one day following blasting of the trench) led to dam failure and inundation of the excavated trench. This resulted in a discharge of sediment-laden water from the worksite. Dams were restored on January 30, 2024.

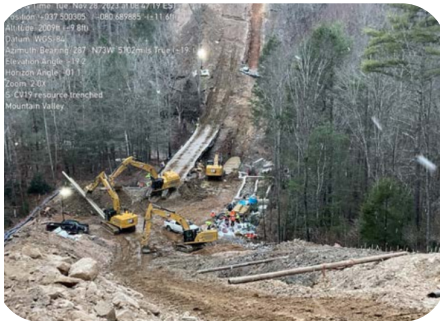
Excavating trench through aquatic resource.

This stream was crossed by the dam and pump method near MVP Milepost 188. Prior to construction, the stream bed consisted of bedrock and boulder, and following construction the bed was cobble. Biological habitat was greatly degraded during construction of the crossing. Prior to construction, this stream provided optimal habitat, with scores of one. Following pipeline installation, sub-optimal biological conditions were documented; the stream received scores of 4, indicating poor habitat or severely impacted conditions.
