# Mountain Valley Pipeline Stream and Wetland Crossings

## Review of Inspection Reports

2024

WEST VIRGINIA  
**RIVERS**

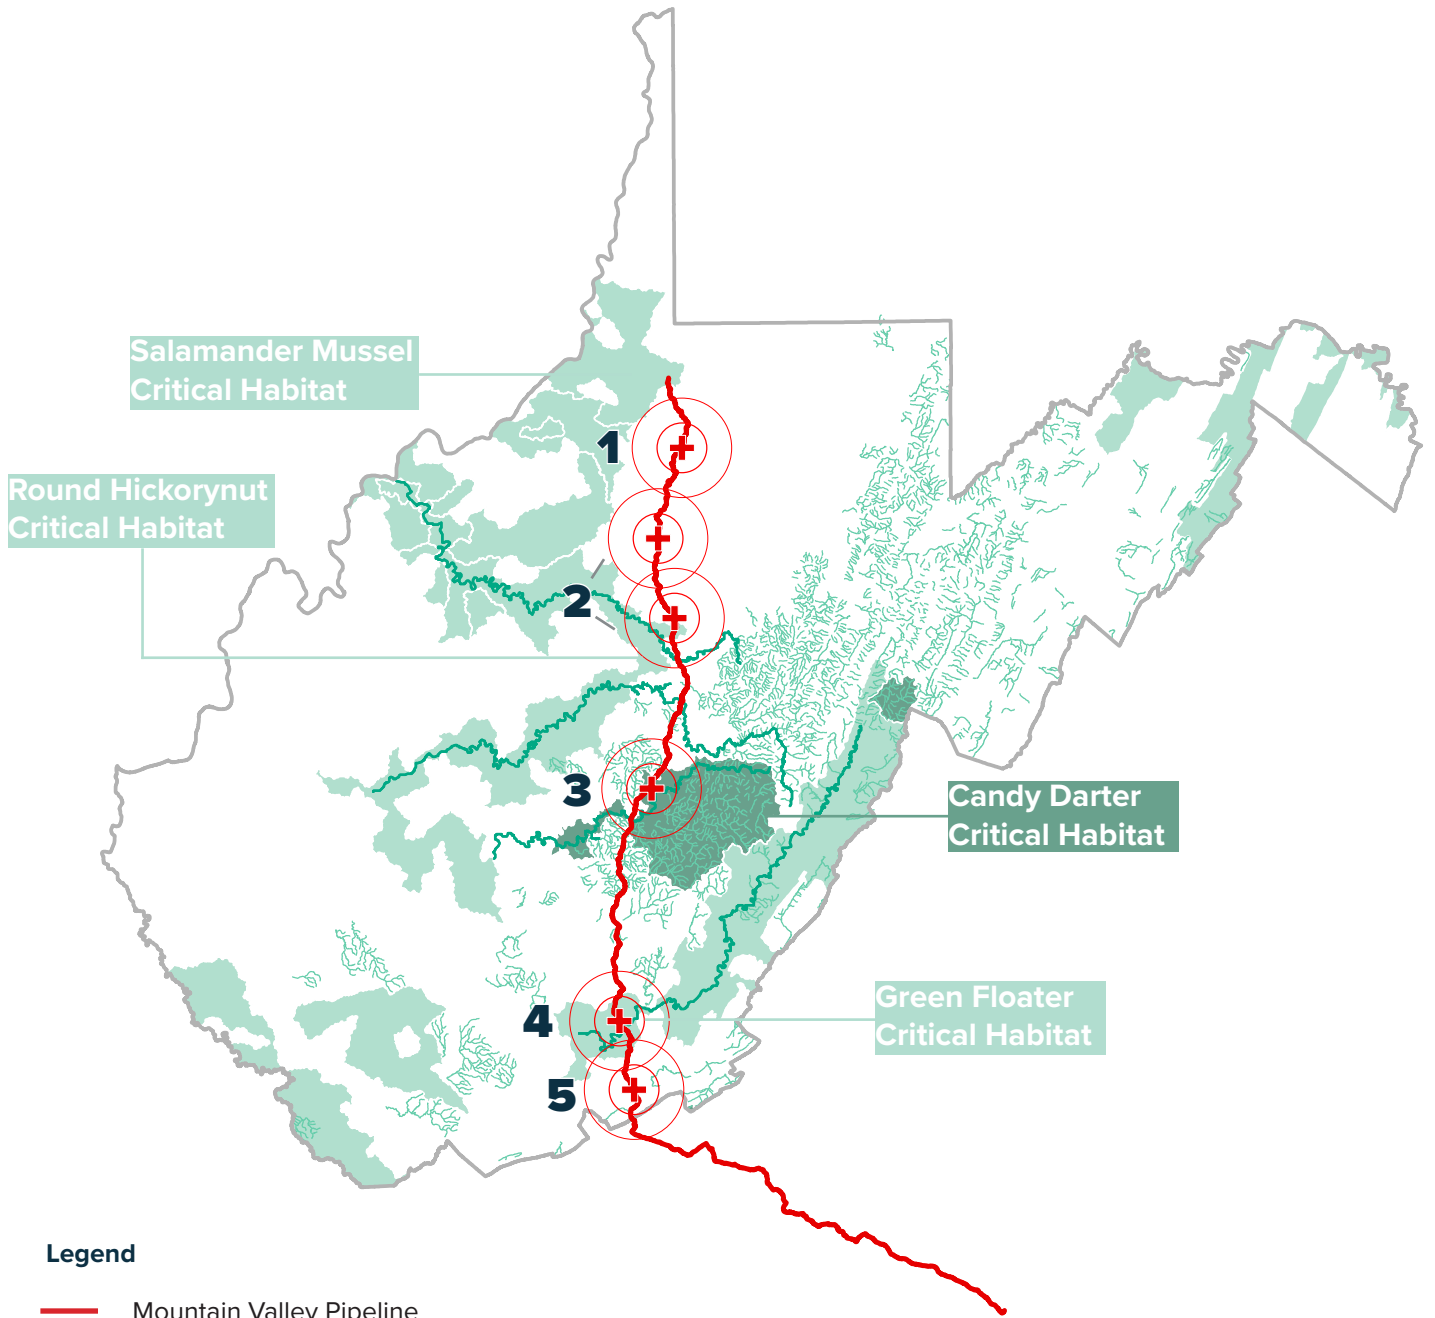
Primary Impacts: Degraded biological conditions

Two crossings of Rockcamp Run near MVP milepost 18.92 were inspected. Both crossings utilized the dam and pump method. Prior to construction of the crossing, both locations were rated “optimal” for biological conditions for each factor reviewed. Following construction, biological conditions were degraded and the lowest score (5) was assigned for all biological conditions assessed at each of the crossings.

However, no indications that any problems occurred during construction were documented. The only exception noted was that a bank on the south side of the crossing area was restored to a shallower angle than the original bank.
