RADIOACTIVE FRACKING WASTE AT FAIRMONT BRINE: PROTECTING COMMUNITIES IN MARION COUNTY, WEST VIRGINIA

FAIRMONT BRINE SITE TIMELINE

EPA'S JUNE 2024 REPORT

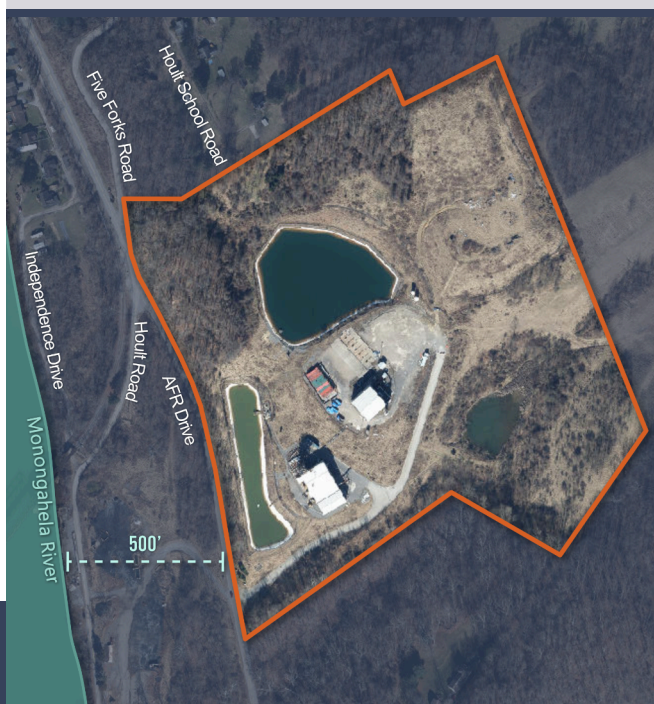
On **May 30, 2023**, a fire and explosion at the Fairmont Brine site damaged an aboveground storage tank. Elevated radiation readings due to TENORM were then found in several areas of the site. The U.S. Environmental Protection Agency (EPA) helped the West Virginia Department of Environmental Protection (DEP) and other state agencies respond. EPA and its contractors posted "No Trespassing" signs at the site, and by November they had fenced the site to mitigate long-term exposure to radiation to trespassers, responders, and the public.

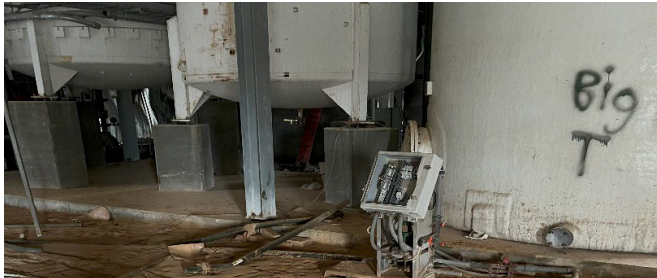
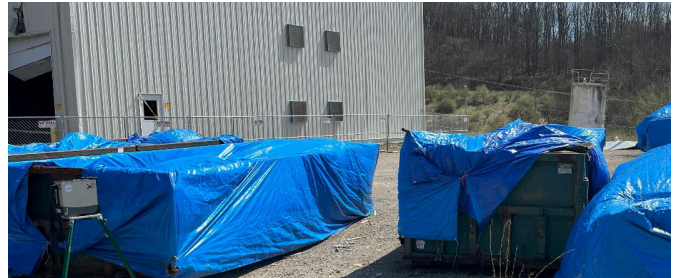
In June 2024, EPA released a report called "Fairmont Brine Processing Site Final Report," which summarizes the results of radiation testing performed in March. EPA scanned all accessible parts of the site and found six locations with elevated radiation levels that were at least three times higher than background. EPA found two additional locations with somewhat lower radiation levels, but that still approached three times background levels. EPA also assessed which types of radionuclides were detected and found that all gamma-emitting radionuclides were TENORM.

The highest readings were found inside the Complex Building and near the roll-off dumpsters. At both of these locations, radiation was approximately 30 times higher than background.

Remove the radioactive material. EPA should remove all radioactive material that is present due to human activities and that is above a site-specific background activity level established for the area. These materials should be disposed of properly so that there will be no further human exposure. EPA has made cleanup of Fairmont Brine a priority, requesting emergency resources to decrease hazards. The surrounding neighborhood is at risk from dust exposure and water runoff during removal of radioactive materials. All caution must be taken to reduce risk.

Confirm that the site is fully remediated. After removal of radioactive materials, EPA should conduct further testing to confirm that radiation levels at the site have returned to background levels.
