west virginia department of environmental protection

**ORDER
ISSUED UNDER THE
WATER POLLUTION CONTROL ACT
WEST VIRGINIA CODE, CHAPTER 22, ARTICLE 11**

ORDER NO.: 8749

1. Rover Pipeline LLC is conducting land disturbance activity in Doddridge and Tyler Counties, West Virginia. Rover Pipeline LLC was issued Water Pollution Control Permit No. WV0116815, Registration No. WVR310726 on December 15, 2016.

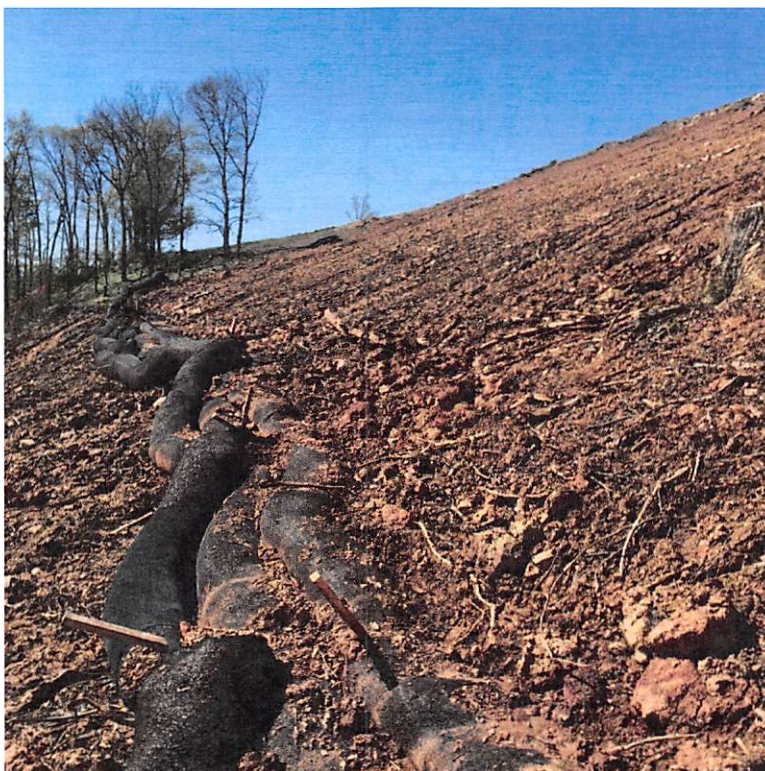
Maintenance issues at Sherwood Compressor.

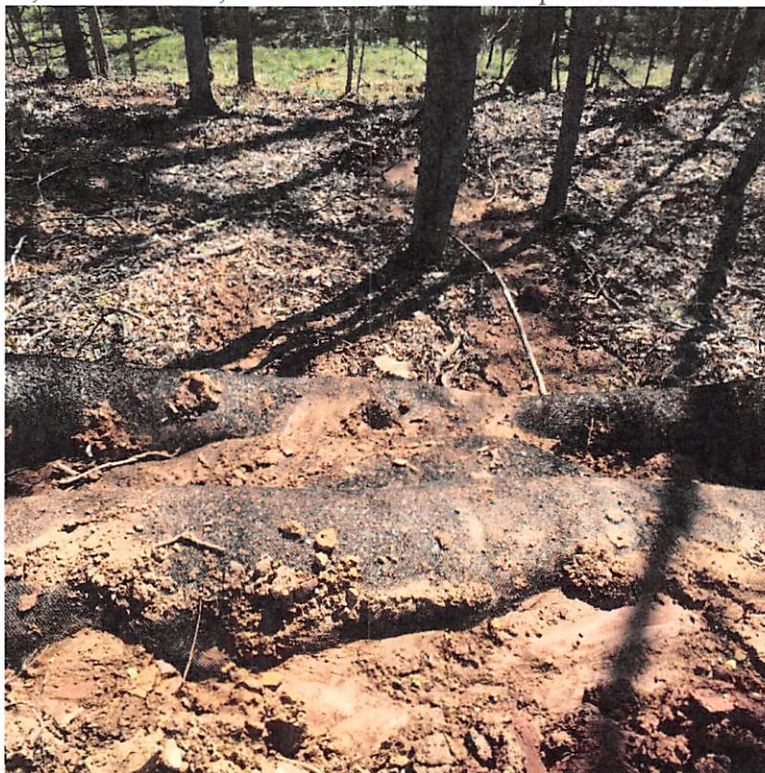
Sediment leaving site at Sherwood Compressor.

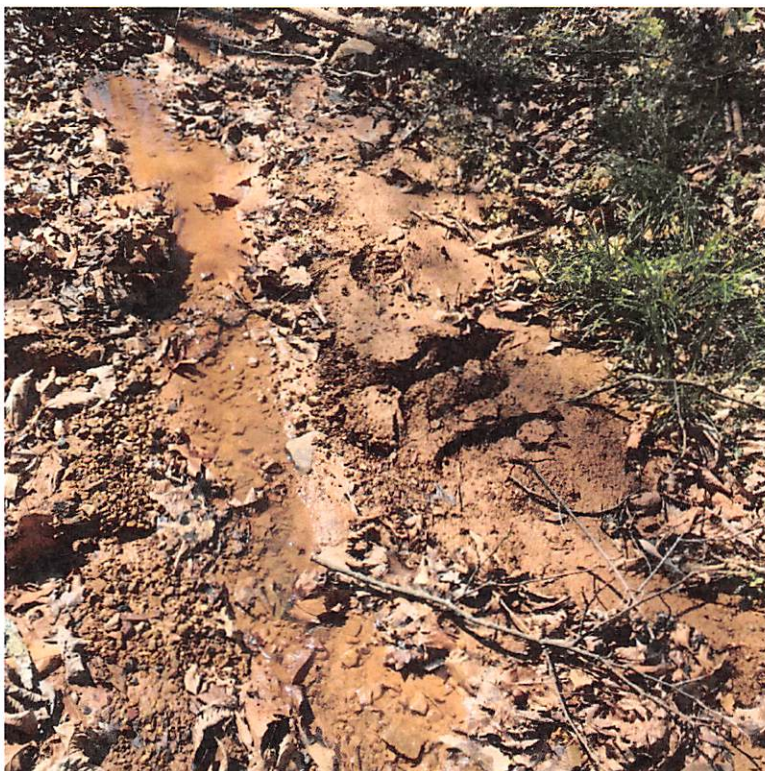
Sediment leaving site at Sherwood Compressor.

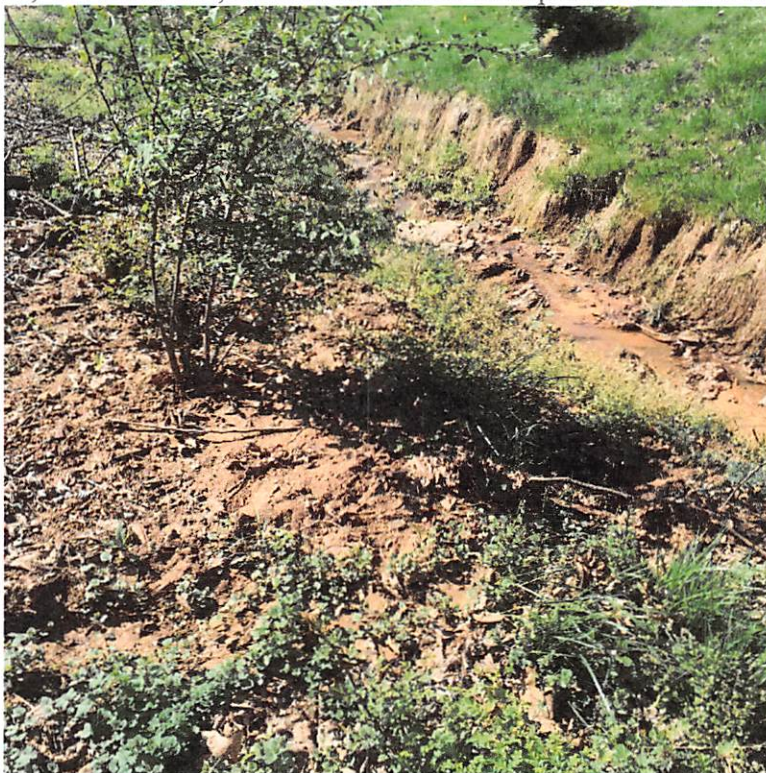
Sediment deposits in Eibscamp Run that have left site (Sherwood Compressor).

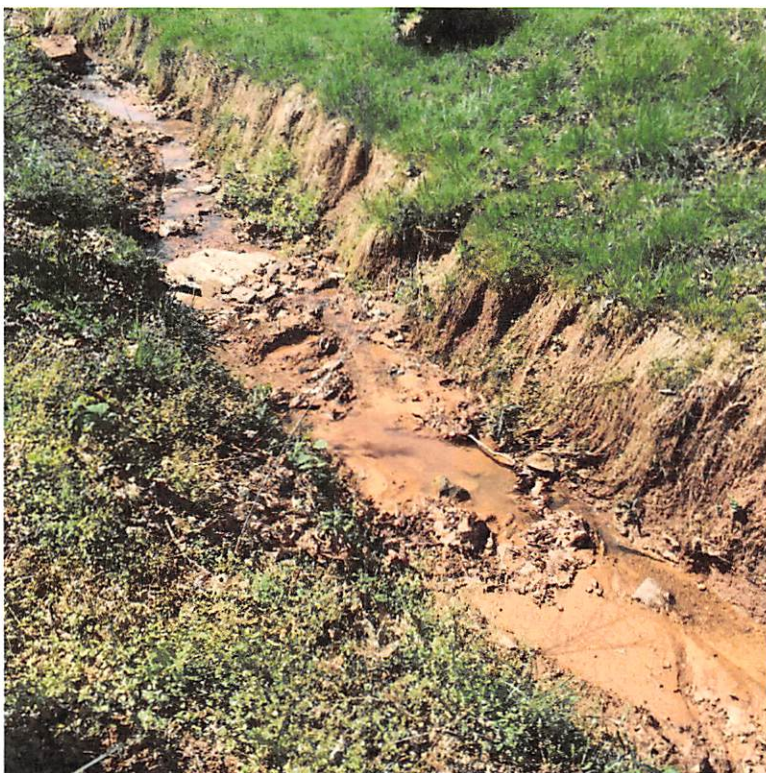
Sediment deposits in Eibscamp Run that have left site (Sherwood Compressor).

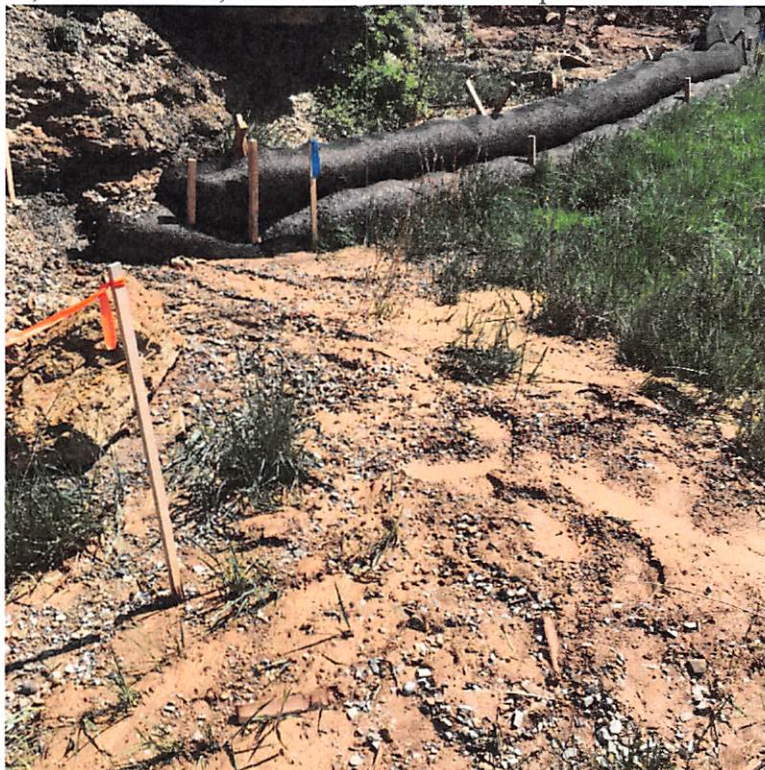
Sediment leaving site behind barn at Sherwood Compressor site.

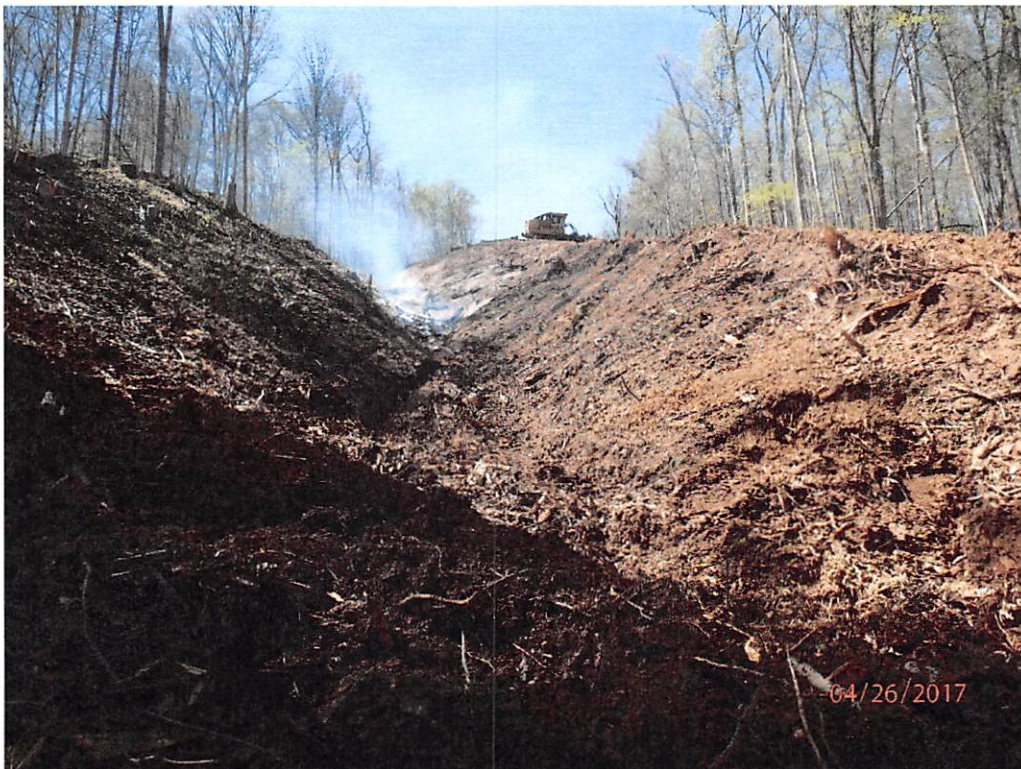
Ephemeral stream that has had equipment in channel. Soil has been disturbed with no E&S controls in place.

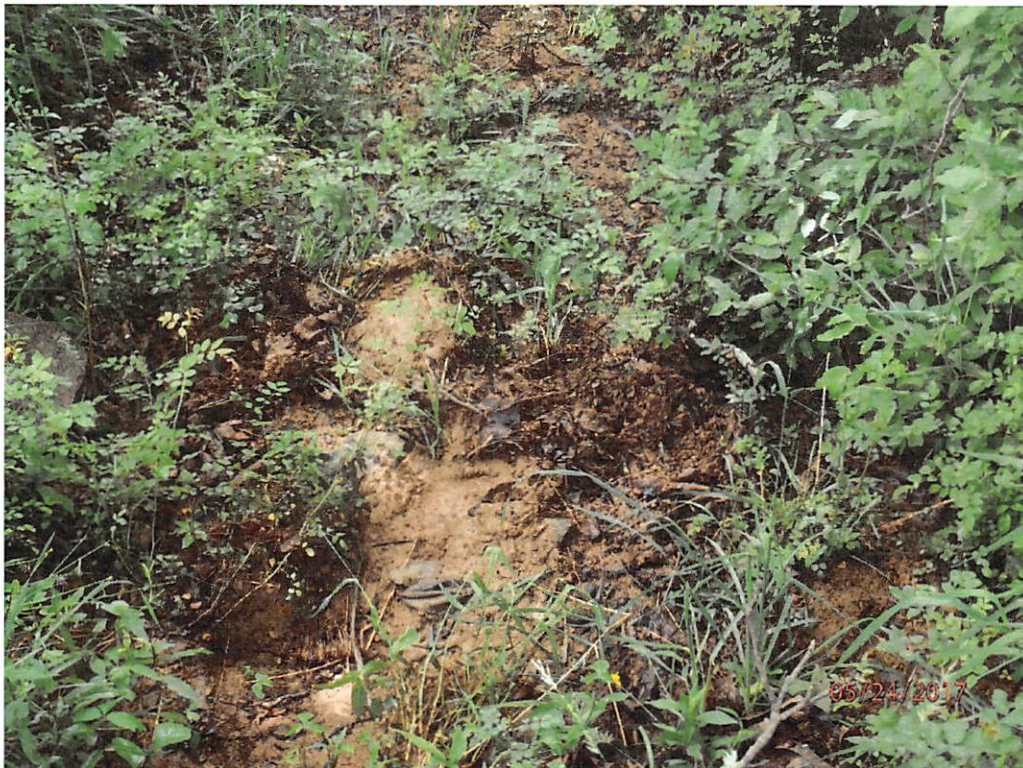
Offsite sediment deposits below upper picture.

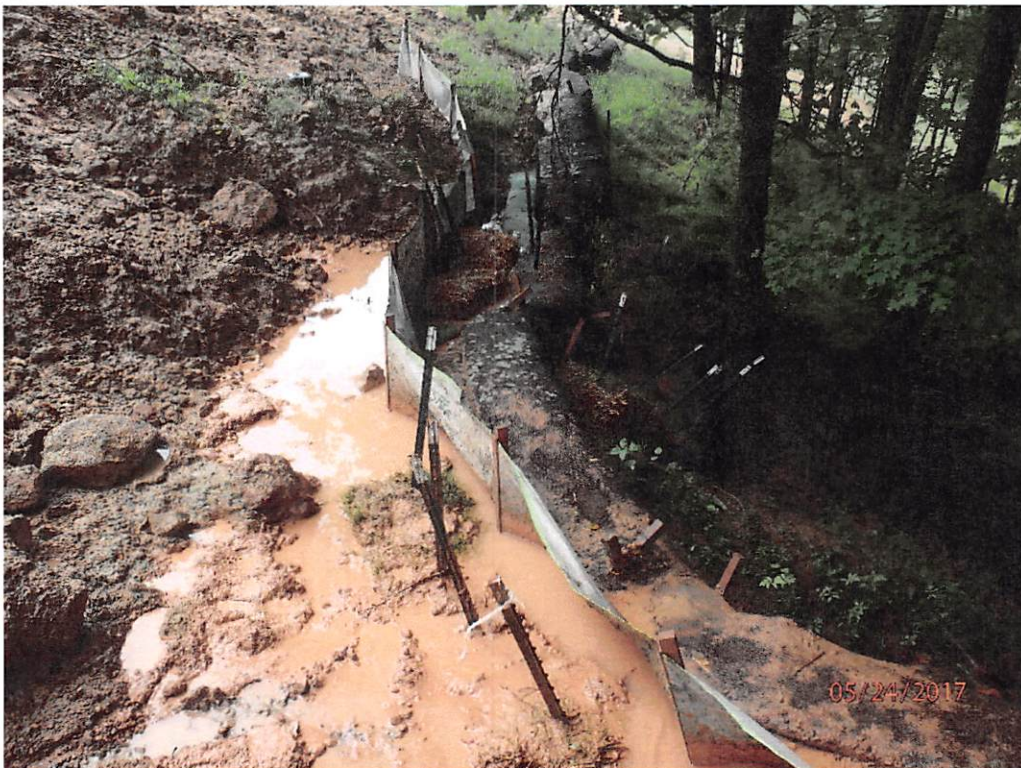
Area below compressor access road where concentrated flow is being treated with sheet flow controls. This area is consistently being overwhelmed which is causing sediment laden water to leave the site.

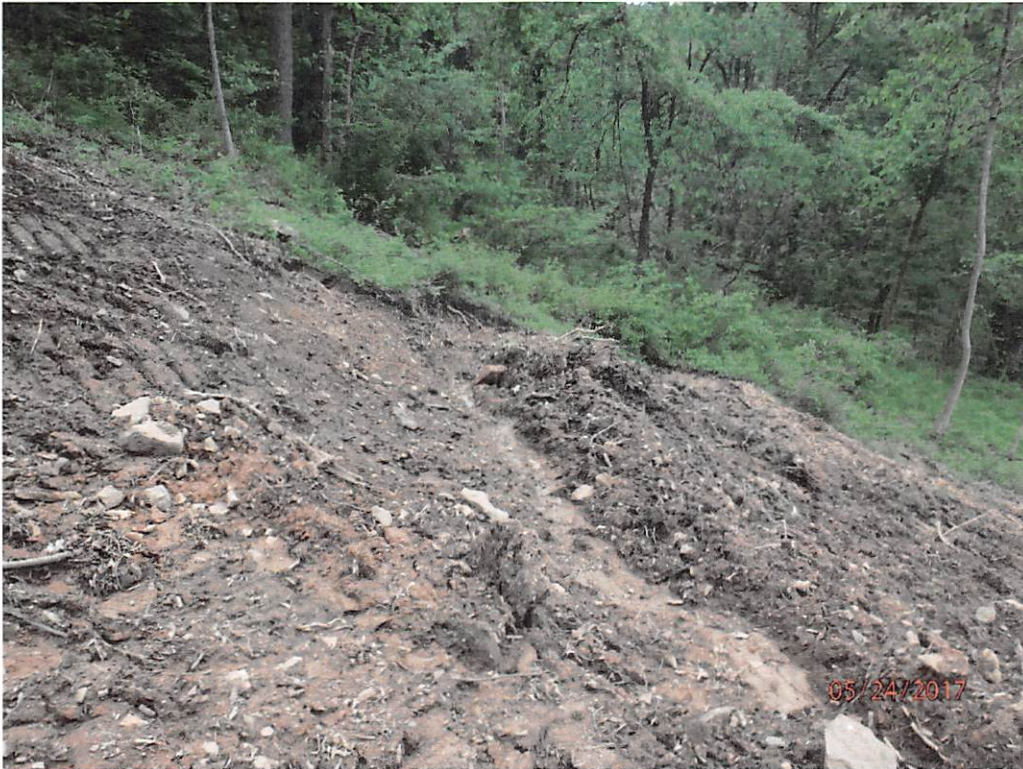
Water bar outlets that have no treatment, which is causing sediment laden water to leave site. The above pictures are representative of all water bars for the portion of the pipeline inspected.

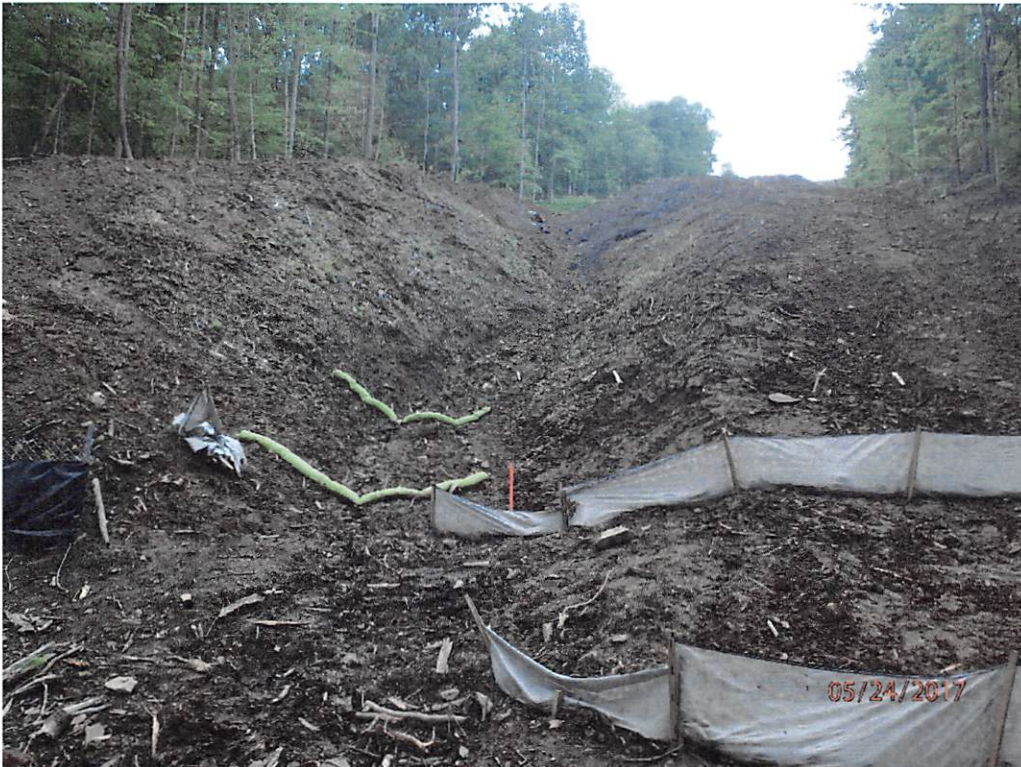
Overview of pipeline stream crossing of UNT of Buckeye Creek. Sheet flow controls being used in concentrated flow of ephemeral stream causing sediment deposits in stream. Silt fence being utilized in place of super silt fence.

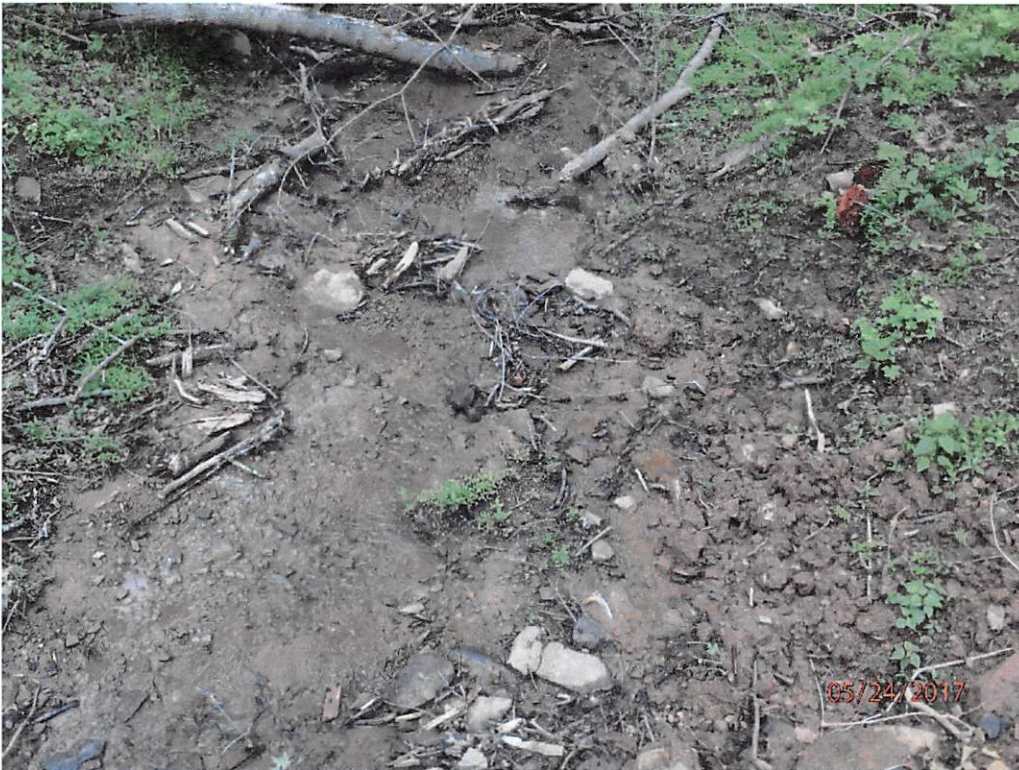
Stream channel downstream of pipeline crossing of UNT of Buckeye Creek showing sediment deposits.

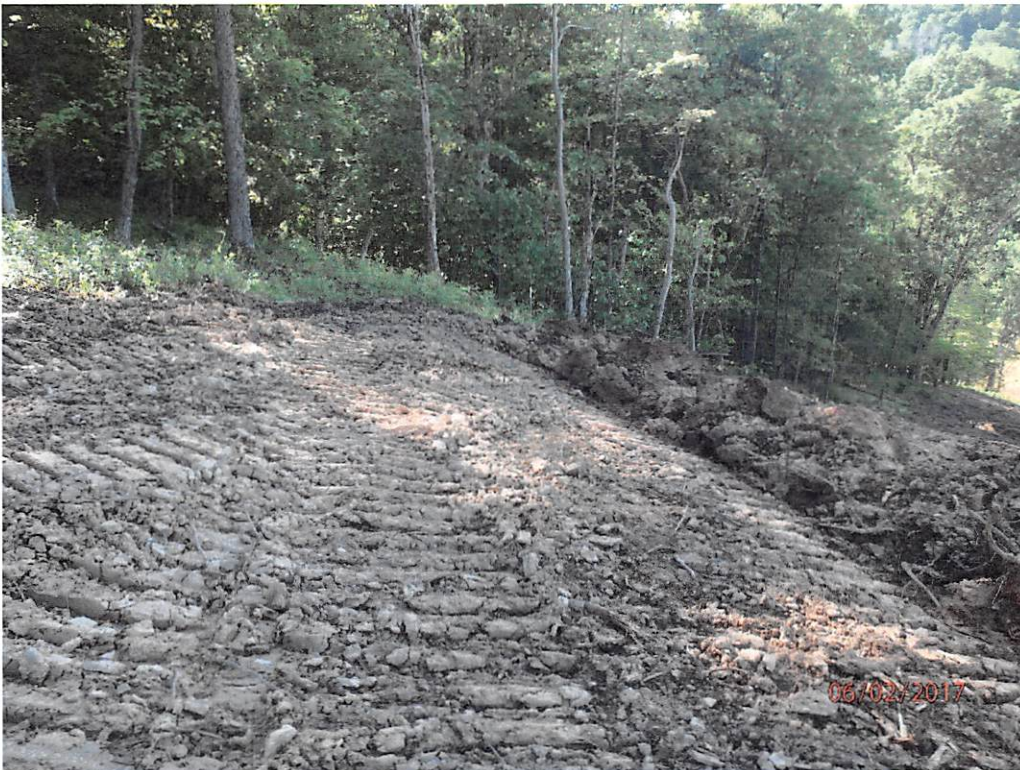
Water bars with no treatment at outlets.

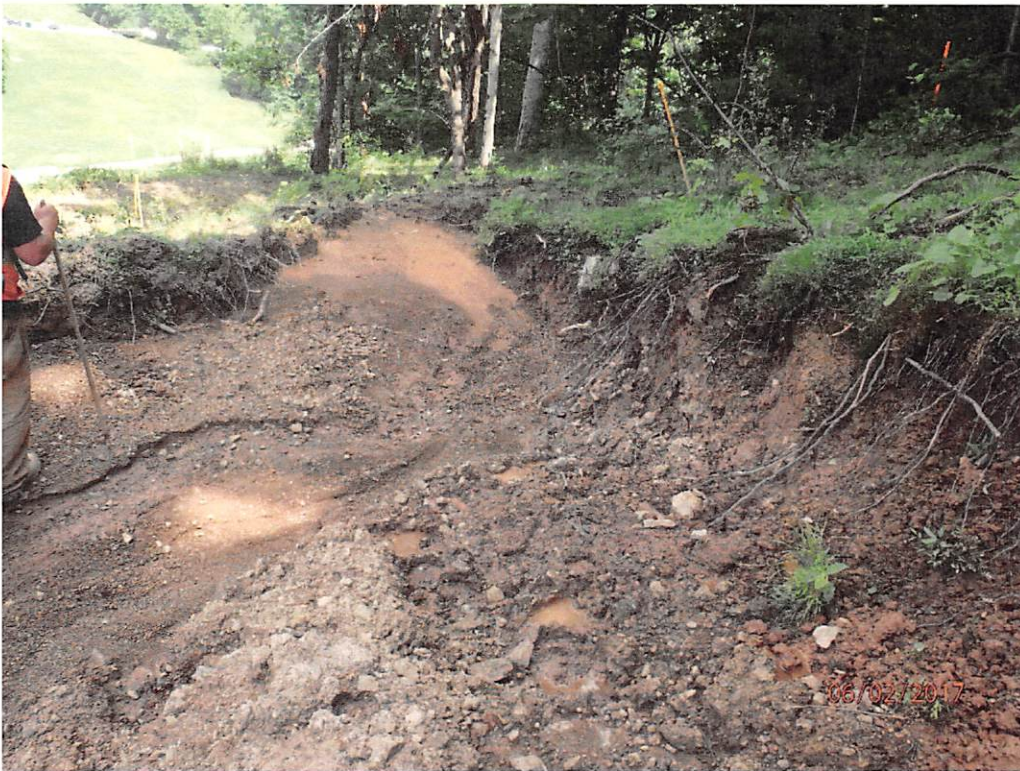
Water bar with no treatment at outlets.

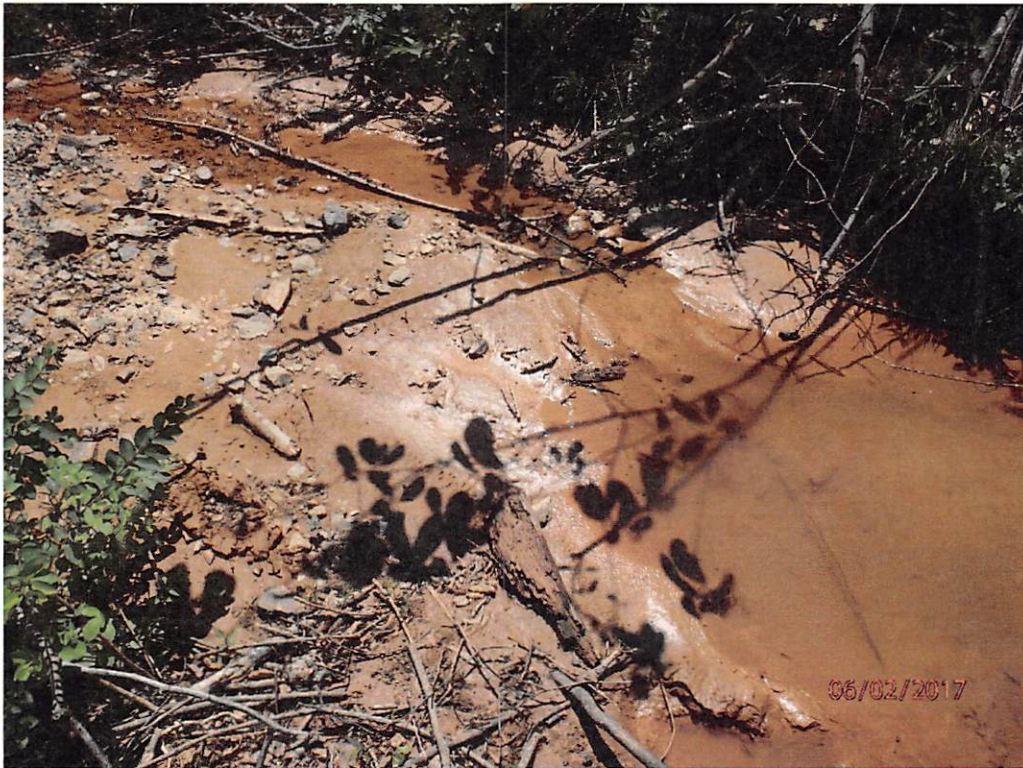
Sediment deposits in UNT of Morgans Run downstream of previously pictured bridge. Picture is taken below LOD.

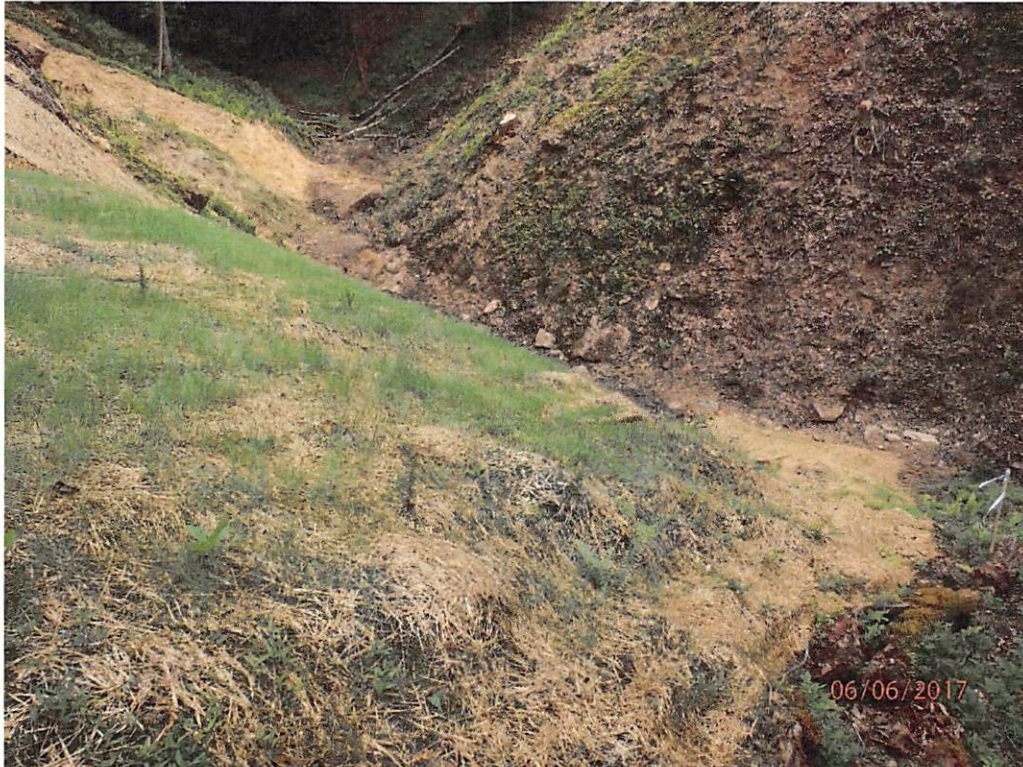
UNT of Nutter Fork with sediment deposits. Controls not in place as indicated in SWPPP.

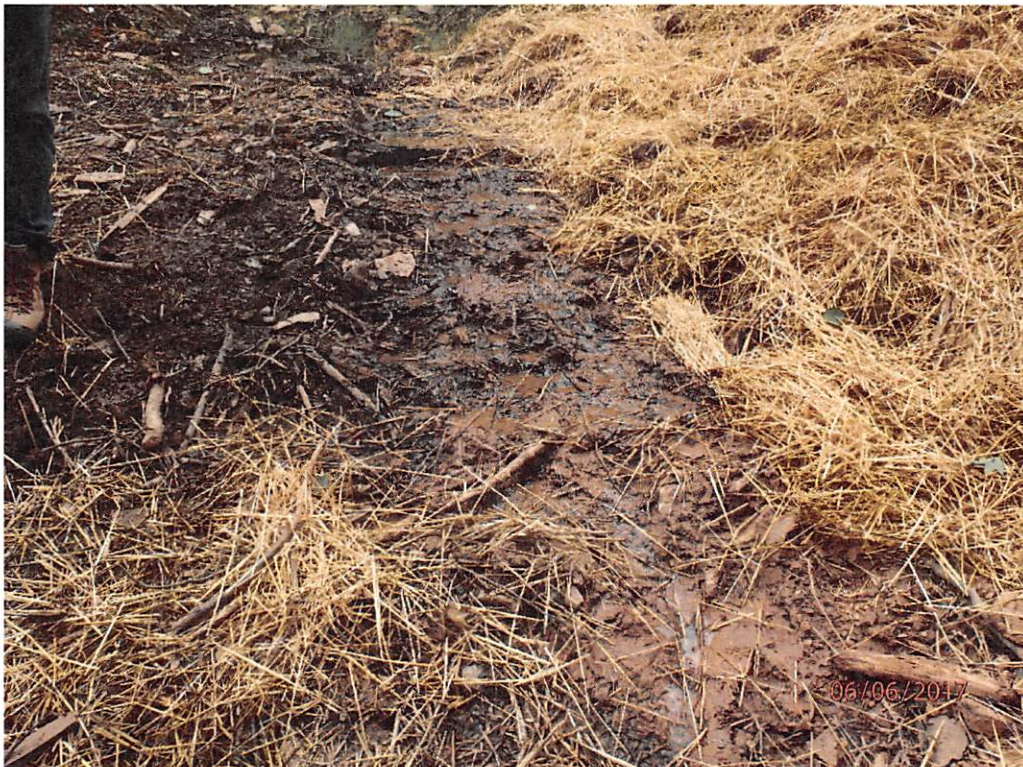
UNT of Nutter Fork with sediment deposits. Controls not in place as indicated in SWPPP.

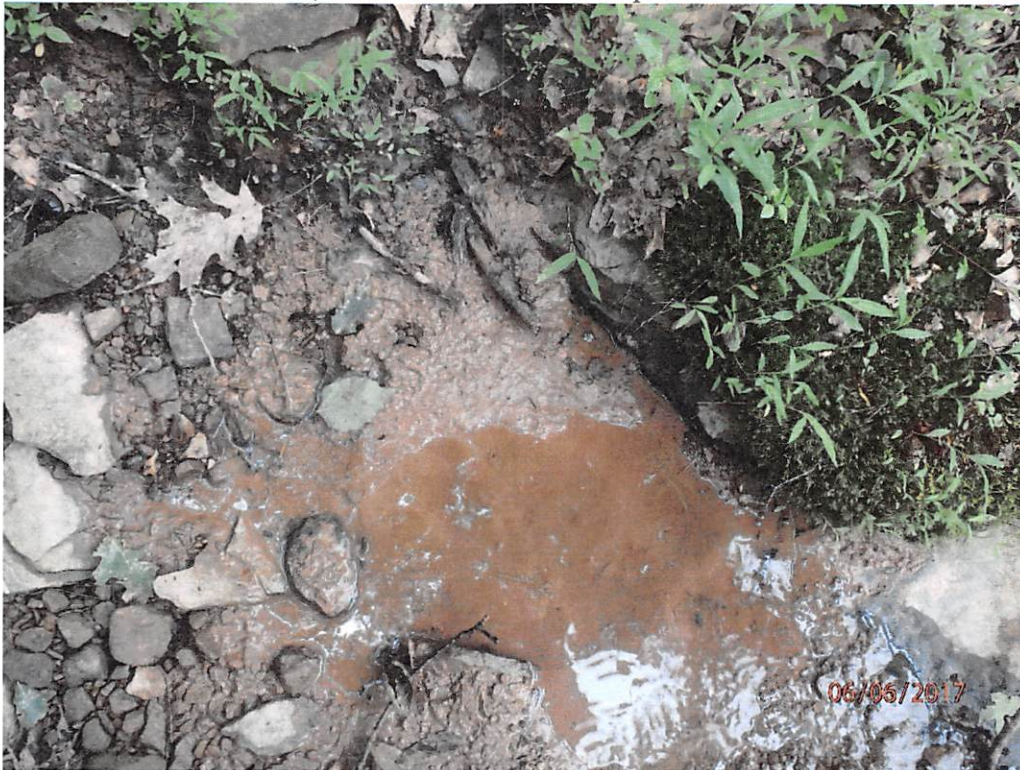
UNT of Nutter Fork with sediment deposits. Pictures taken downstream of LOD.

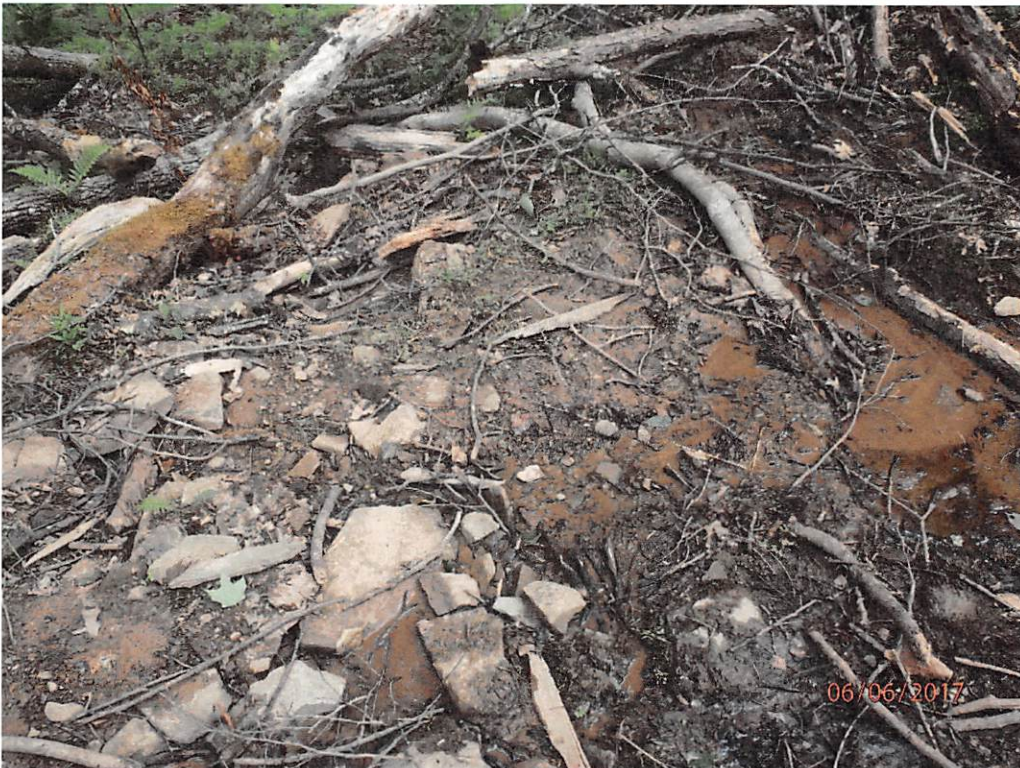
UNT of Nutter Fork with sediment deposits. Pictures taken downstream of LOD.

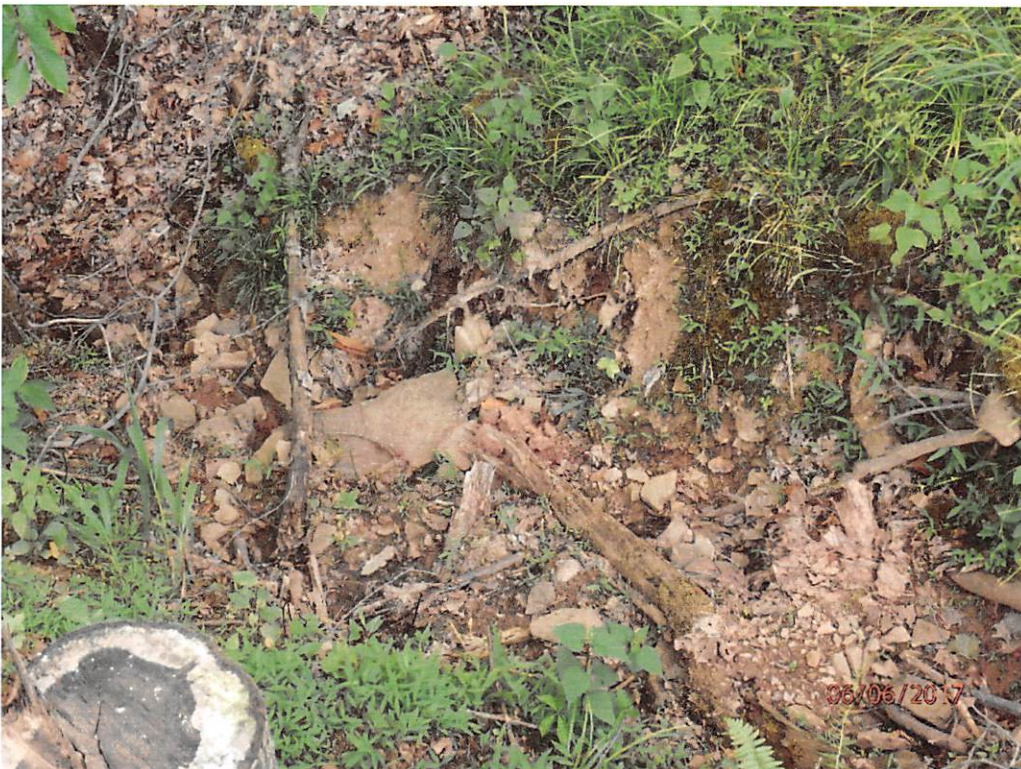
Ephemeral UNT of Nutter Fork with sediment deposits. Sheet flow BMP being used in concentrated flow.

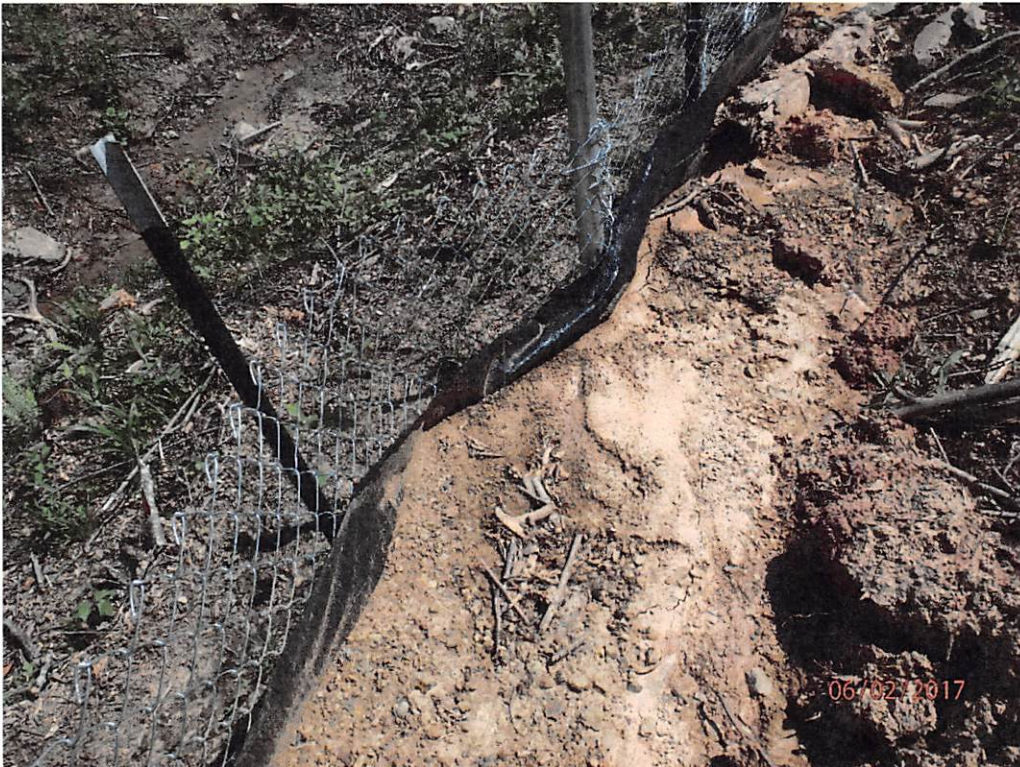
Silt fence in need of maintenance near UNT of Morgans Run.

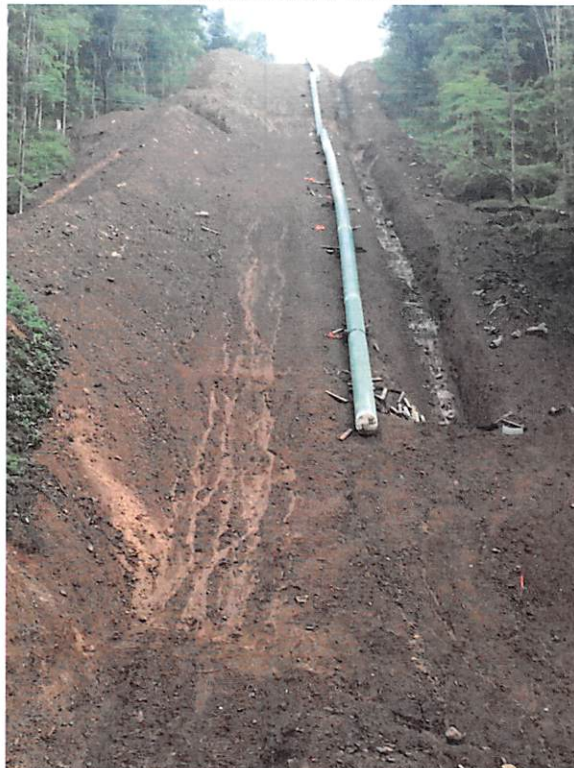
ROW with pipe trench near UNT of Buckeye creek. Water bars not in place and functioning as indicated in SWPPP.

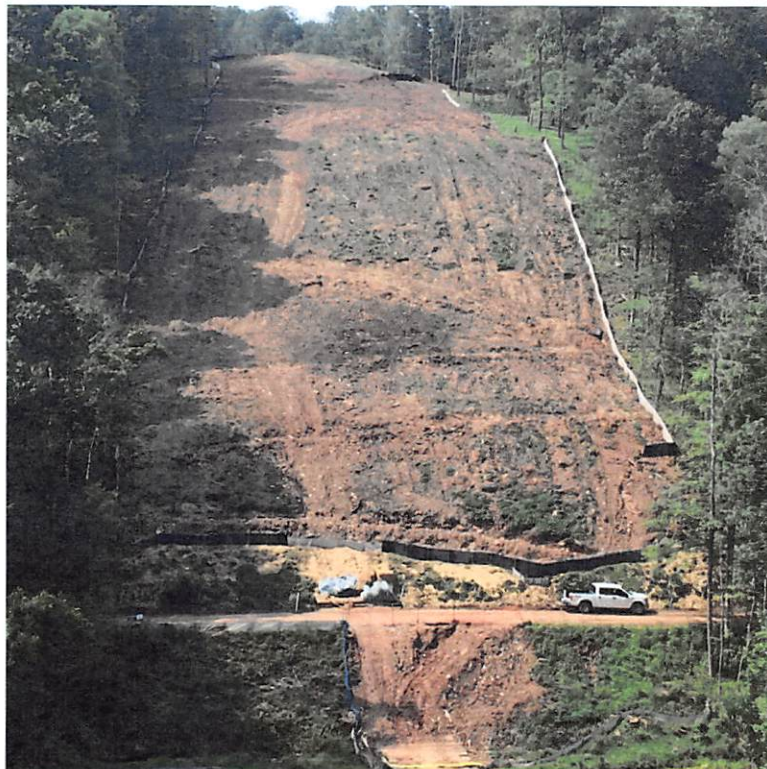
Area near Camp Mistake where water bars end prior to exiting perimeter silt fence.

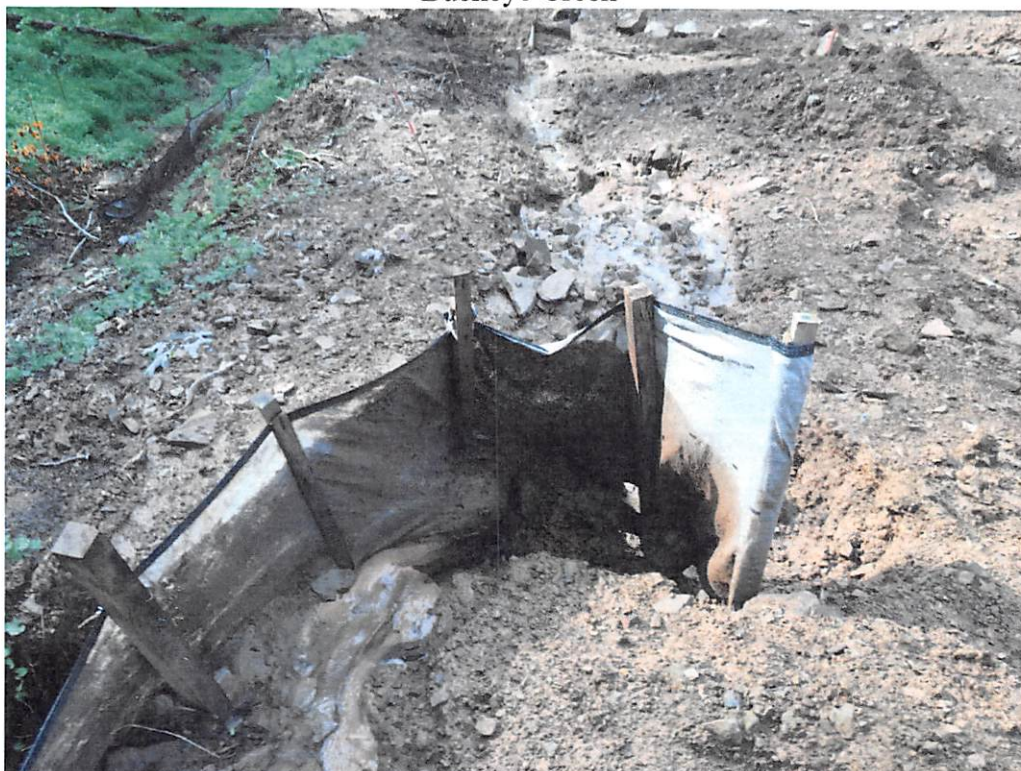
Sheet flow BMPs in need of maintenance and being used in concentrated flow areas near UNT of Buckeye Creek.

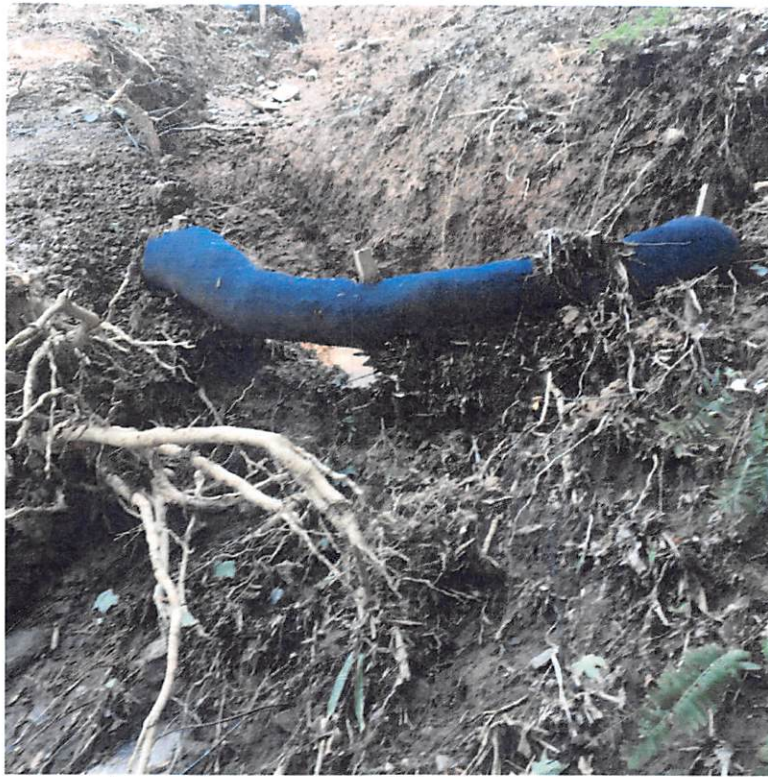
BMPs at water bar outlet near Camp Mistake Run in need of maintenance.

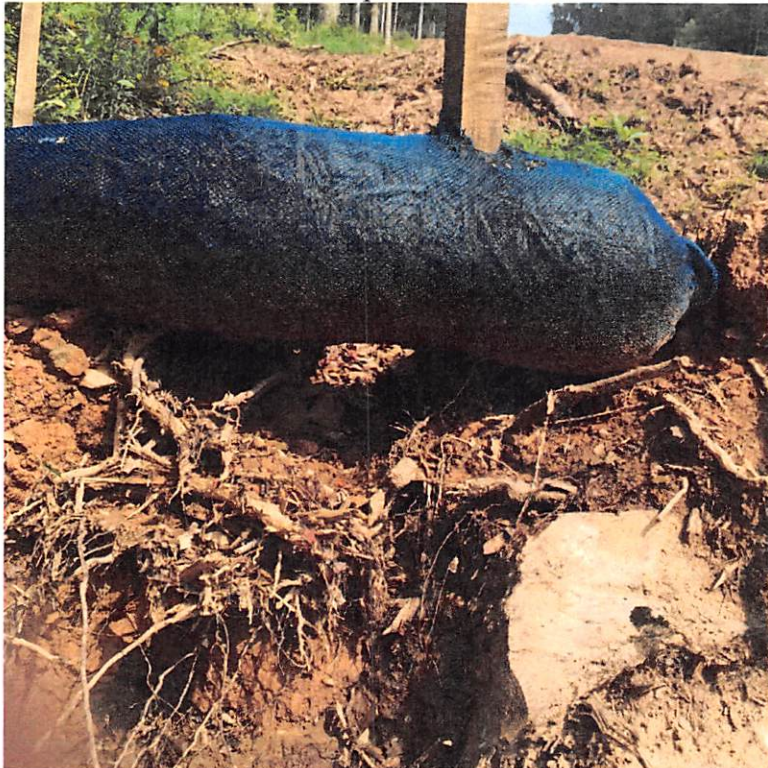
BMPs at water bar outlet near Camp Mistake Run in need of maintenance.

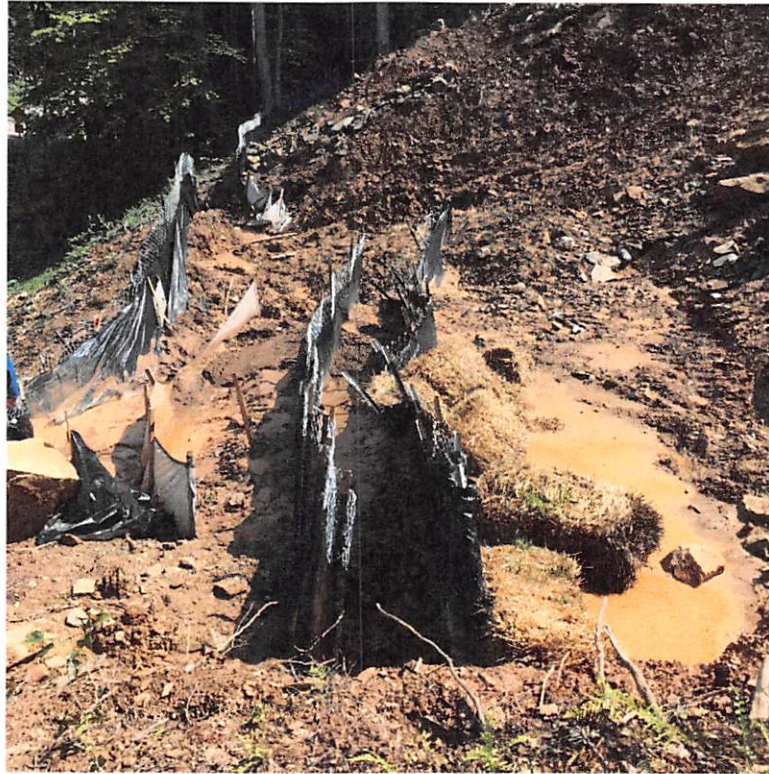
Area upslope of UNT of England's Run.

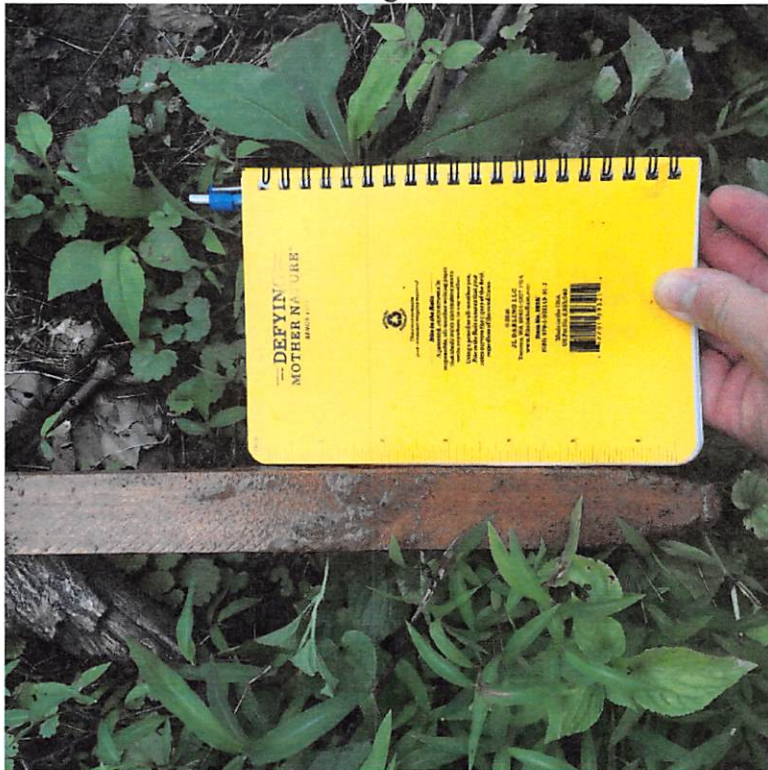
UNT of England's Run – In-stream sediment depth in excess of six inches (6") indicated by notebook.

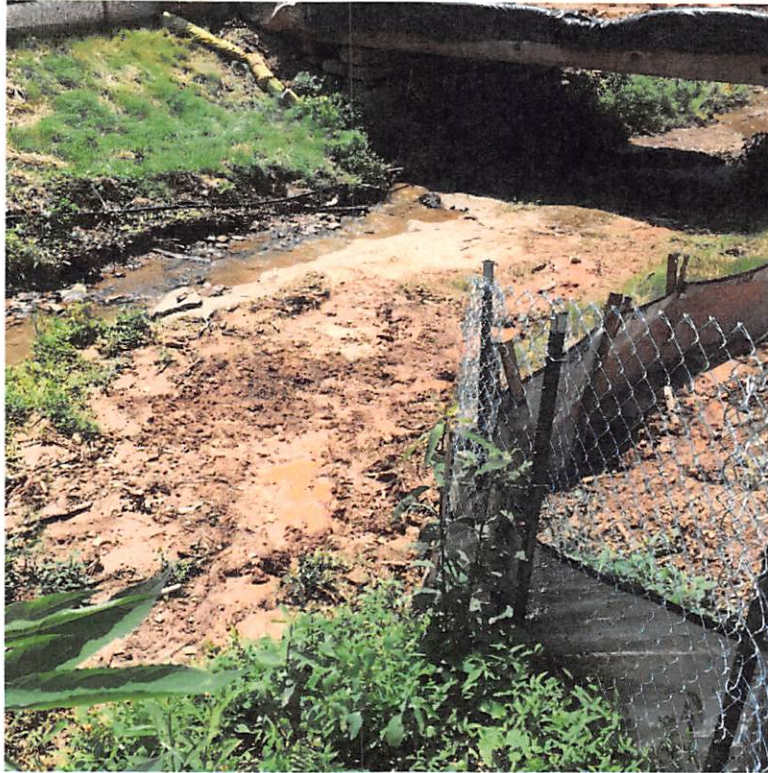
Sediment laden water leaving site at UNT of Jockey Camp Run.

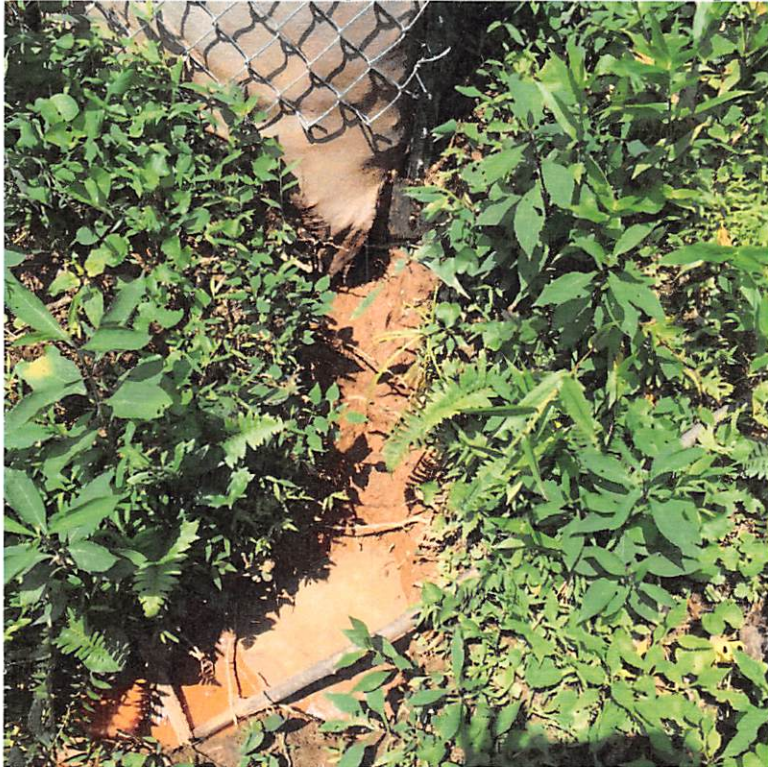
Sediment laden water leaving site at UNT of Jockey Camp Run due to concentrated flow damaging controls.

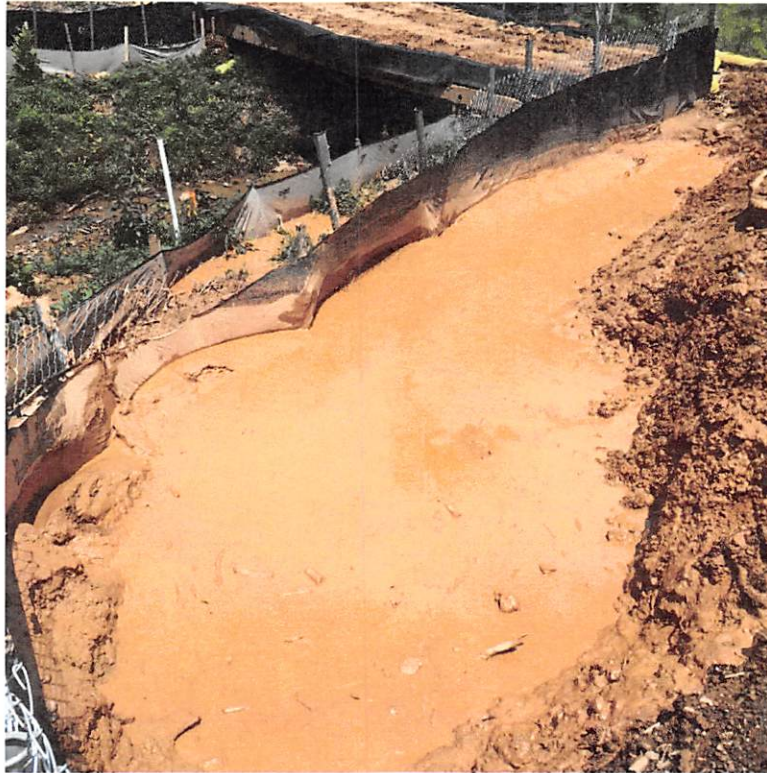
Sediment laden water leaving the site and migrating toward receiving stream adjacent to UNT of Jockey Camp Run.

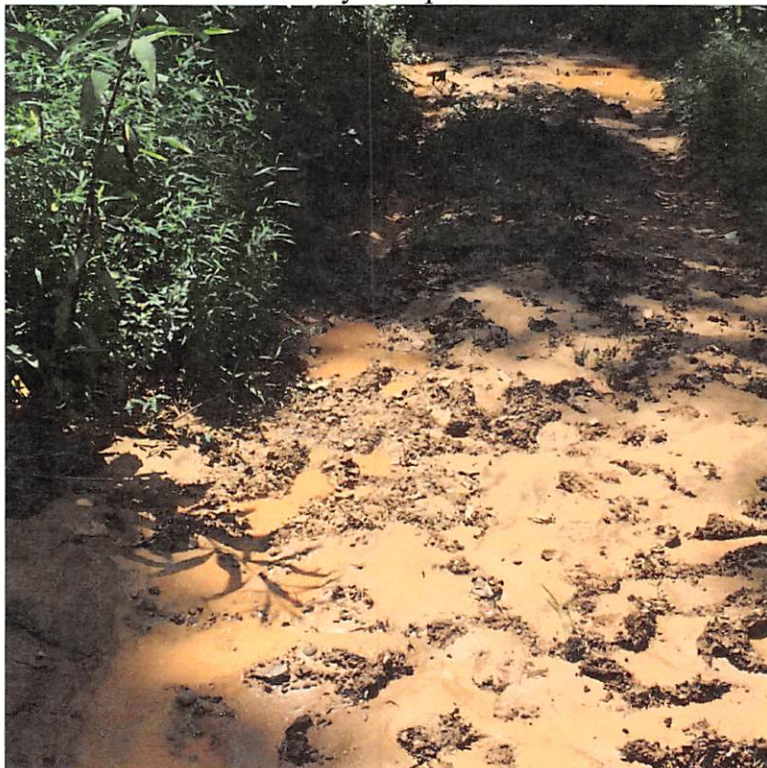
Sediment laden water leaving the site and migrating toward receiving stream adjacent to UNT of Jockey Camp Run.
