west virginia department of environmental protection

**ORDER
ISSUED UNDER THE
WATER POLLUTION CONTROL ACT
WEST VIRGINIA CODE, CHAPTER 22, ARTICLE 11**

ORDER NO.: 8749

1. Rover Pipeline LLC is conducting land disturbance activity in Doddridge and Tyler Counties, West Virginia. Rover Pipeline LLC was issued Water Pollution Control Permit No. WV0116815, Registration No. WVR310726 on December 15, 2016.

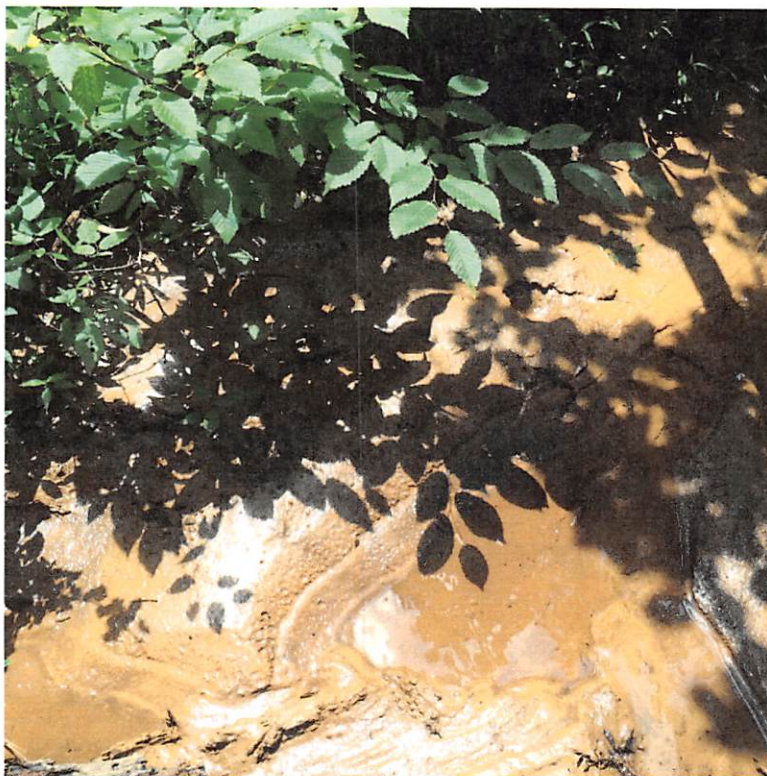
Sediment deposits downstream of LOD on UNT of Jockey Camp Run.

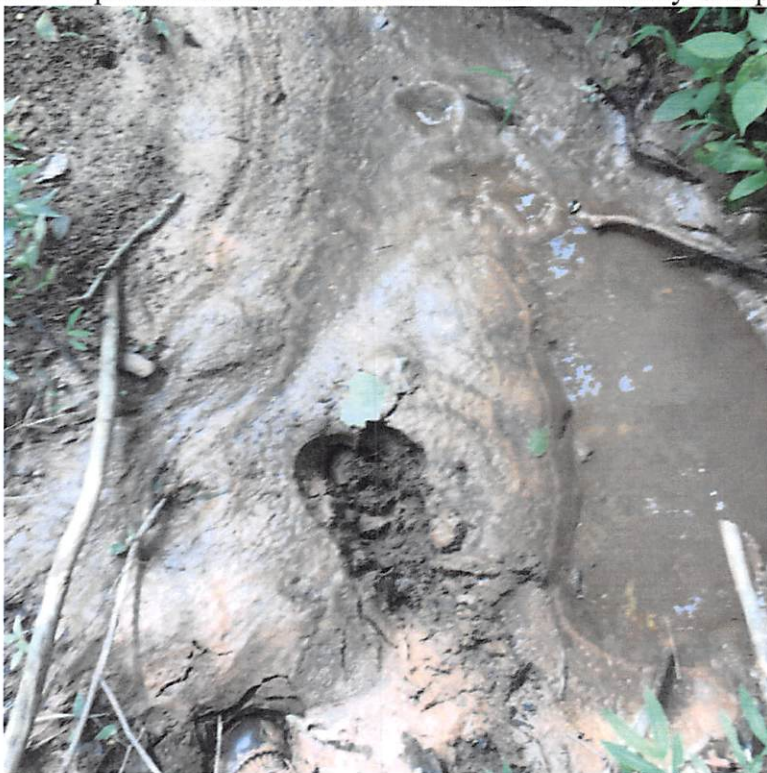
Sediment deposits downstream of LOD on UNT of Jockey Camp Run.

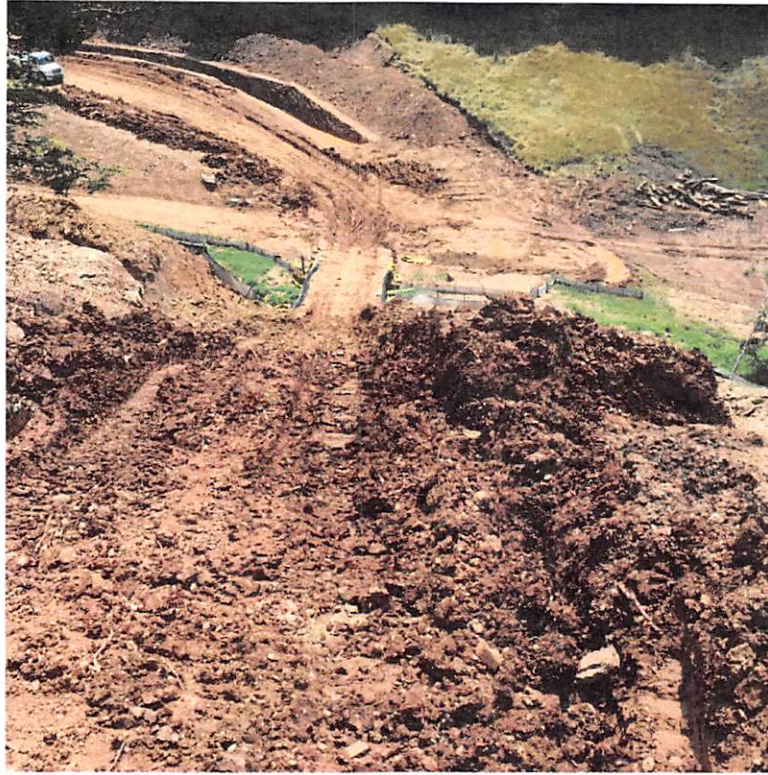
Area adjacent to UNT of Rock Camp Run.

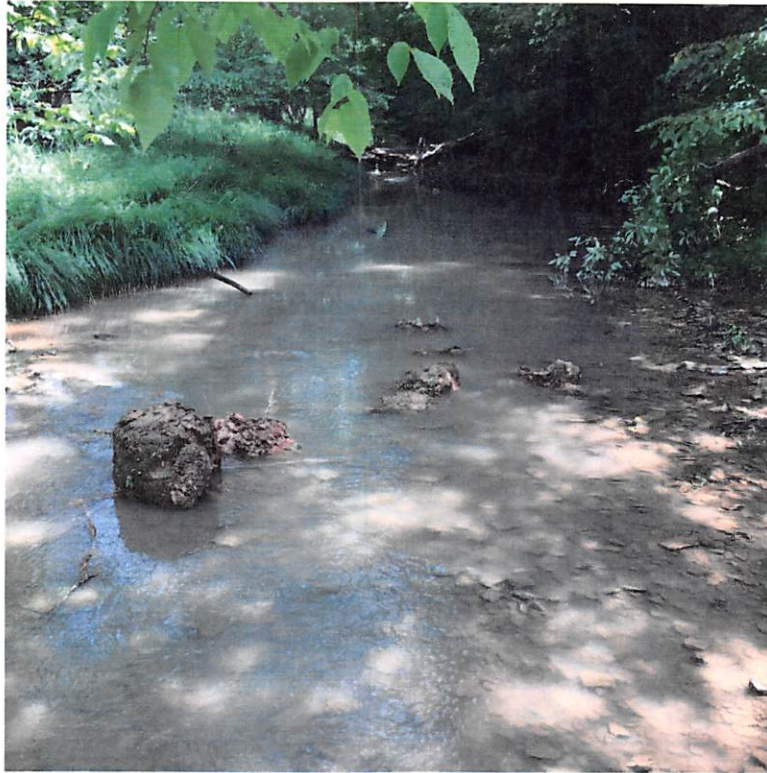
Sediment deposits (rollers) in Nutter Fork.

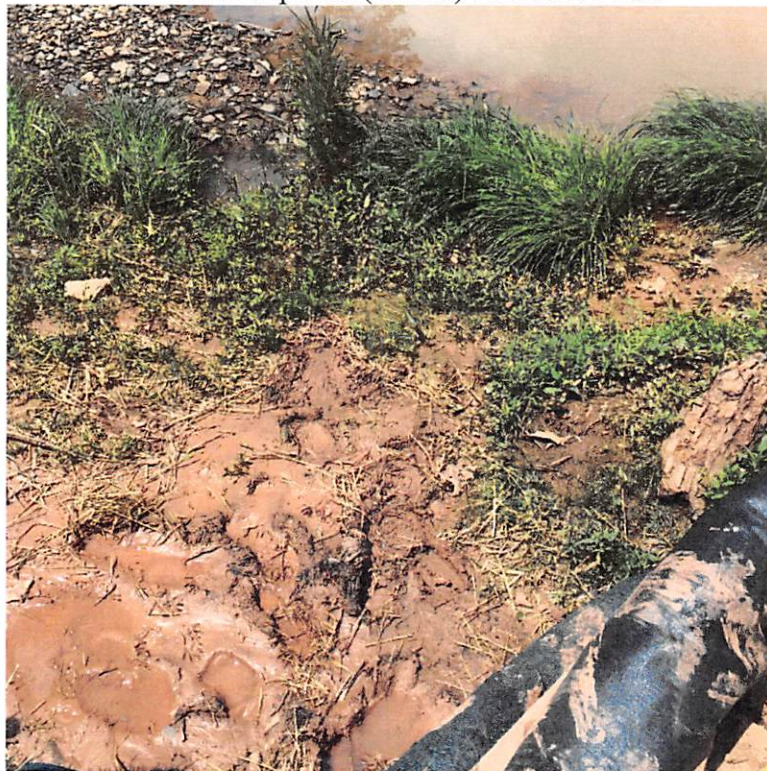
Offsite sediment deposits adjacent to Nutter Fork.

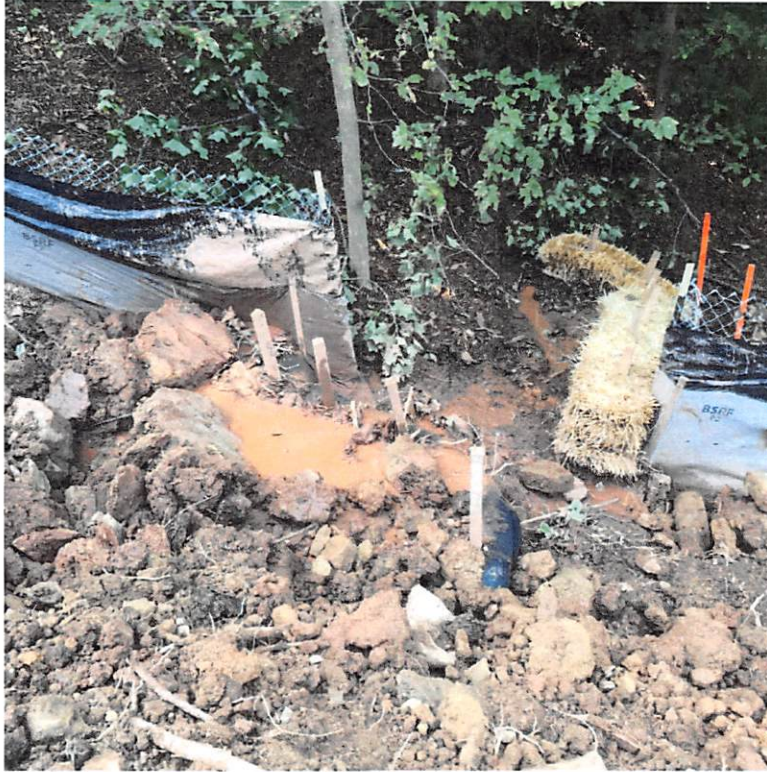
Area above offsite sediment deposits near Nutter Fork

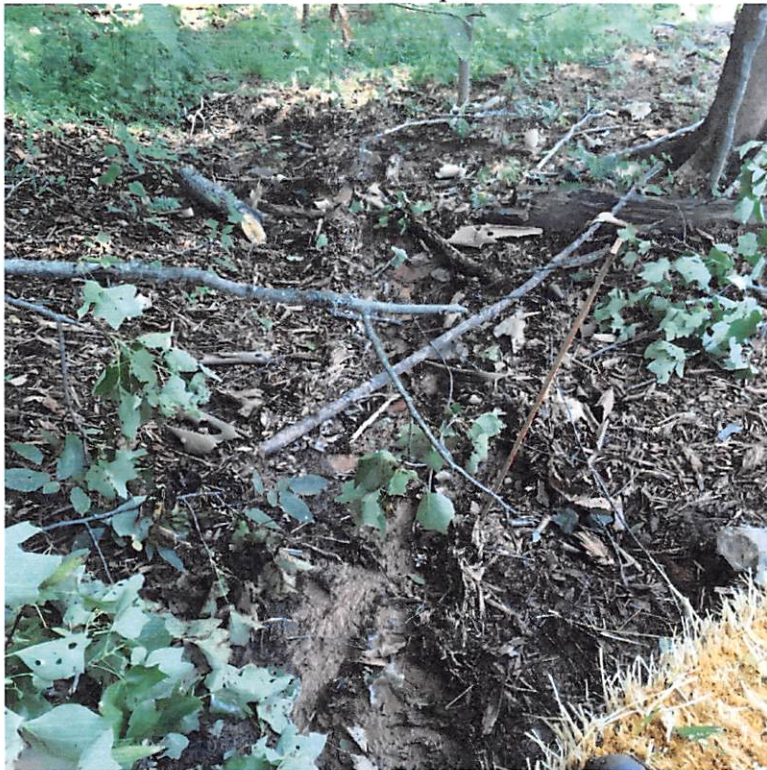
Offsite sediment deposits near Nutter Fork.

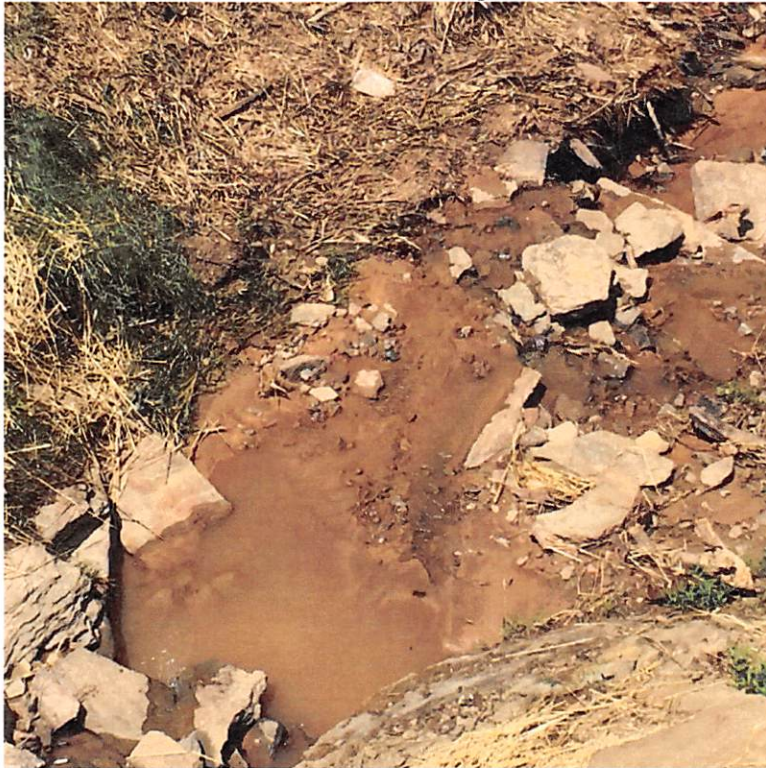
Offsite sediment deposits at UNT of Nutter Fork.

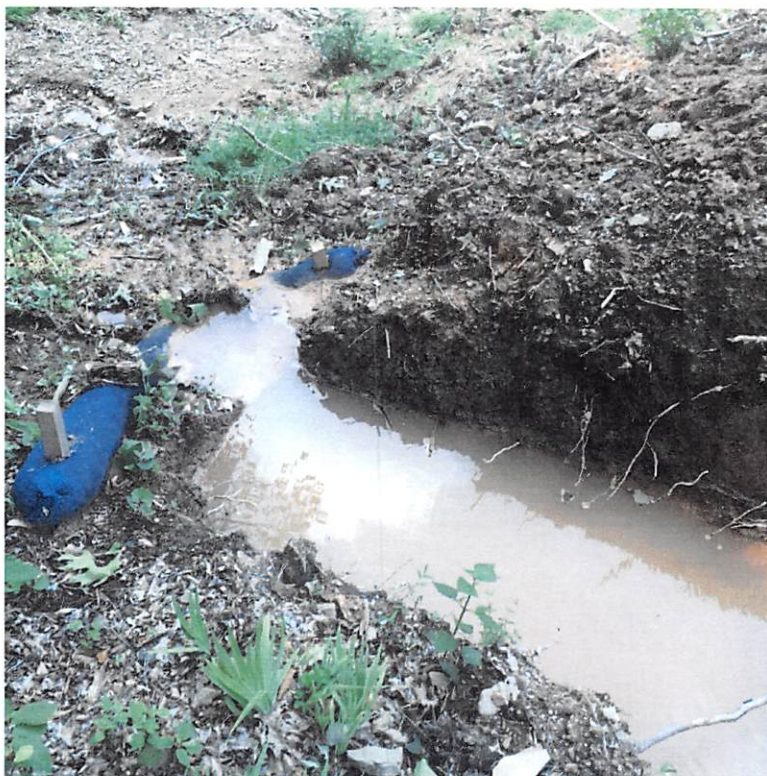
Area upslope of offsite sediment deposits at Camp Mistake Run.

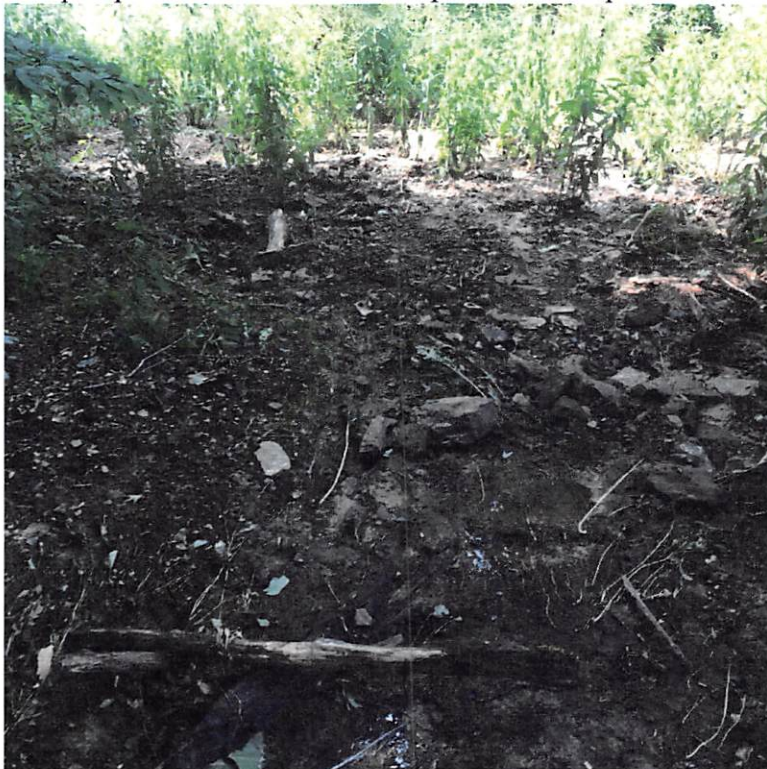
Offsite sediment deposits at Camp Mistake Run.

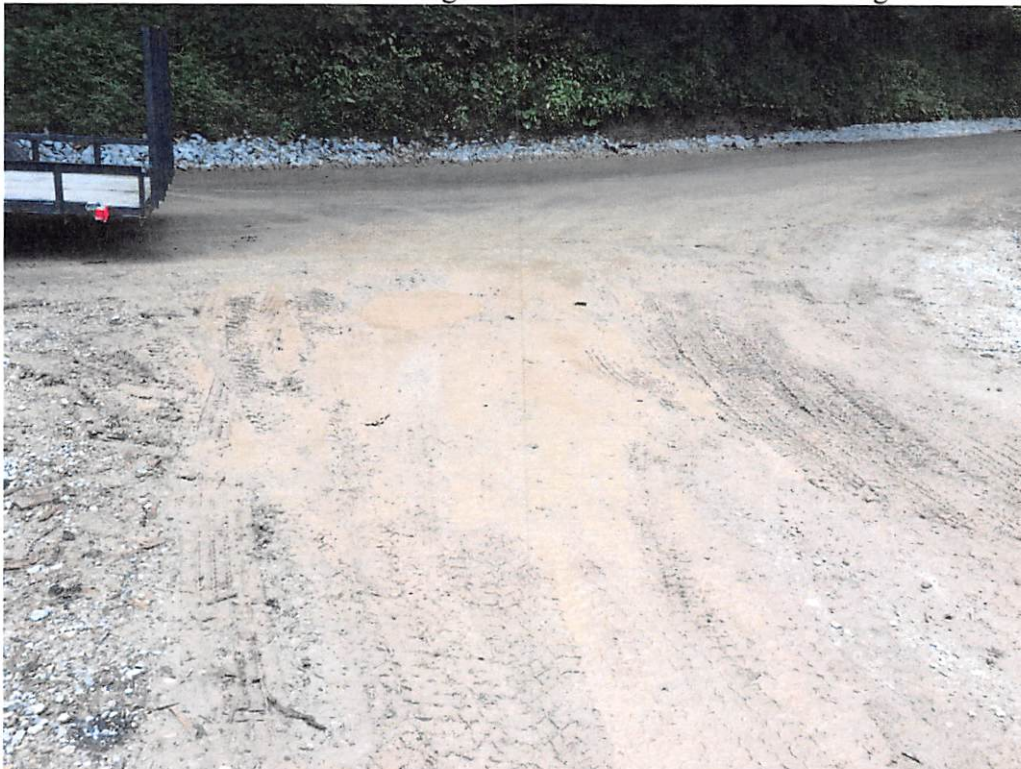
Unstable construction entrance causing mud to be tracked out onto Morgan's Run Road.
